## FIELD INSPECTION REPORT

| Project Name: | Mountain Valley Pipeline | Inspector: | Marshall Willis |
| Inspection Date: | Tuesday, July 19, 2022 | Project Contact: | Brian Clauto, Cory Chalmers |
| Spread H:<br>Roanoke County | STA 12601+00 – 12637+00<br>MVP-RO-279.01/02 | Weather: | Wet |

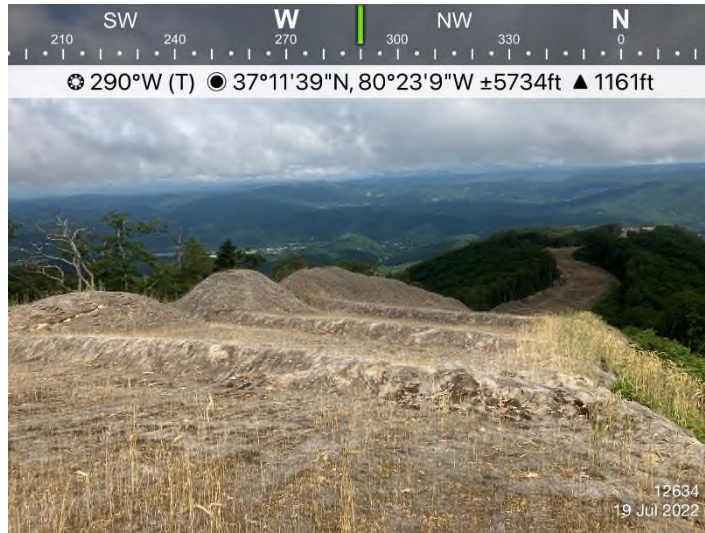
**Figure 1: STA 12634+00** – Controls in place and functioning properly.

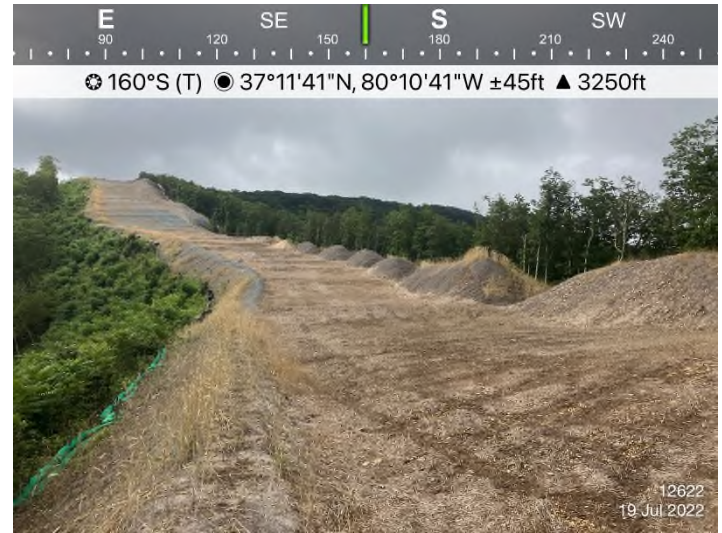
**Figure 2: STA 12622+00** – Controls in place and functioning properly.

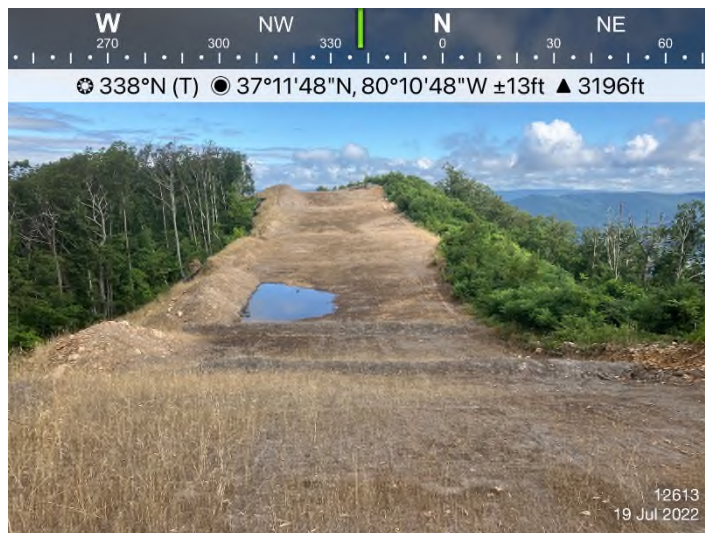
**Figure 3: STA 12613+00** – Controls in place and functioning properly.

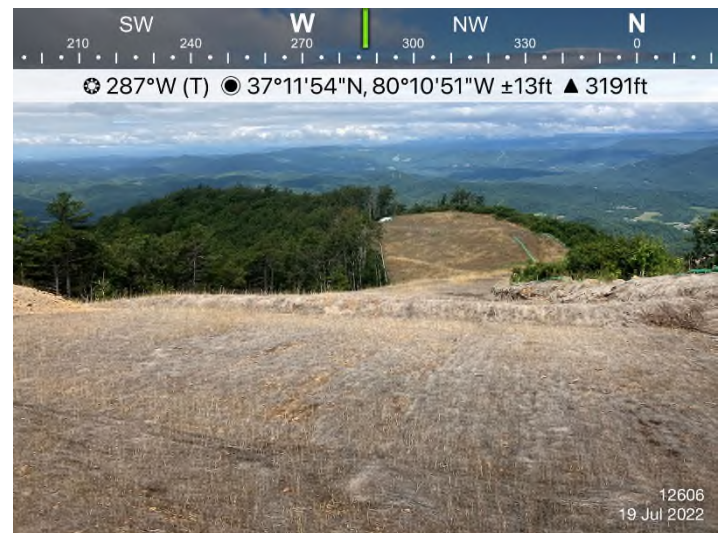
**Figure 4: STA 12606+00** – Controls in place and functioning properly.
