## FIELD INSPECTION REPORT

| Project Name: | Mountain Valley Pipeline | Inspector: | Marshall Willis |
| Spread H:<br>Montgomery County | STA 12373+28 – 12435+16<br>MVP-MN-279.02 | Weather: | Wet |

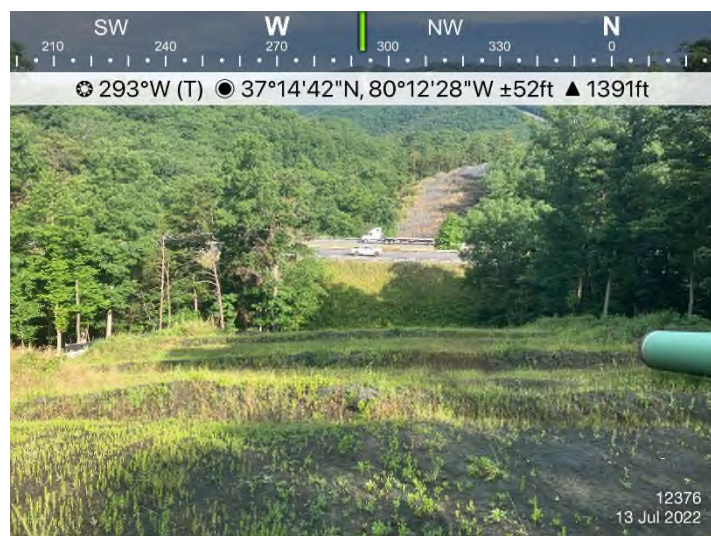
**Figure 1: STA 12376+00** – Controls in place and functioning properly.

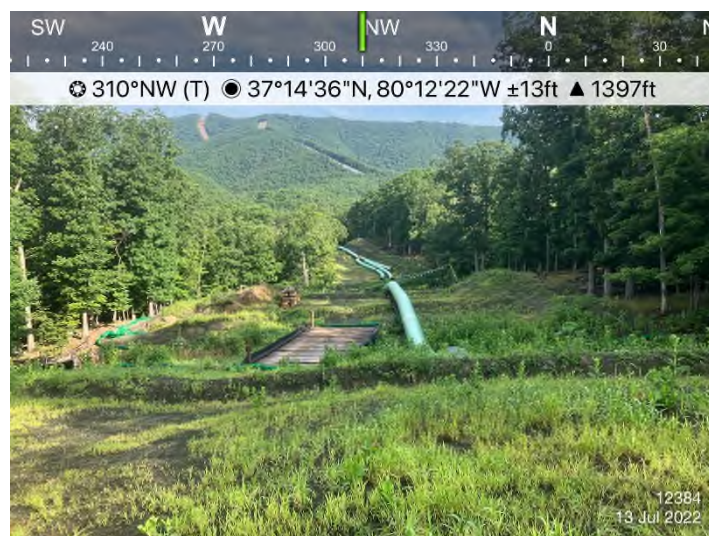
**Figure 2: STA 12384+00** – Controls in place and functioning properly.

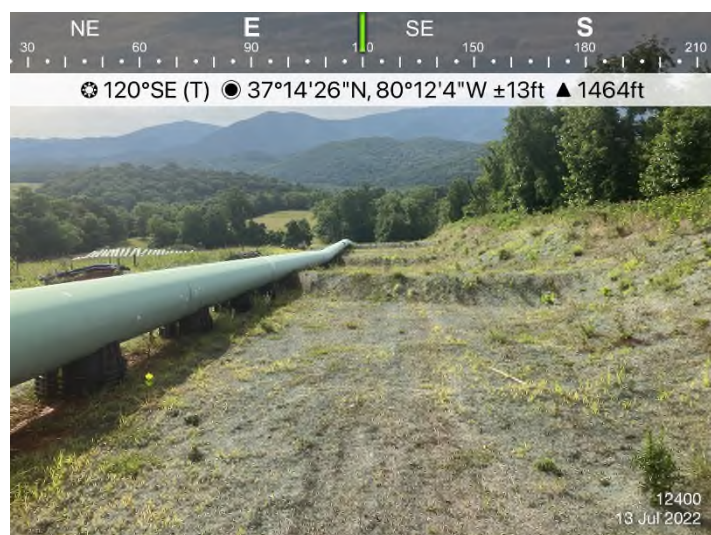
**Figure 3: STA 12400+00** – Controls in place and functioning properly.

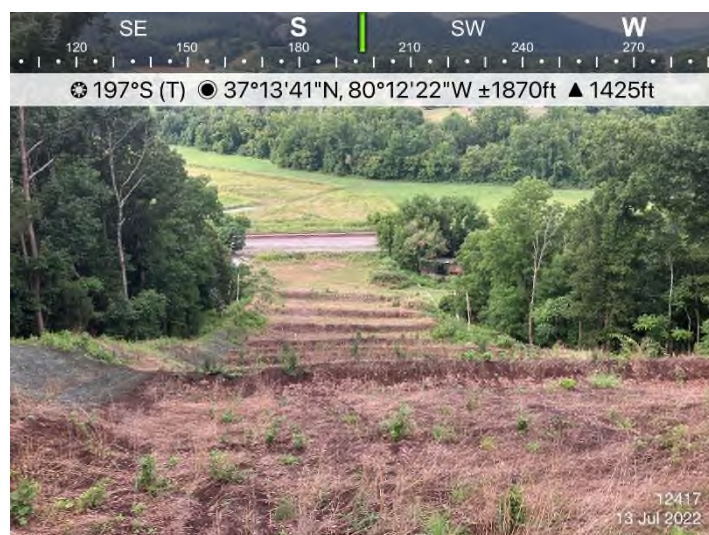
**Figure 4: STA 12417+00** – Controls in place and functioning properly.
