FIELD INSPECTION REPORT

Project Name:	Mountain Valley Pipeline	Inspector:	Marshall Willis
Inspection Date:	Wednesday, July 6, 2022	Project Contact:	Brian Clauto, Cory Chalmers
Spread H: Roanoke County	STA 12866+36 – 12937+00 MVP-RO-286	Weather:	Wet

FIELD INSPECTION PHOTO LOG

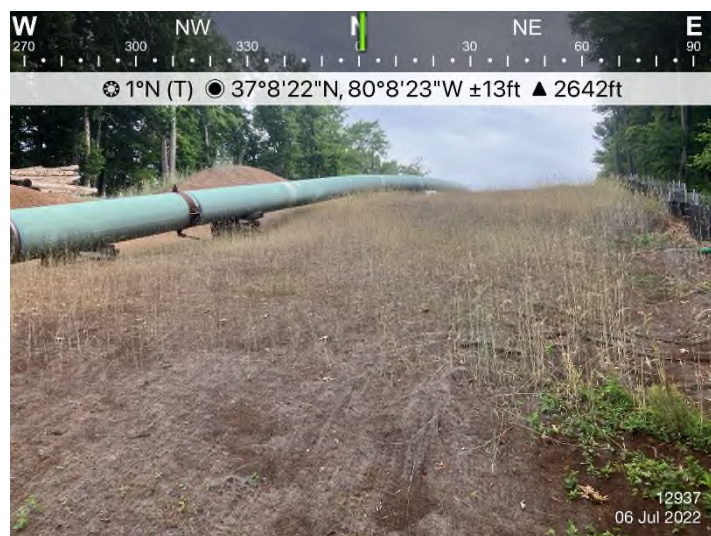
Figure 1: STA 12937+00 – Controls in place and functioning properly.

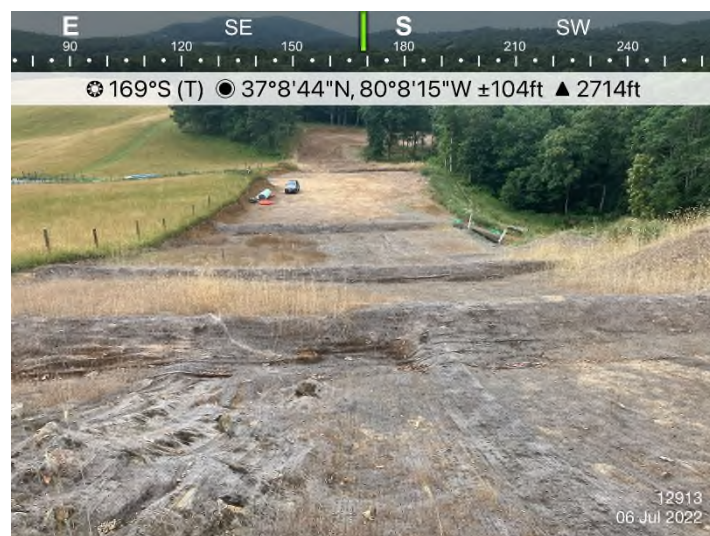
Figure 2: STA 12913+00 – Controls in place and functioning properly.

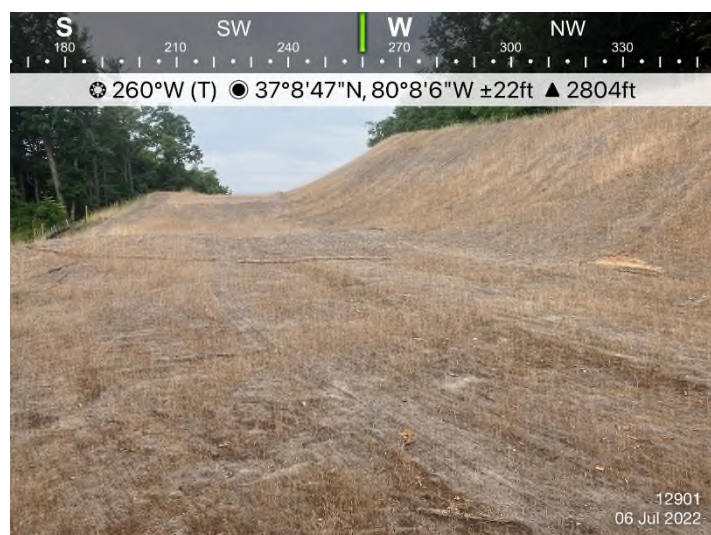
Figure 3: STA 12901+00 – Controls in place and functioning properly.

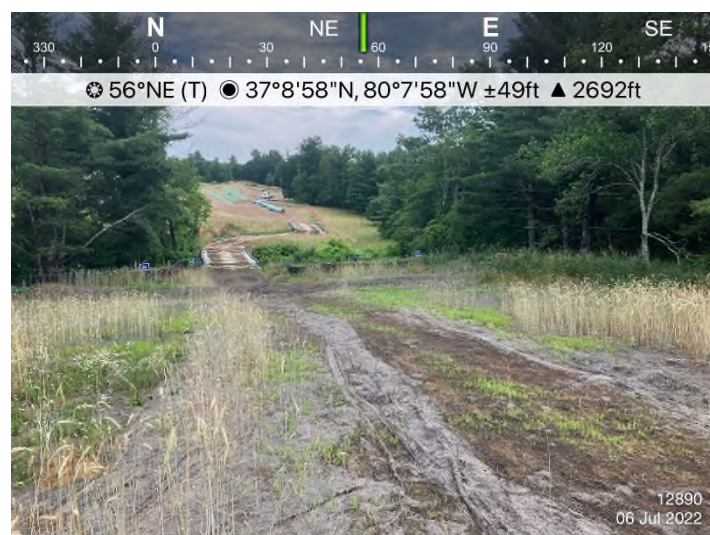
Figure 4: STA 12890+00 – Controls in place and functioning properly.
