## FIELD INSPECTION REPORT

| Project Name: | Mountain Valley Pipeline | Inspector: | Marshall Willis |
| Spread H:<br>Roanoke County | STA 12446+00 – 12485+00<br>MVP-MLV-AR-28 | Weather: | Dry |

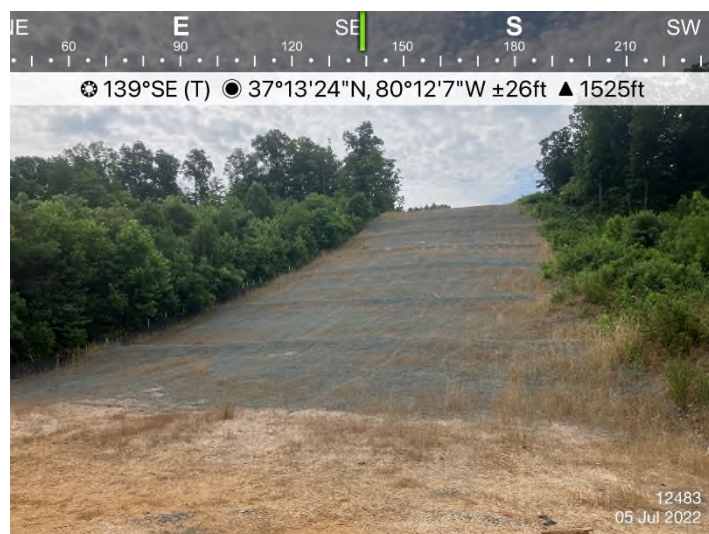
**Figure 1: STA 12483+00** – Controls in place and functioning properly.

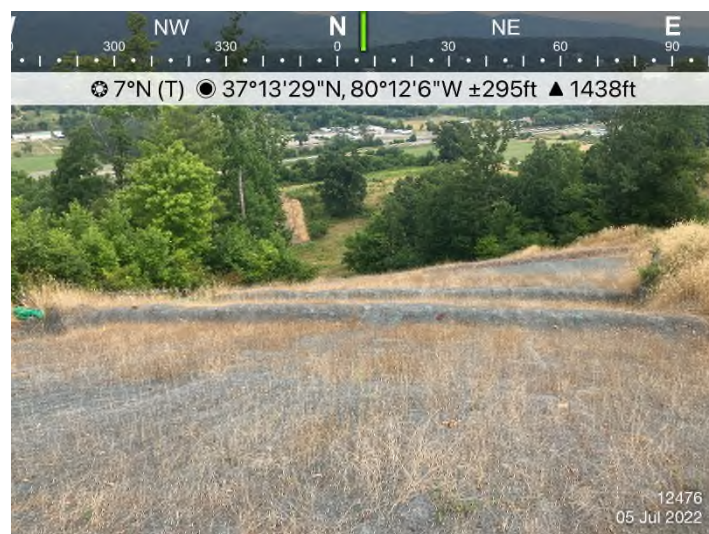
**Figure 2: STA 12480+00** – Controls in place and functioning properly.

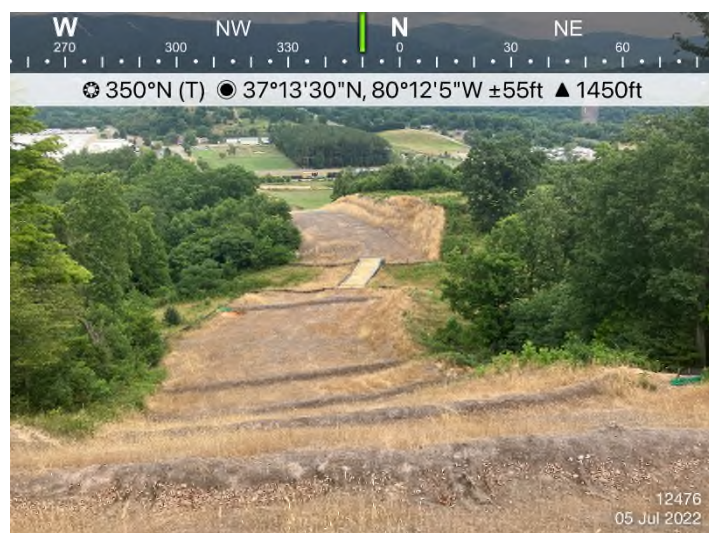
**Figure 3: STA 12476+00** – Controls in place and functioning properly.

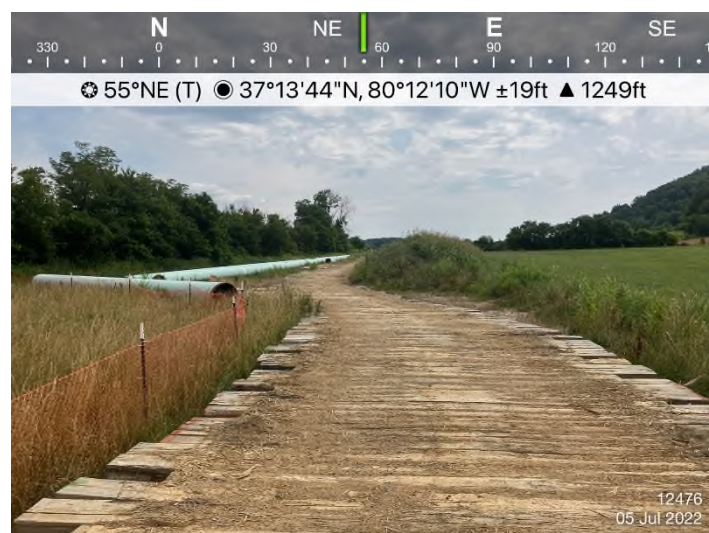
**Figure 4: STA 12460+00** – Controls in place and functioning properly.
