## FIELD INSPECTION REPORT

| Project Name: | Mountain Valley Pipeline | Inspector: | Marshall Willis |
| Inspection Date: | Wednesday, June 29, 2022 | Project Contact: | Brian Clauto, Cory Chalmers |
| Spread H:<br>Montgomery County | STA 12071+80- 12188+34<br>MVP-MN-270 | Weather: | Dry |

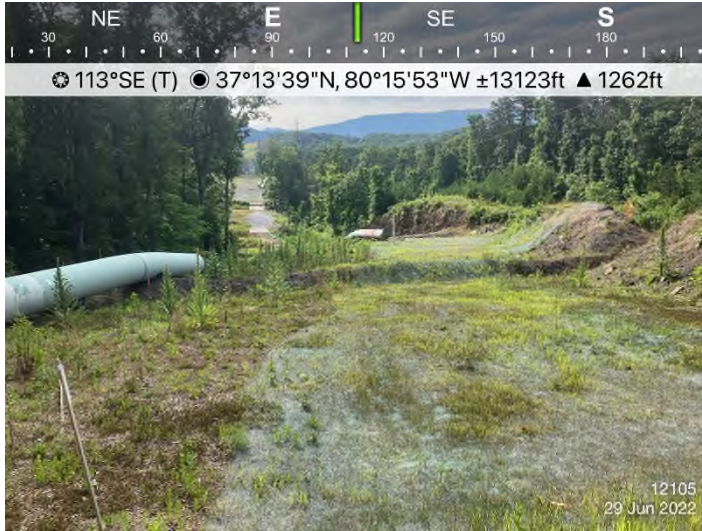
**Figure 1: STA 12105+00** – Controls in place and functioning properly. Area stabilized with erosion matting.

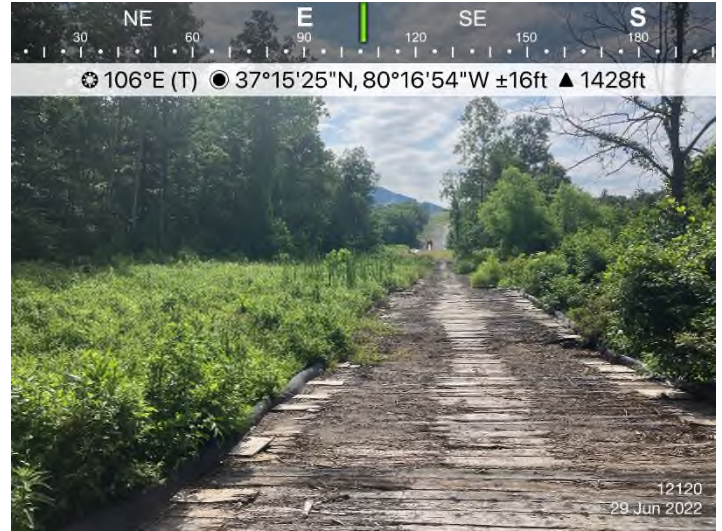
**Figure 2: STA 12120+00** – Controls in place and functioning properly.

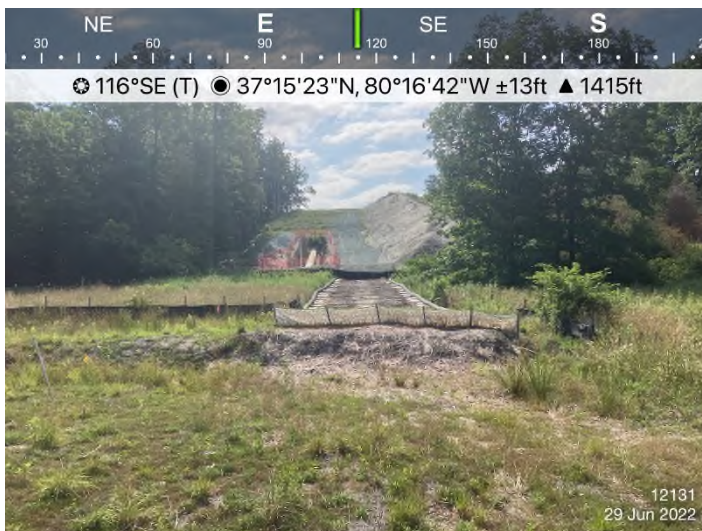
**Figure 3: STA 12131+00** – Controls in place and functioning properly. Area stabilized with erosion matting.

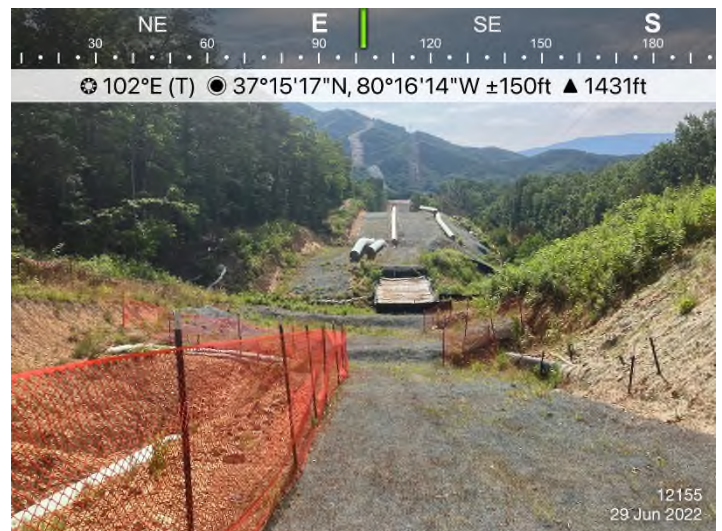
**Figure 4: STA 12155+00** – Controls in place and functioning properly. Area stabilized with erosion matting.
