## FIELD INSPECTION REPORT

| Project Name: | Mountain Valley Pipeline | Inspector: | Marshall Willis |
| Inspection Date: | Tuesday, June 28, 2022 | Project Contact: | Brian Clauto, Cory Chalmers |
| Spread H:<br>Roanoke County | STA 12690+43- 12730+00<br>MVP-RO-280/281 | Weather: | Dry |

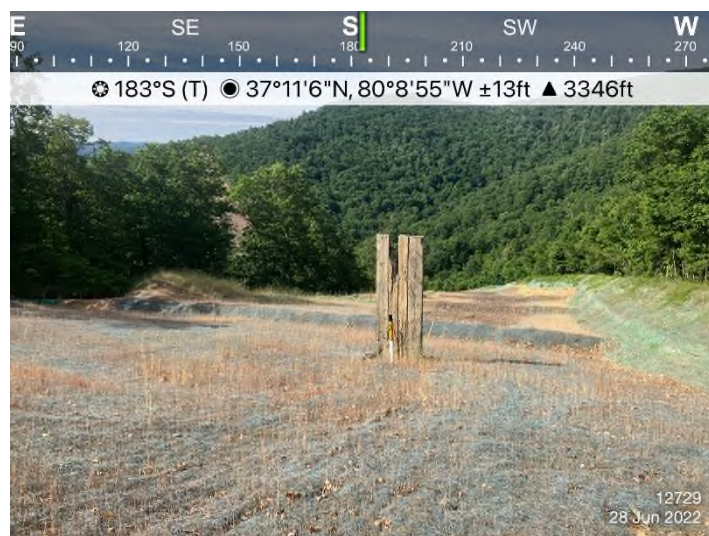
**Figure 1: STA 12729+00** – Controls in place and functioning properly. Area stabilized with erosion matting.

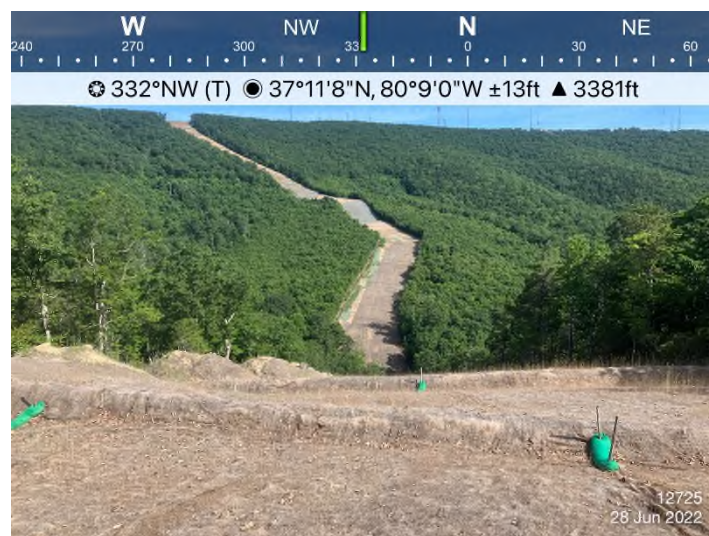
**Figure 2: STA 12725+00** – Controls in place and functioning properly. Area stabilized with erosion matting.

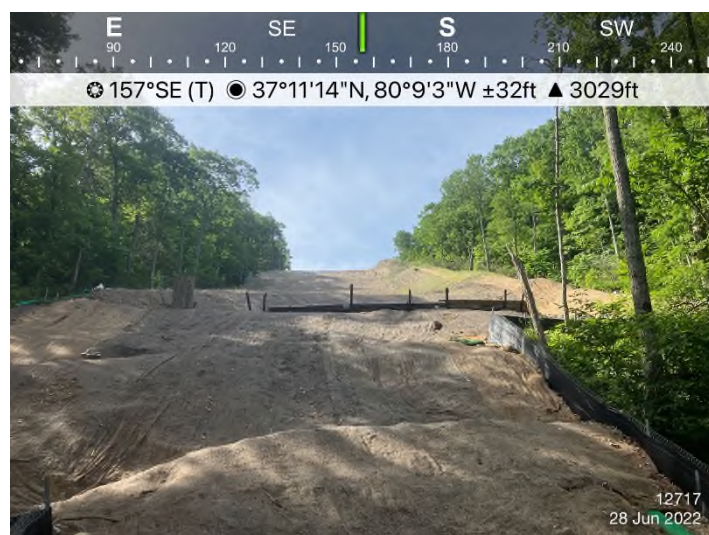
**Figure 3: STA 12717+00** – Controls in place and functioning properly. Area stabilized with erosion matting.

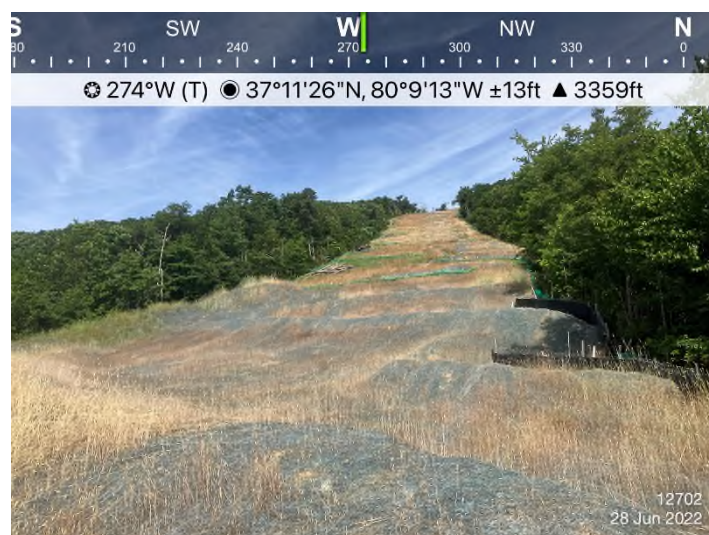
**Figure 4: STA 12702+00** – Controls in place and functioning properly. Area stabilized with erosion matting.
