## FIELD INSPECTION REPORT

| Project Name: | Mountain Valley Pipeline | Inspector: | Marshall Willis |
| Spread I:<br>Franklin County | STA 13850+00– 13892+50<br>MVP-FR-303.01 | Weather: | Dry |

## FIELD INSPECTION PHOTO LOG

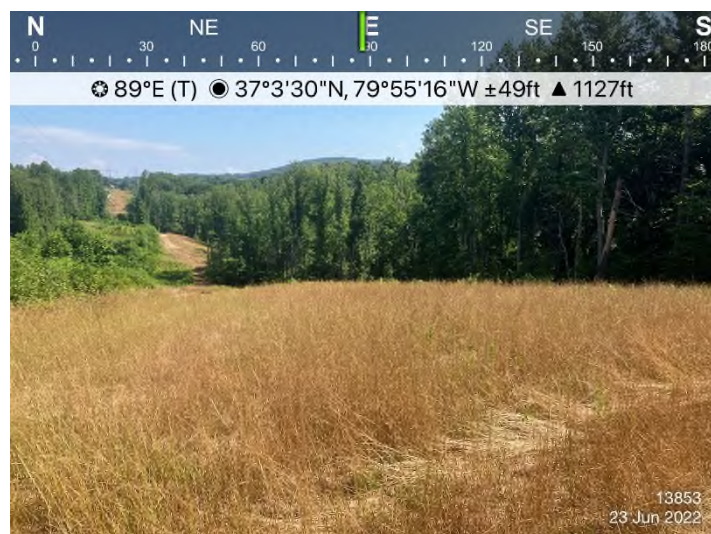
**Figure 1: STA 13853+00** – Controls in place and functioning properly.

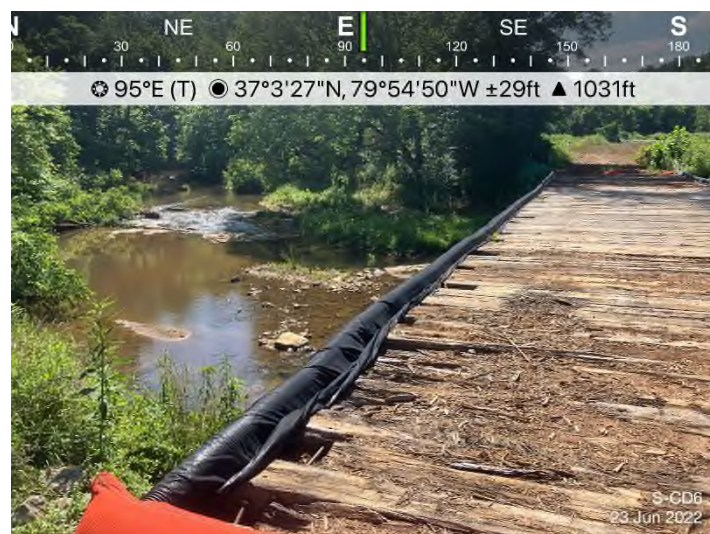
**Figure 2: Stream S-CD6** – Controls in place and functioning properly along stream crossing.

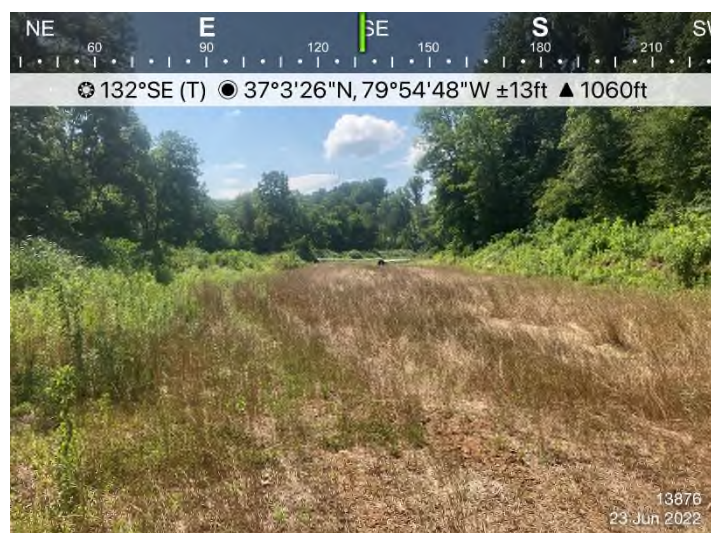
**Figure 3: STA 13876+00** – Controls in place and functioning properly.

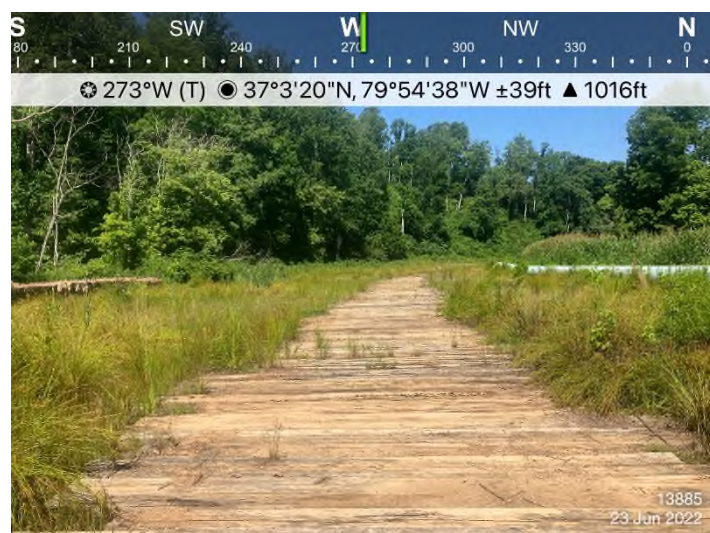
**Figure 4: STA 13885+00** – Controls in place and functioning properly.
