## FIELD INSPECTION REPORT

| Project Name: | Mountain Valley Pipeline | Inspector: | Marshall Willis |
| Inspection Date: | Wednesday, June 22, 2022 | Project Contact: | Brian Clauto, Cory Chalmers |
| Spread I:<br>Pittsylvania County | STA 15693+42- 15741+92<br>MVP-PI-337 | Weather: | Dry |

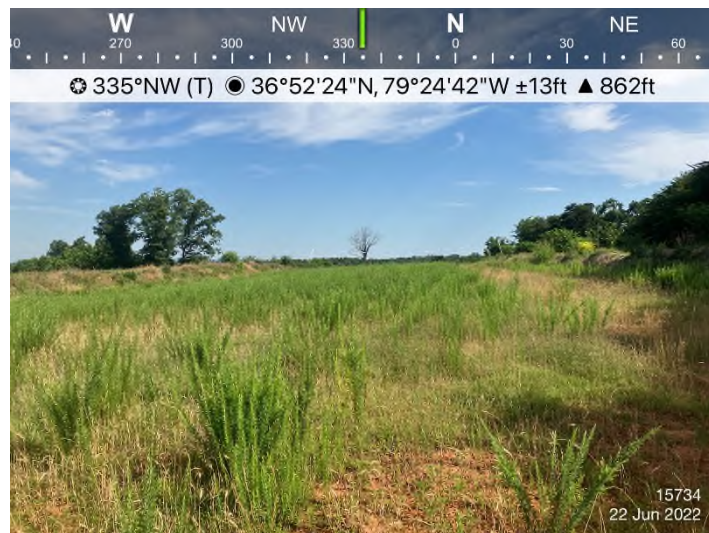
**Figure 2: STA 15734+00** – Controls in place and functioning properly.

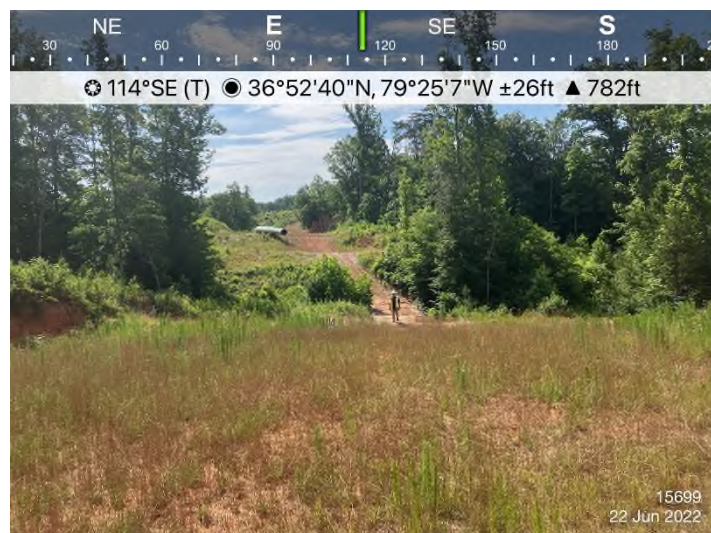
**Figure 3: STA 15699+00** – Controls in place and functioning properly.

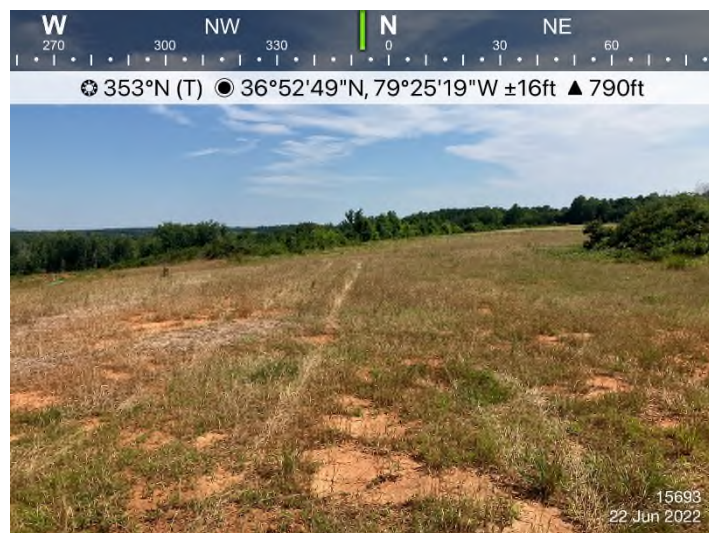
**Figure 4: STA 15693+00** – Controls in place and functioning properly.
