## FIELD INSPECTION REPORT

| Project Name: | Mountain Valley Pipeline | Inspector: | Marshall Willis |
| Inspection Date: | Friday, June 17, 2022 | Project Contact: | Brian Clauto, Cory Chalmers |
| Spread H:<br>Franklin County | STA 13030+00 – 13068+00<br>MVP-FR-289/290 | Weather: | Wet |

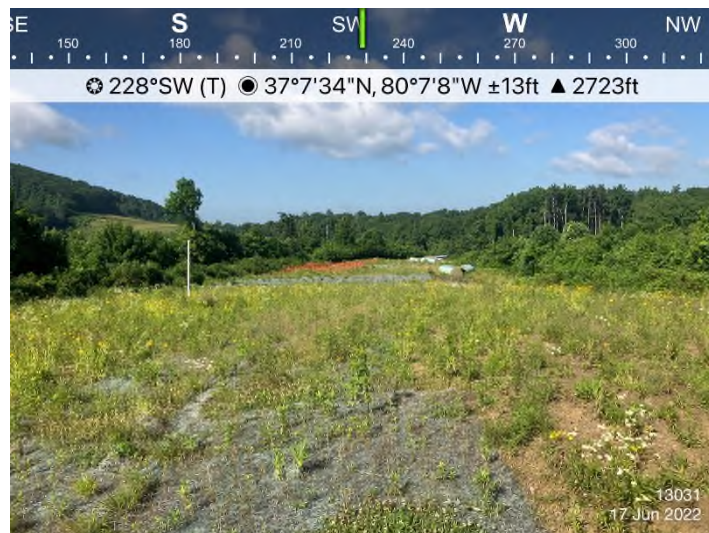
**Figure 1: STA 13031+00** – Controls in place and functioning properly.

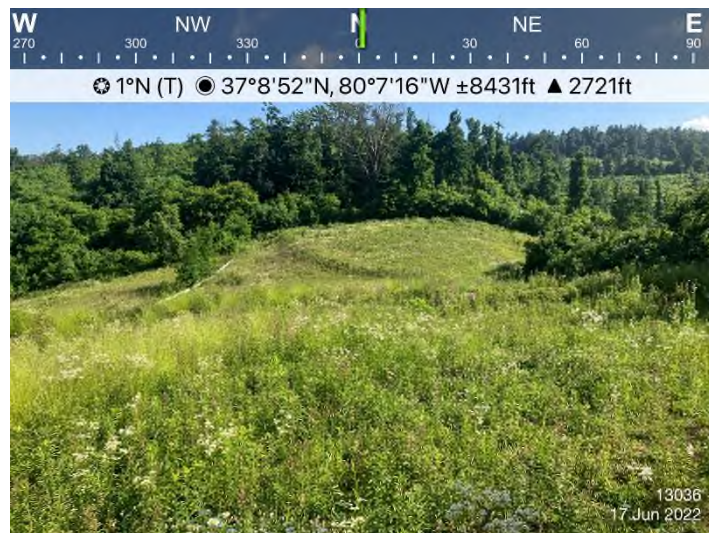
**Figure 2: STA 13036+00** – Controls in place and functioning properly.

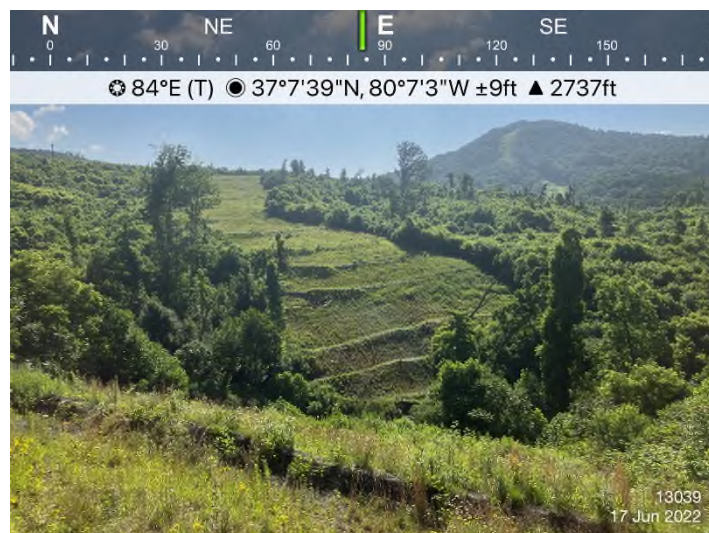
**Figure 3: STA 13039+00** – Controls in place and functioning properly.

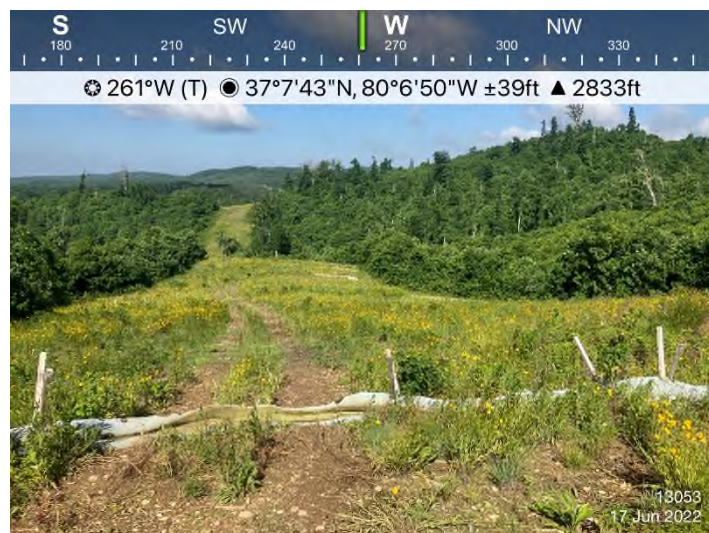
**Figure 4: STA 13053+00** – Controls in place and functioning properly.
