## FIELD INSPECTION REPORT

| Project Name: | Mountain Valley Pipeline | Inspector: | Marshall Willis |
| Inspection Date: | Thursday, June 16, 2022 | Project Contact: | Brian Clauto, Cory Chalmers |
| Spread H:<br>Montgomery County | STA 12001+72 – 12015+00<br>MVP-MN-268/268.01 | Weather: | Dry |

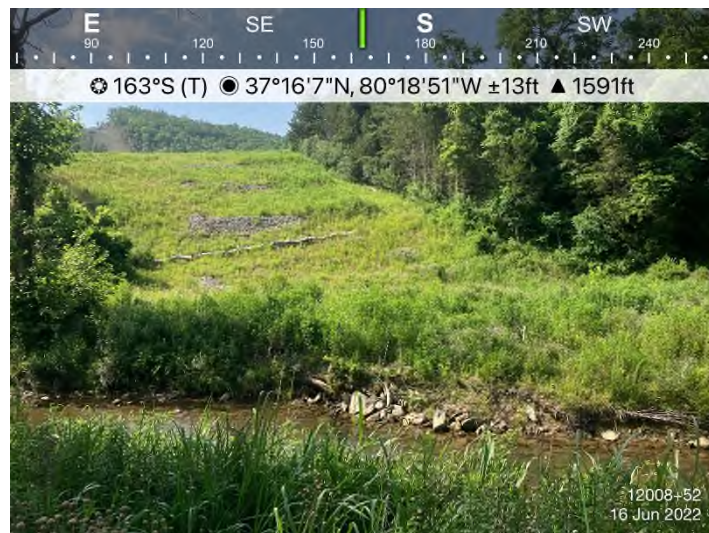
**Figure 1: STA 12008+52** – Area permanently vegetated; adequate to inhibit erosion.

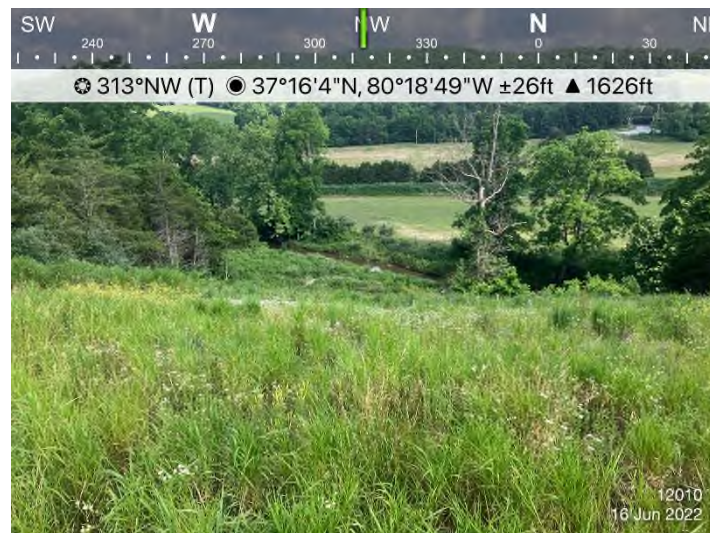
**Figure 2: STA 12010+00** – Area permanently vegetated; adequate to inhibit erosion.

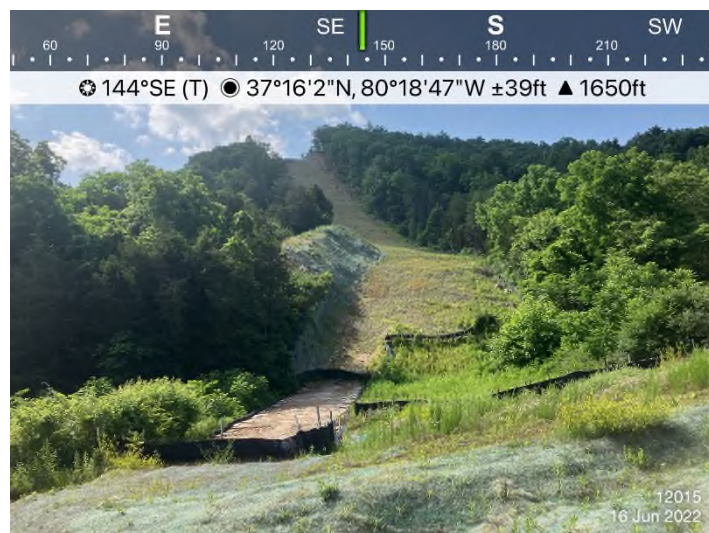
**Figure 3: STA 12015+00** – Controls in place and functioning properly.

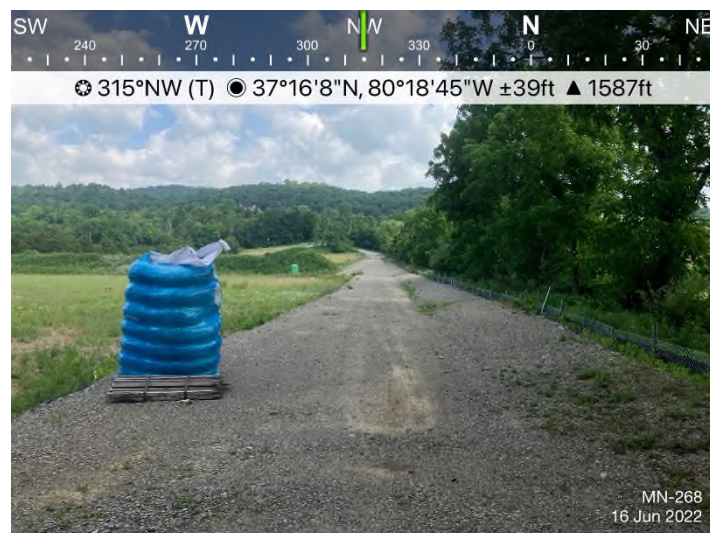
**Figure 4: MVP-MN-268** – Controls in place and functioning properly along access road.
