FIELD INSPECTION REPORT

Project Name:	Mountain Valley Pipeline	Inspector:	Marshall Willis
Inspection Date:	Wednesday, June 15, 2022	Project Contact:	Brian Clauto, Cory Chalmers
Spread H: Franklin County	STA 13197+55 – 13262+66 MVP-FR-293.01	Weather:	Dry

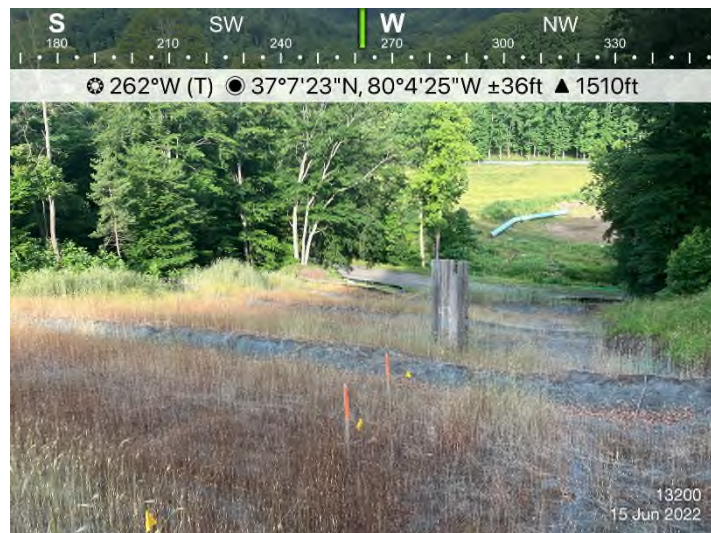
Figure 1: STA 13200+00 – Controls in place and functioning properly. Area stabilized with erosion matting.

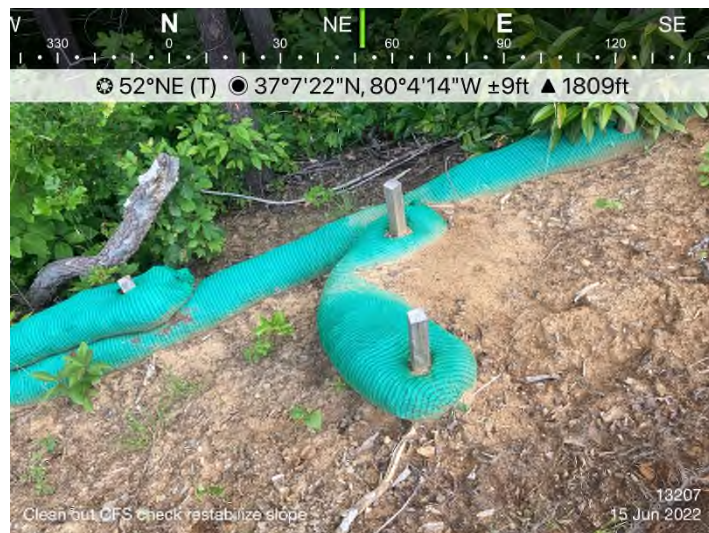
Figure 2: STA 13207+00 – Maintain CFS/re-stabilize area.

- STA 13207+00: CFS maintenance needed. Re-stabilize area.

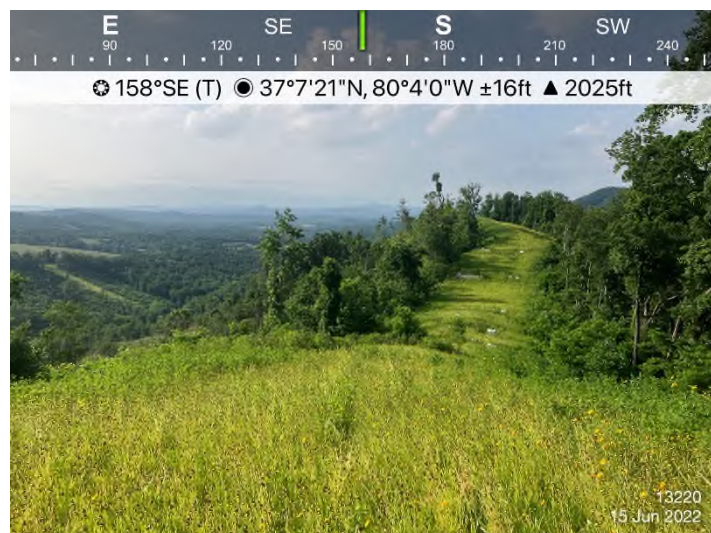
Figure 3: STA 13220+00 – Controls in place and functioning properly.

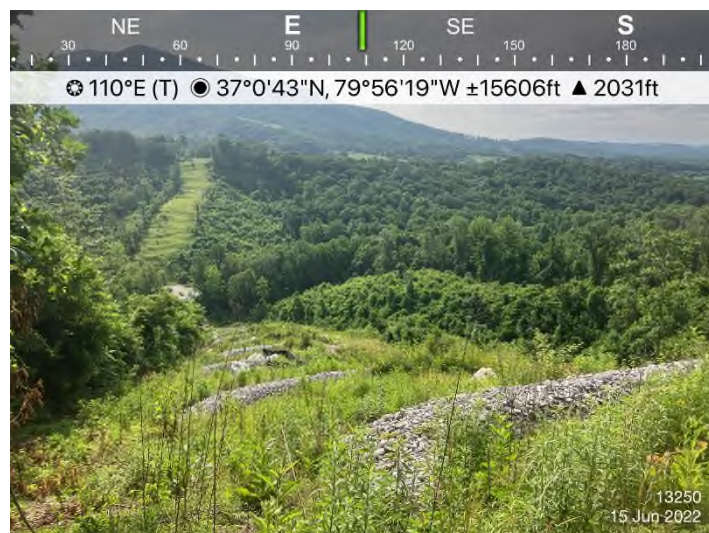
Figure 4: STA 13250+00 – Controls in place and functioning properly.
