## FIELD INSPECTION REPORT

| Project Name: | Mountain Valley Pipeline | Inspector: | Marshall Willis |
| Inspection Date: | Friday, June 10, 2022 | Project Contact: | Brian Clauto, Cory Chalmers |
| Spread H:<br>Roanoke County | STA 12601+11 – 12637+17<br>MVP-RO-279.01/279.02 | Weather: | Dry |

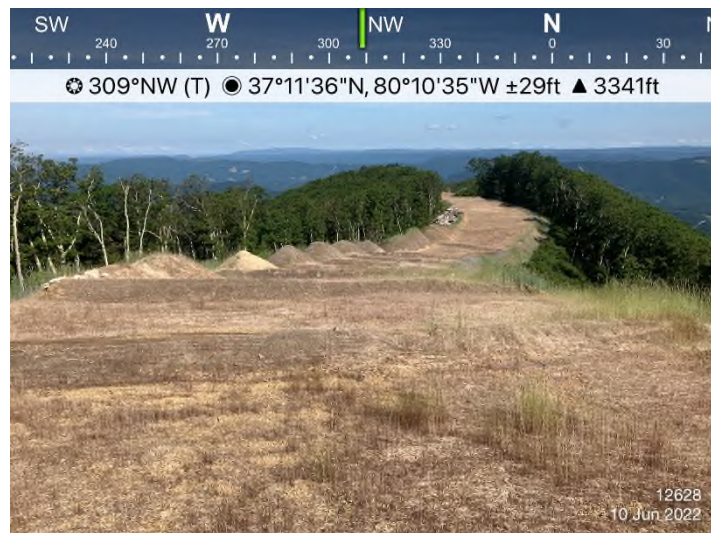
**Figure 1: STA 12628+00** – Controls in place and functioning properly. Area stabilized with erosion matting.

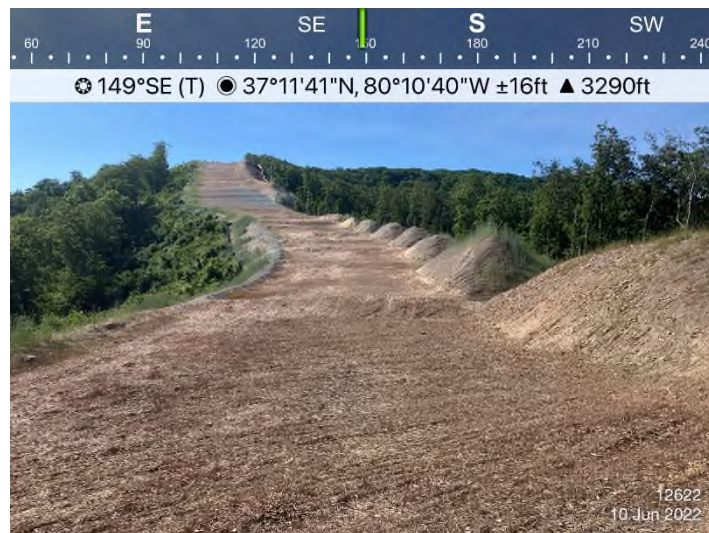
**Figure 2: STA 12622+00** – Controls in place and functioning properly. Area stabilized with erosion matting.

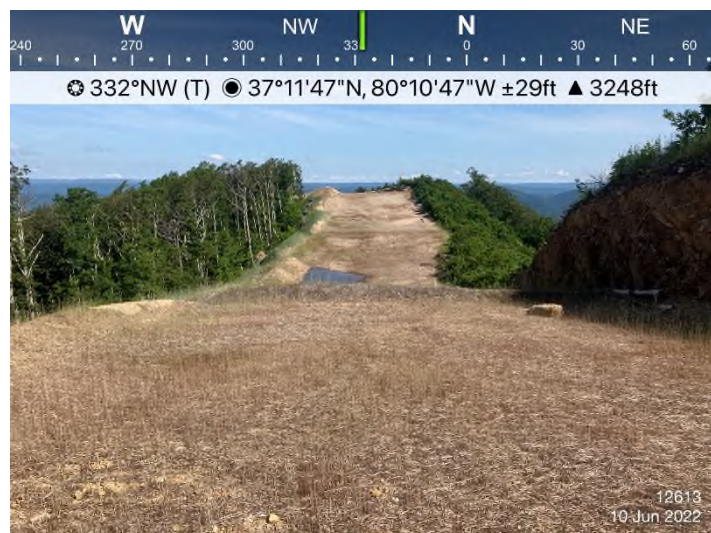
**Figure 3: STA 12613+00** – Controls in place and functioning properly. Area stabilized with erosion matting.

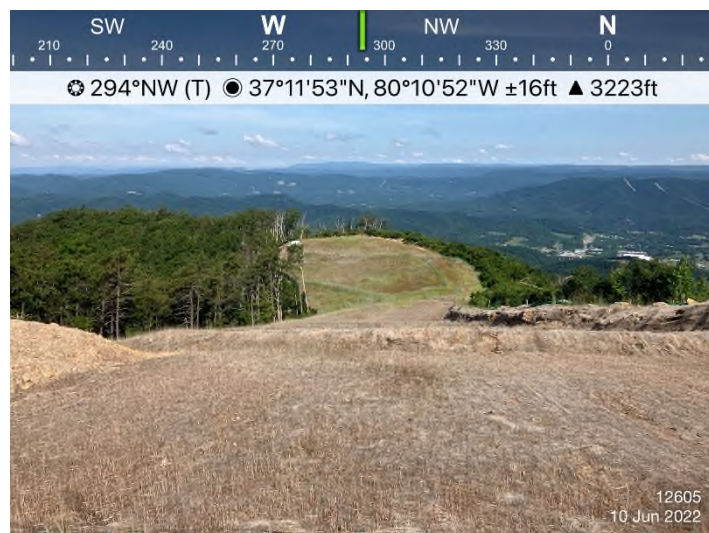
**Figure 4: STA 12605+00** – Controls in place and functioning properly. Area stabilized with erosion matting.
