## FIELD INSPECTION REPORT

| Project Name: | Mountain Valley Pipeline | Inspector: | Marshall Willis |
| Inspection Date: | Thursday, June 9, 2022 | Project Contact: | Brian Clauto, Cory Chalmers |
| Spread H:<br>Roanoke County | STA 12724+00 – 12777+00<br>MVP-RO-282/281 | Weather: | Dry |

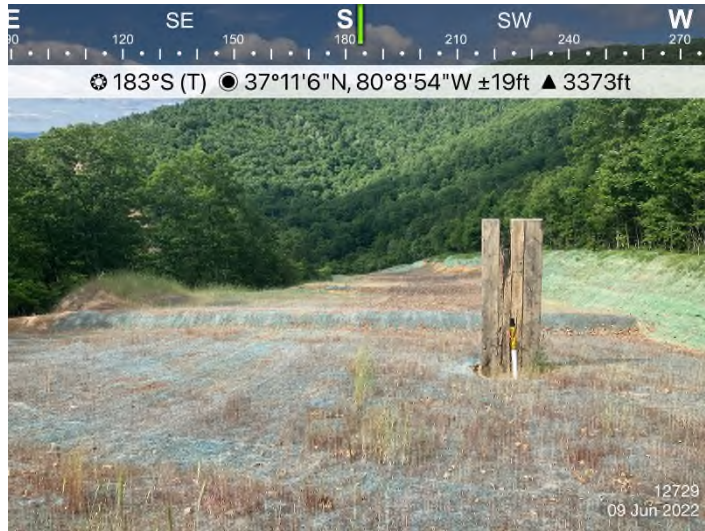
**Figure 1: STA 12729+00** – Controls in place and functioning properly. Area stabilized with erosion matting.

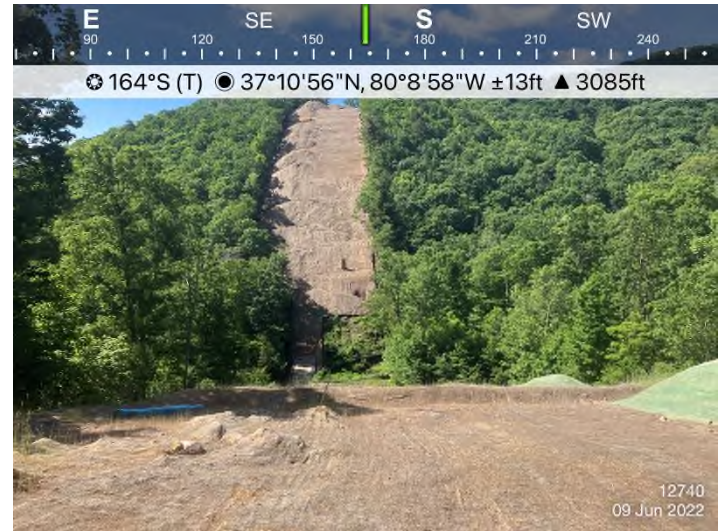
**Figure 2: STA 12740+00** – Controls in place and functioning properly. Area stabilized with erosion matting.

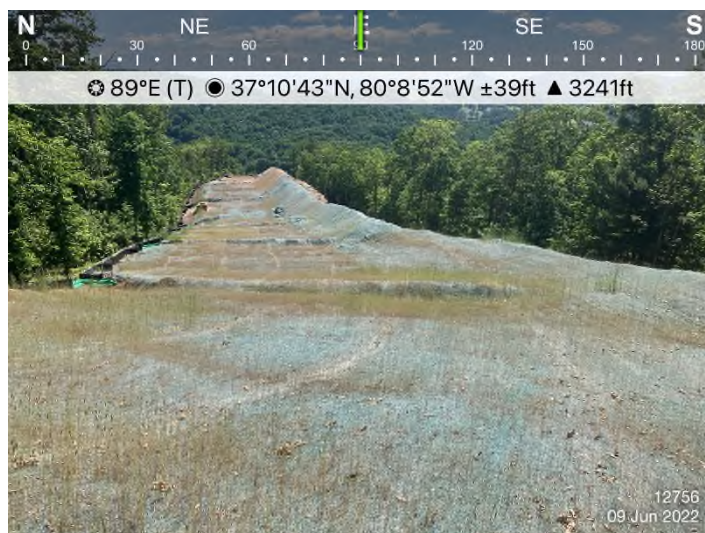
**Figure 3: STA 12756+00** – Controls in place and functioning properly. Area stabilized with erosion matting.

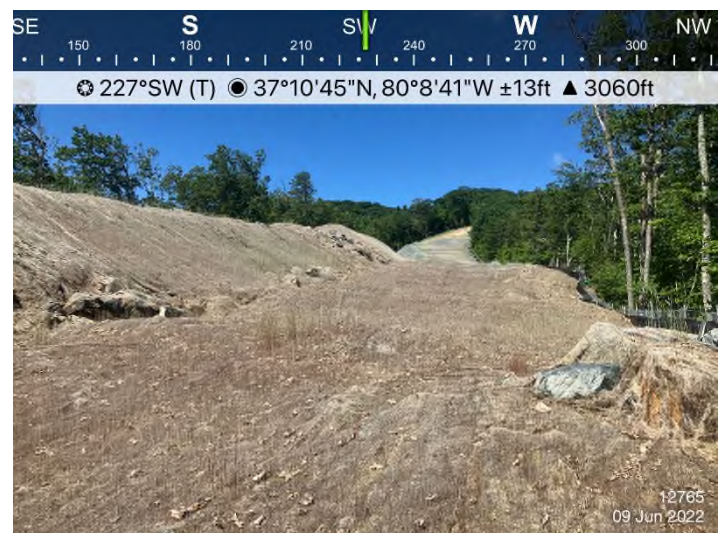
**Figure 4: STA 12765+00** – Controls in place and functioning properly. Area stabilized with erosion matting.
