## FIELD INSPECTION REPORT

| <b>Project Name:</b> | Mountain Valley Pipeline | <b>Inspector:</b> | Marshall Willis |
| <b>Inspection Date:</b> | Tuesday, June 7, 2022 | <b>Project Contact:</b> | Brian Clauto, Cory Chalmers |
| <b>Spread H:<br/>Roanoke County</b> | STA 12970+00 – 12980+00<br>STA 12760+00 – 12777+00<br>MVP-RO-282/288 | <b>Weather:</b> | Rainy |

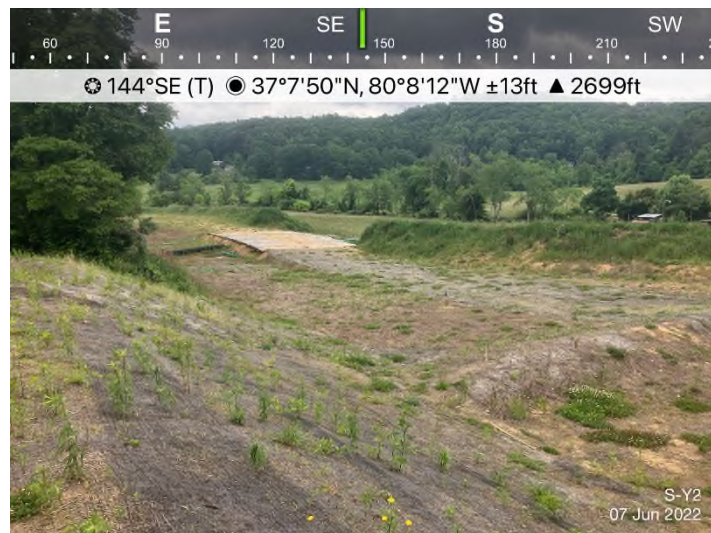
**Figure 1: STA 12974+00** – Controls in place and functioning properly.

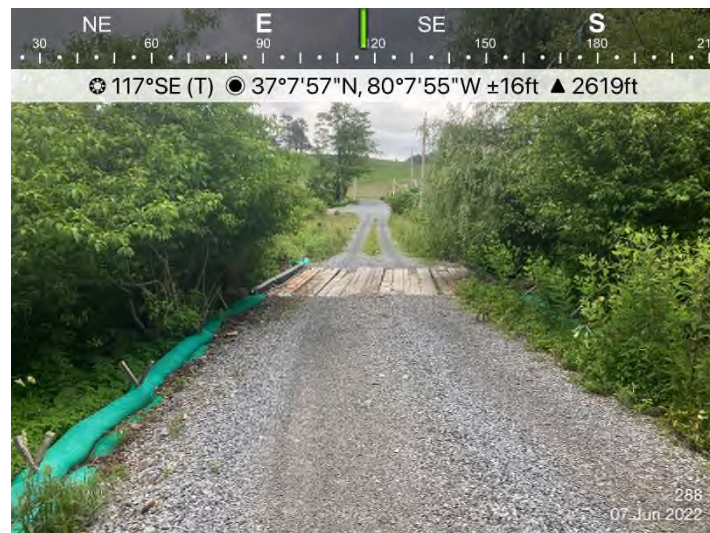
**Figure 2: MVP-RO-288** – Controls in place and functioning properly along access road.

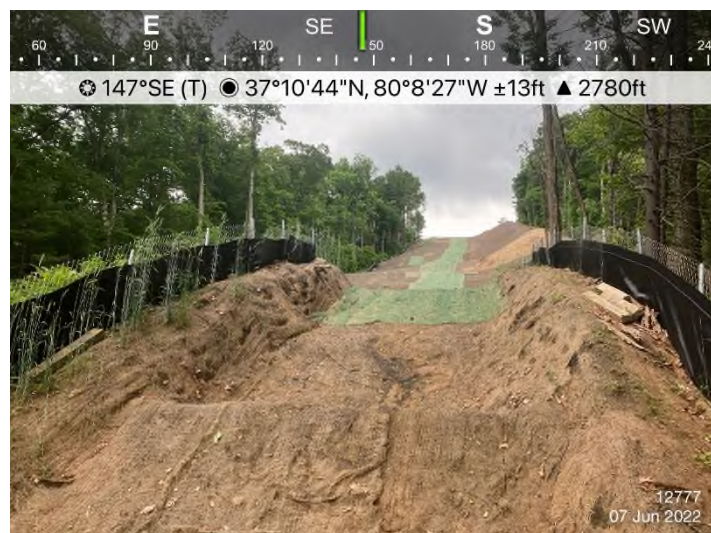
**Figure 3: STA 12777+00** – Controls in place and functioning properly.

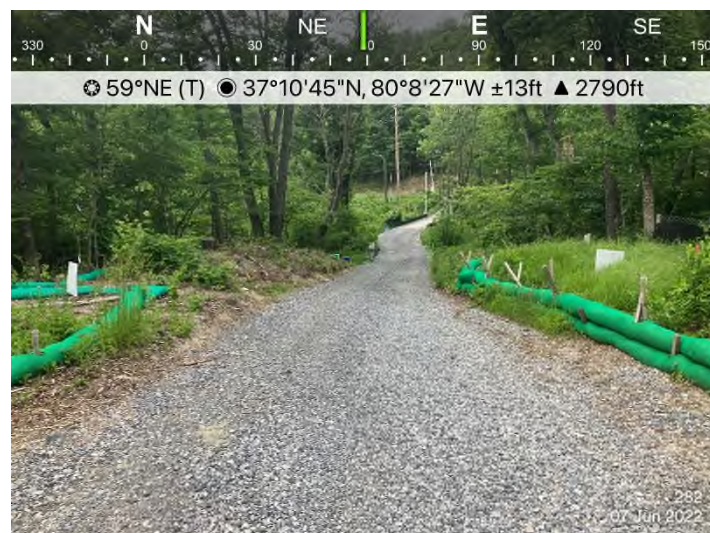
**Figure 4: MVP-RO-282** – Controls in place and functioning properly along access road.
