FIELD INSPECTION REPORT

Project Name:	Mountain Valley Pipeline	Inspector:	Marshall Willis
Inspection Date:	Wednesday, May 18, 2022	Project Contact:	Brian Clauto, Cory Chalmers
Spread I: Franklin County	Laydown Yard 032 Laydown Yard 033 Laydown Yard 034	Weather:	Dry

FIELD INSPECTION PHOTO LOG

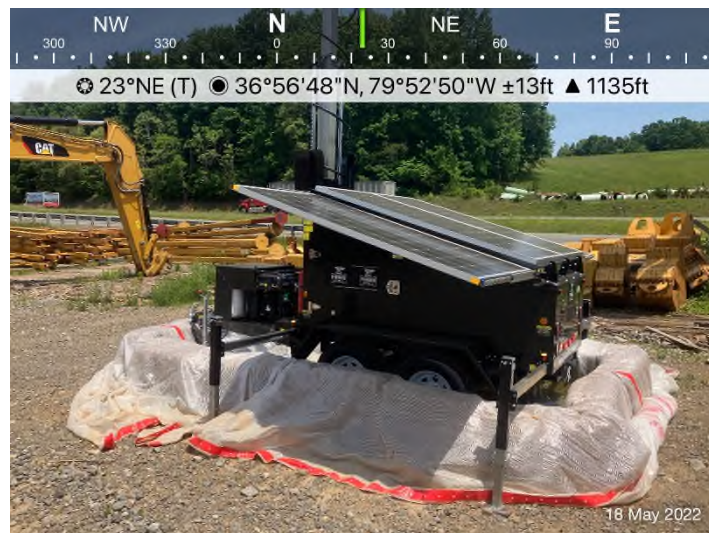
Figure 1: LY 032 – Secondary containment in place and functioning properly.

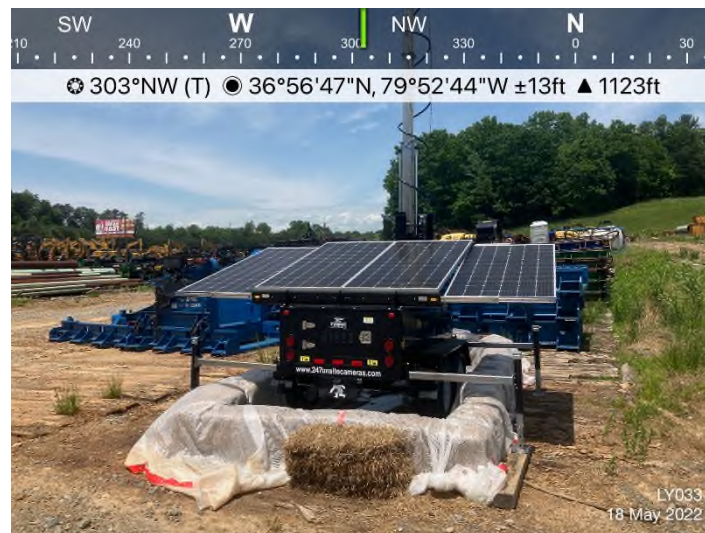
Figure 2: LY 033 – Secondary containment in place and functioning properly.

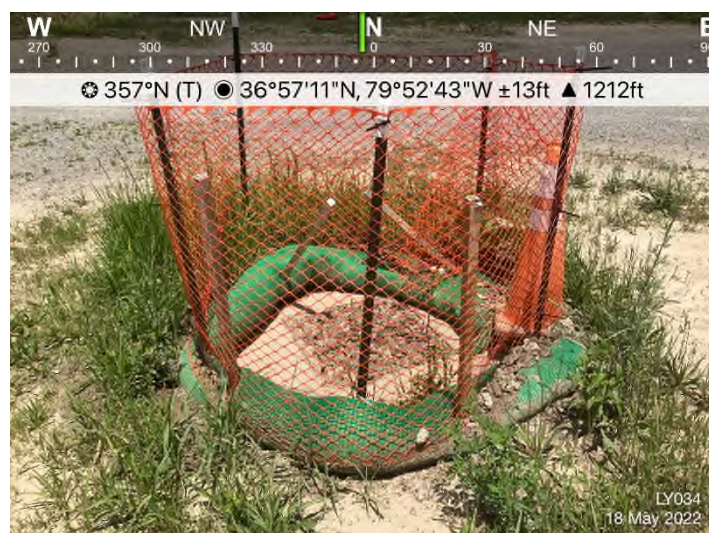
Figure 3: LY 034 – Mulch debris obstructing flow of SW inlet. Maintenance needed.

- Laydown Yard 034: Clean debris off stormwater inlet.
- Laydown Yard 034: Clean up trash around/outside dumpster.

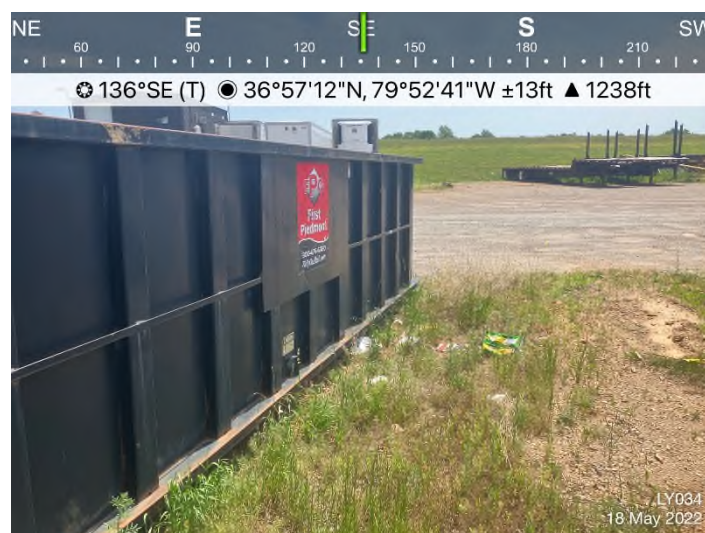
Figure 4: LY 034 – Trash clean up needed around dumpster.
