FIELD INSPECTION REPORT

Project Name:	Mountain Valley Pipeline	Inspector:	Marshall Willis
Inspection Date:	Monday, May 16, 2022	Project Contact:	Brian Clauto, Cory Chalmers
Spread I: Franklin County	STA 14062+17 – 14131+28 MVP-FR-309.05/309	Weather:	Dry

FIELD INSPECTION PHOTO LOG

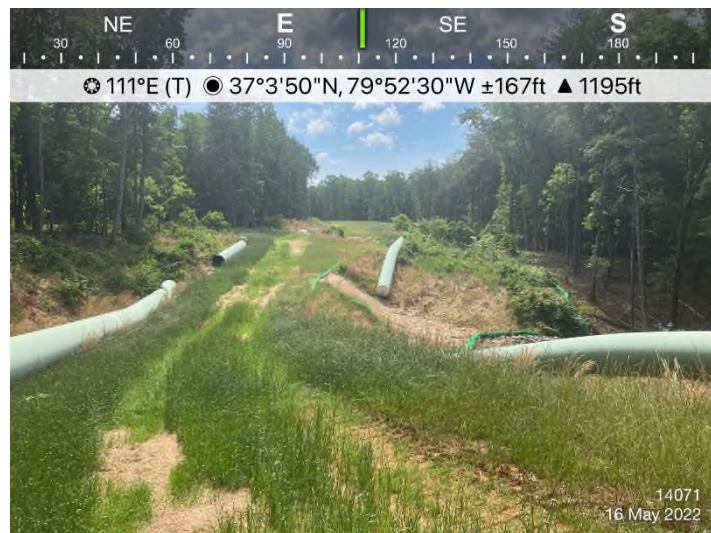
Figure 1: STA 14071+00 – Controls in place and functioning properly.

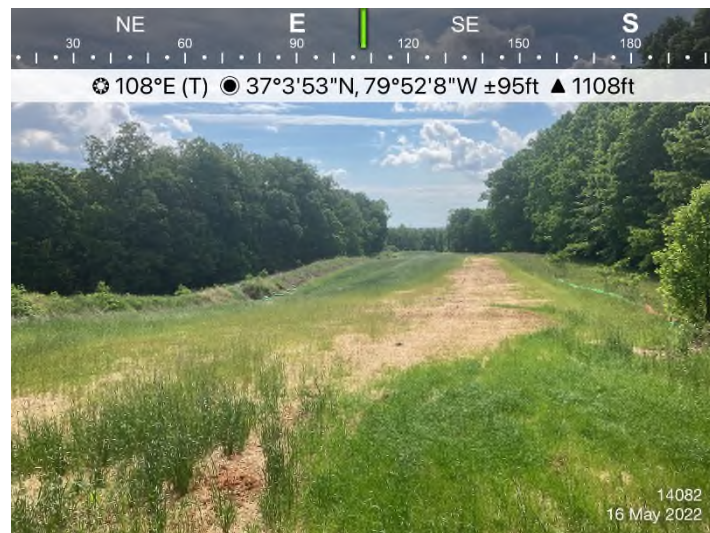
Figure 2: STA 14082+00 – Controls in place and functioning properly.

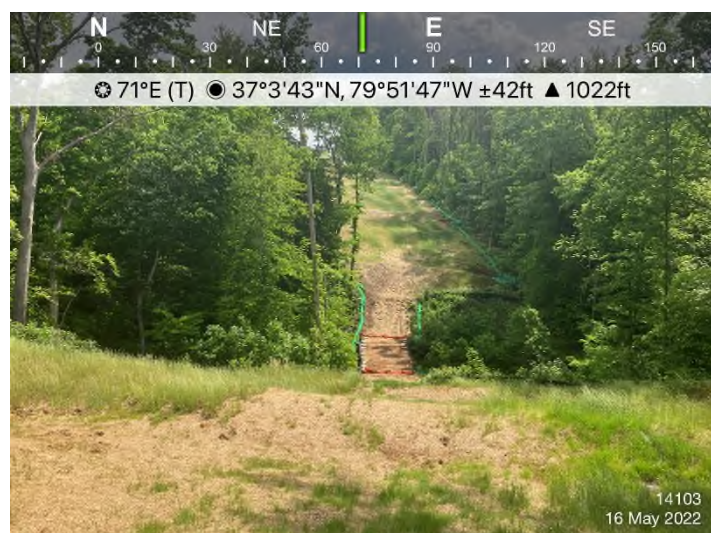
Figure 3: STA 14103+00 – Controls in place and functioning properly.

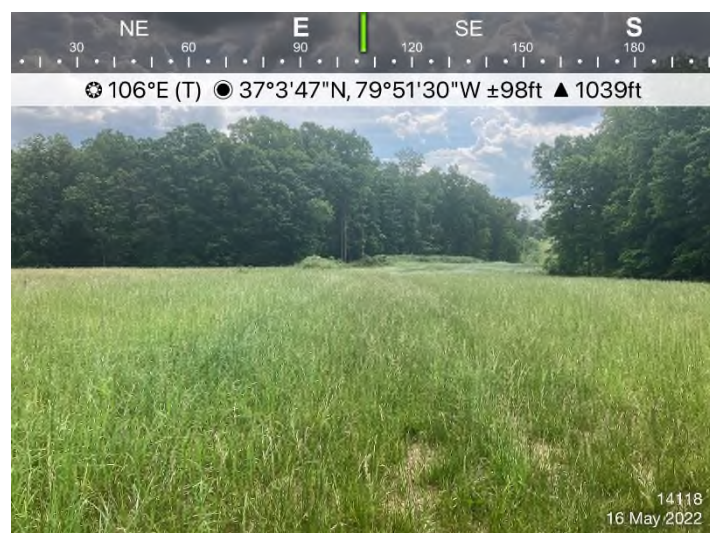
Figure 4: STA 14118+00 – Controls in place and functioning properly.
