FIELD INSPECTION REPORT

Project Name:	Mountain Valley Pipeline	Inspector:	Marshall Willis
Inspection Date:	Friday, June 3, 2022	Project Contact:	Brian Clauto, Cory Chalmers
Spread H: Franklin County	STA 13334+00 – 13350+00 STA 13316+00 – 12206+00 STA 13263+45 – 13260+00 MVP-FR-293.01	Weather:	Dry

FIELD INSPECTION PHOTO LOG

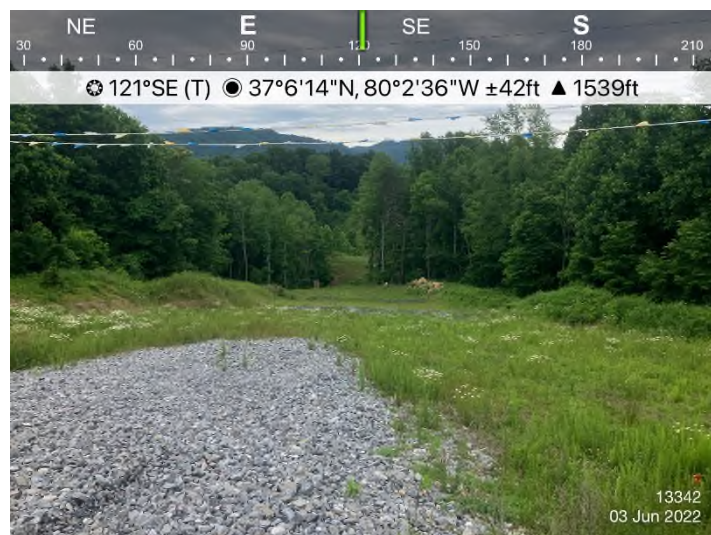
Figure 1: STA 13342+00 – Controls in place and functioning properly.

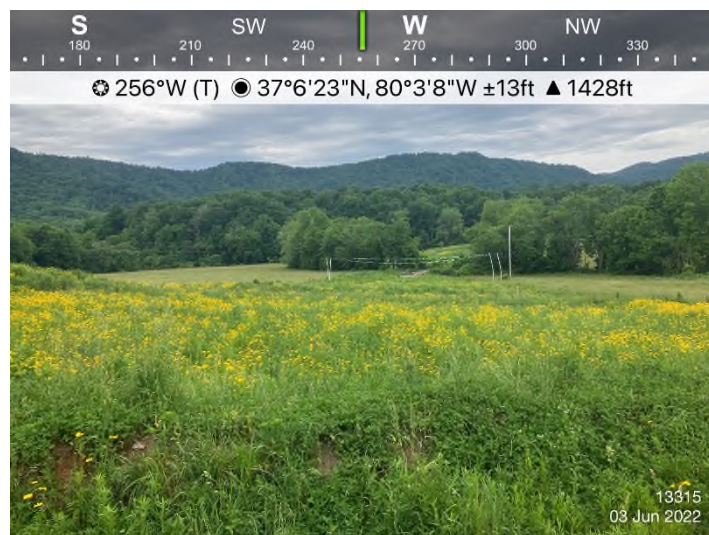
Figure 2: STA 13315+00 – Controls in place and functioning properly.

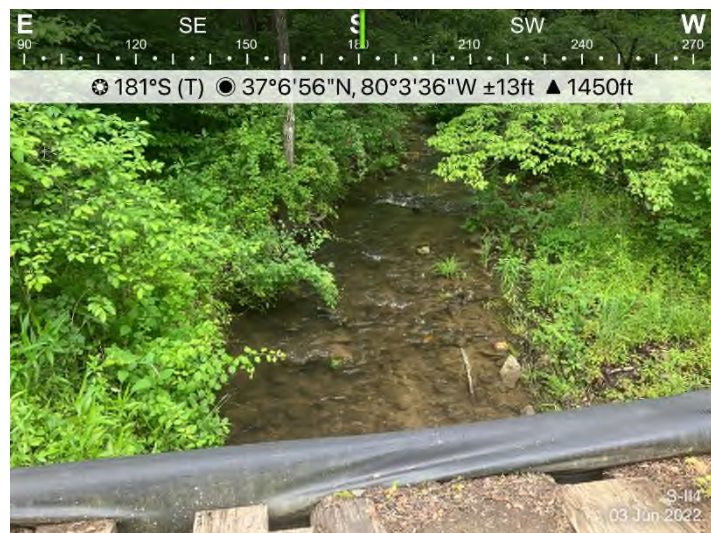
Figure 3: Stream S-II4 – Controls in place and functioning properly.

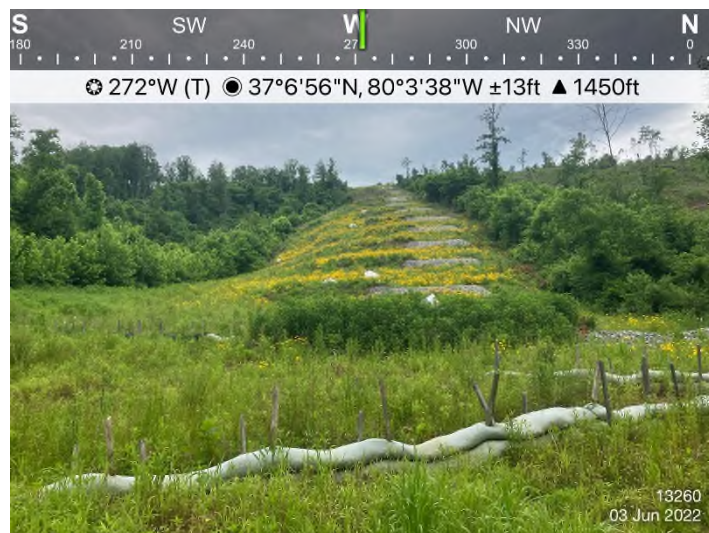
Figure 4: STA 13260+00 – Controls in place and functioning properly.
