## FIELD INSPECTION REPORT

| Project Name: | Mountain Valley Pipeline | Inspector: | Marshall Willis |
| Spread H:<br>Roanoke County | STA 12866+36 – 12915+25<br>MVP-RO-286 | Weather: | Dry |

## FIELD INSPECTION PHOTO LOG

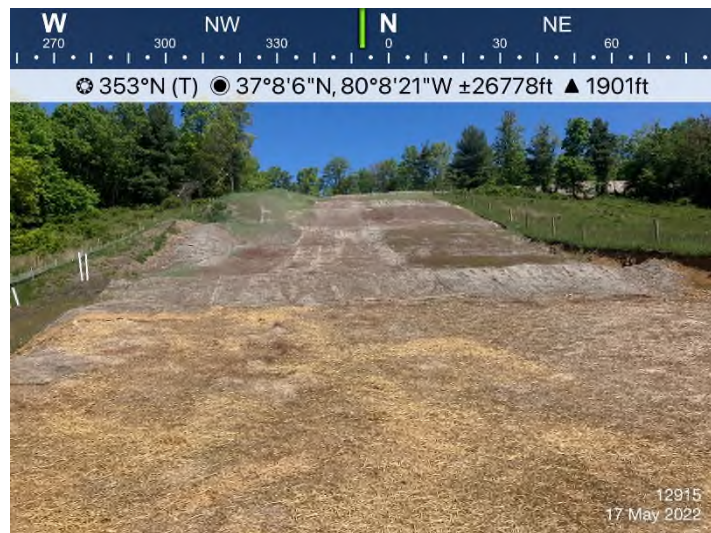
**Figure 1: STA 12915+00** – Controls in place and functioning properly. Area stabilized with straw.

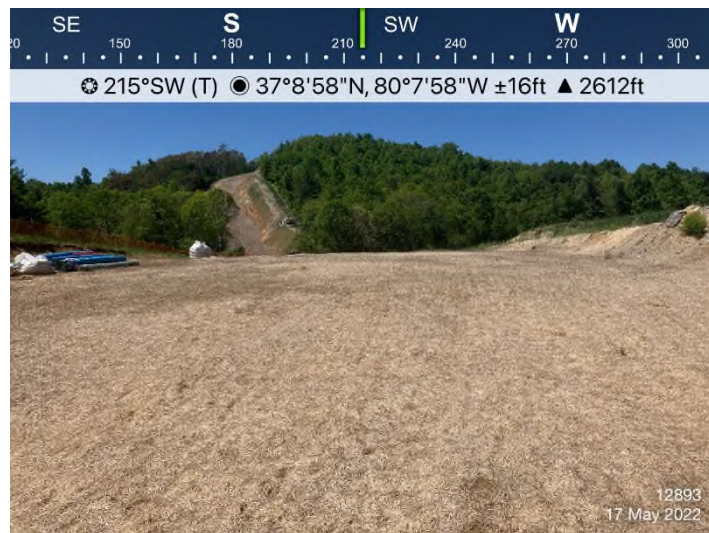
**Figure 2: STA 12893+00** – Controls in place and functioning properly. Area stabilized with straw.

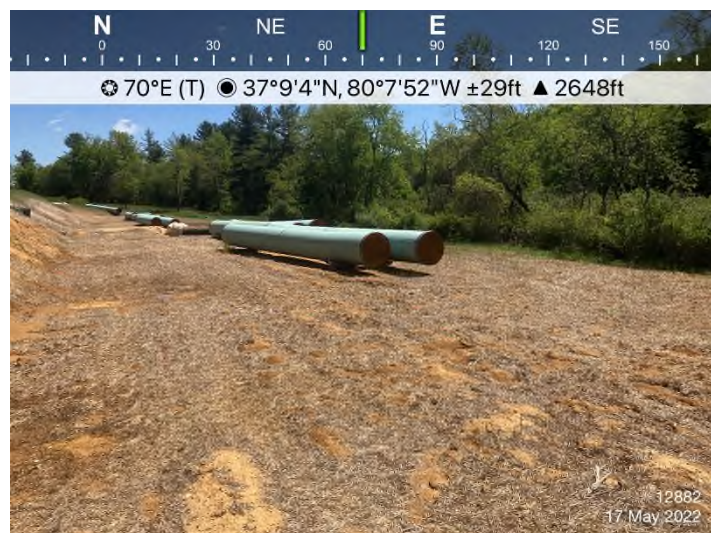
**Figure 3: STA 12882+00** – Controls in place and functioning properly. Area stabilized with straw.

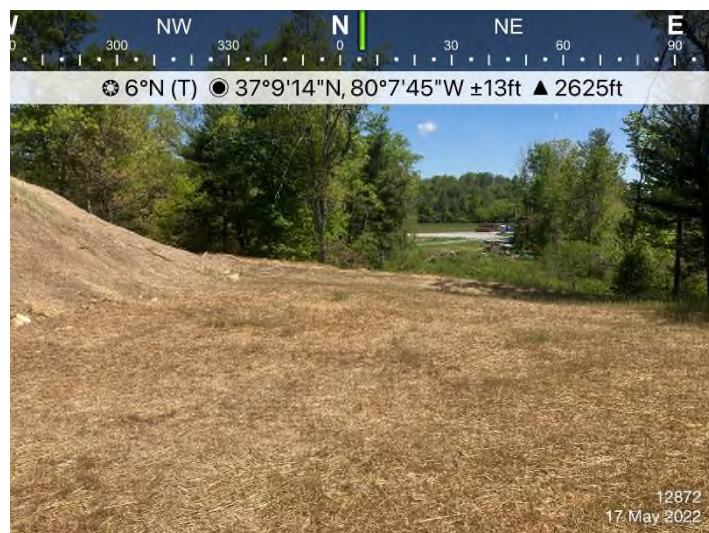
**Figure 4: STA 12872+00** – Controls in place and functioning properly. Area stabilized with straw.
