## FIELD INSPECTION REPORT

| Project Name: | Mountain Valley Pipeline | Inspector: | Marshall Willis |
| Spread H:<br>Roanoke County | STA 12601+11 – 12637+17<br>MVP-RO-279.02/01 | Weather: | Dry |

## FIELD INSPECTION PHOTO LOG

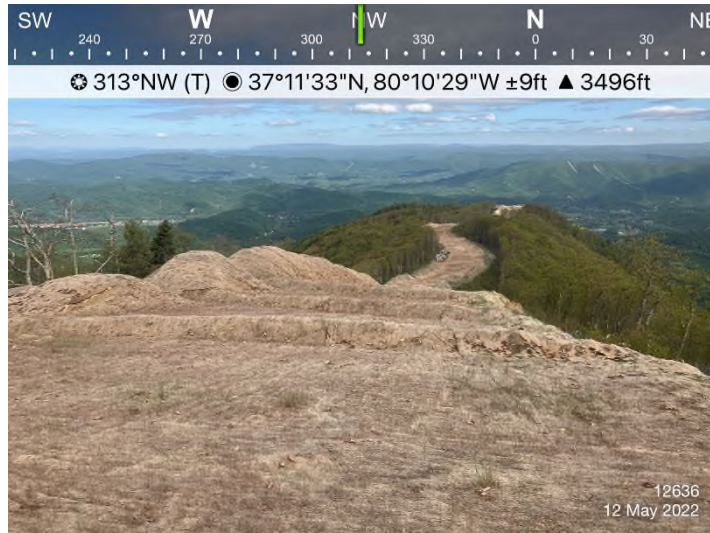
**Figure 1: STA 12636+00** – Controls in place and functioning properly.

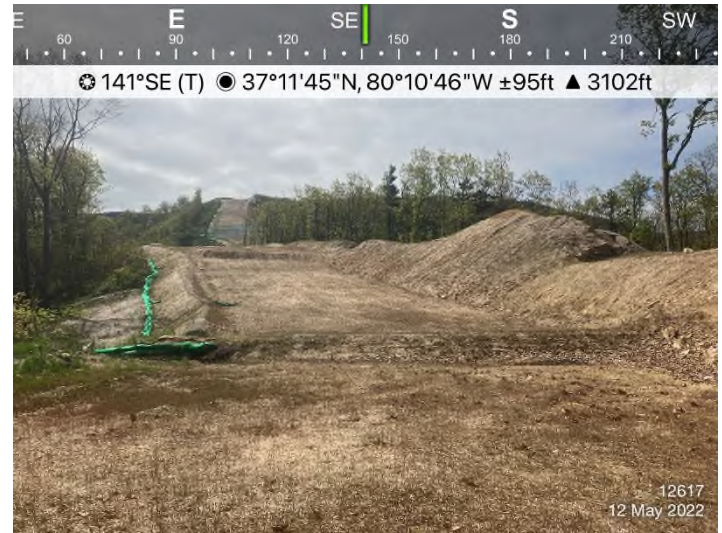
**Figure 2: STA 12617+00** – Controls in place and functioning properly.

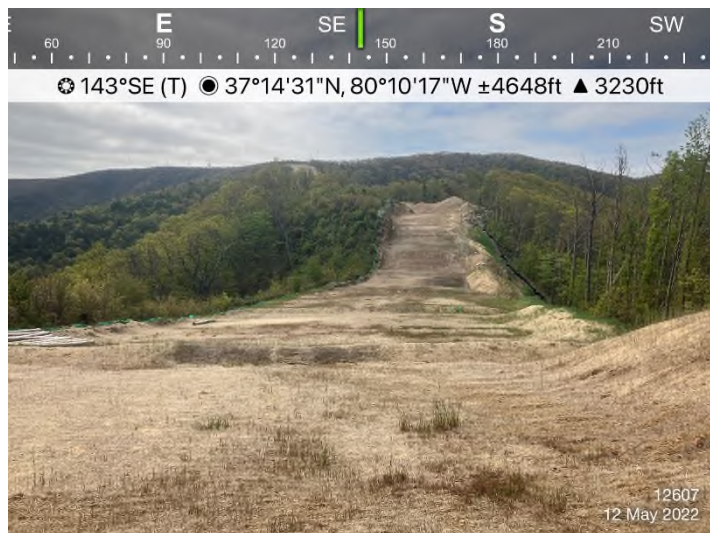
**Figure 3: STA 12607+00** – Controls in place and functioning properly.

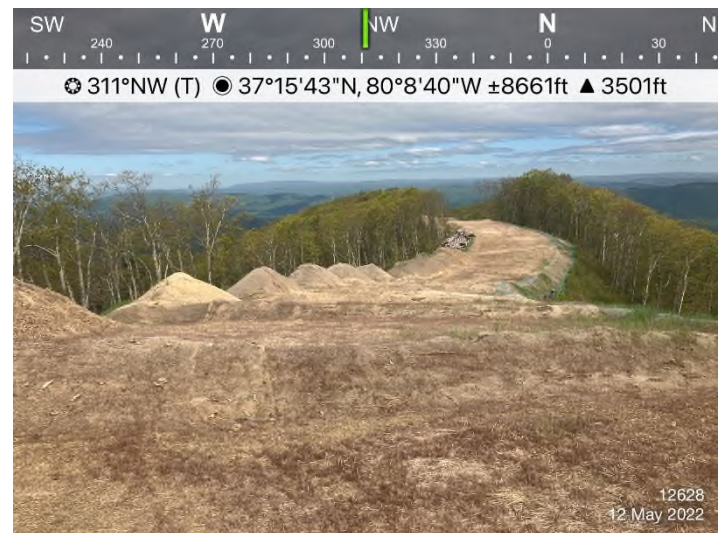
**Figure 4: STA 12628+00** – Controls in place and functioning properly.
