## FIELD INSPECTION REPORT

| Project Name: | Mountain Valley Pipeline | Inspector: | Marshall Willis |
| Spread H:<br>Montgomery County | STA 12373+28 – 12420+73<br>MVP-MLV-AR-27 | Weather: | Dry |

## FIELD INSPECTION PHOTO LOG

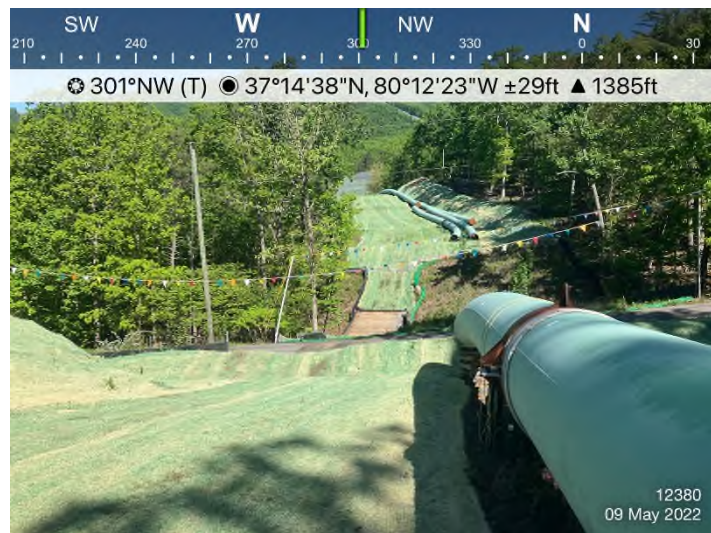
**Figure 1: STA 12380+00** – Controls in place and functioning properly. Area stabilized with erosion matting.

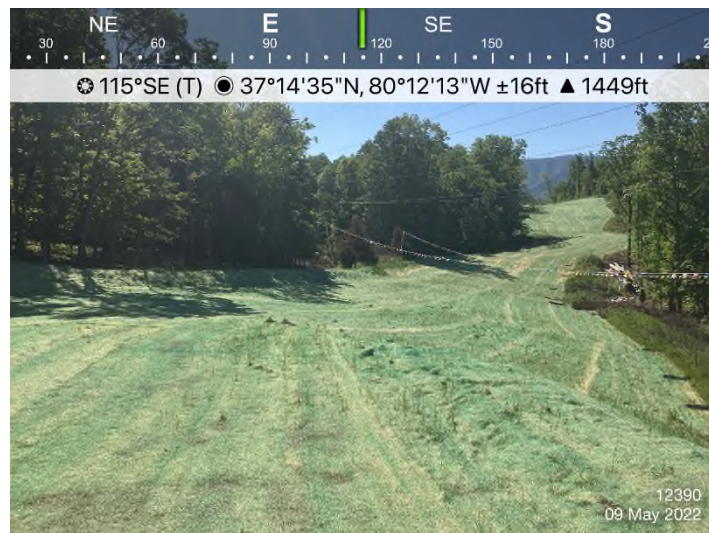
**Figure 2: STA 12390+00** – Controls in place and functioning properly. Area stabilized with erosion matting.

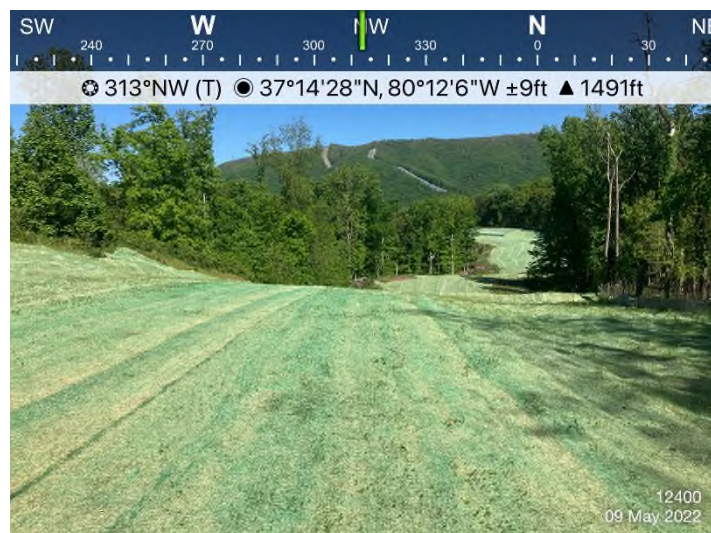
**Figure 3: STA 12400+00** – Controls in place and functioning properly. Area stabilized with erosion matting.

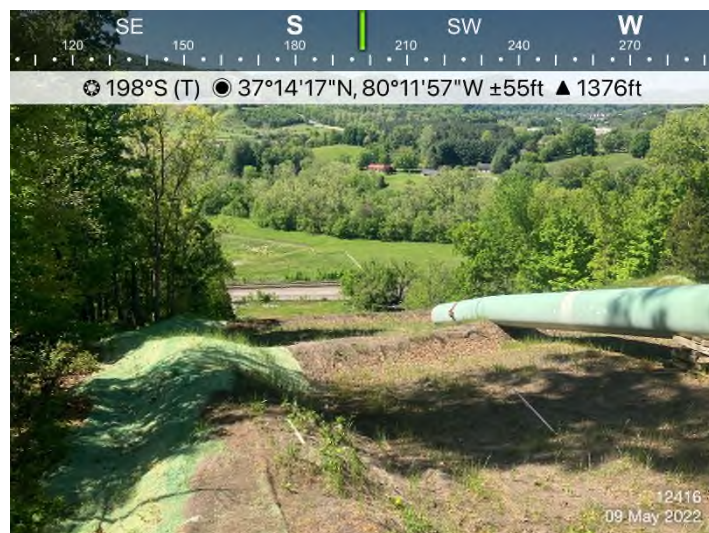
**Figure 4: STA 12416+00** – Controls in place and functioning properly. Area stabilized with erosion matting.
