## FIELD INSPECTION REPORT

| Project Name: | Mountain Valley Pipeline | Inspector: | Marshall Willis |
| Inspection Date: | Tuesday, May 10, 2022 | Project Contact: | Brian Clauto, Cory Chalmers |
| Spread I:<br>Franklin County | STA 13644+82 – 13748+30 | Weather: | Dry |

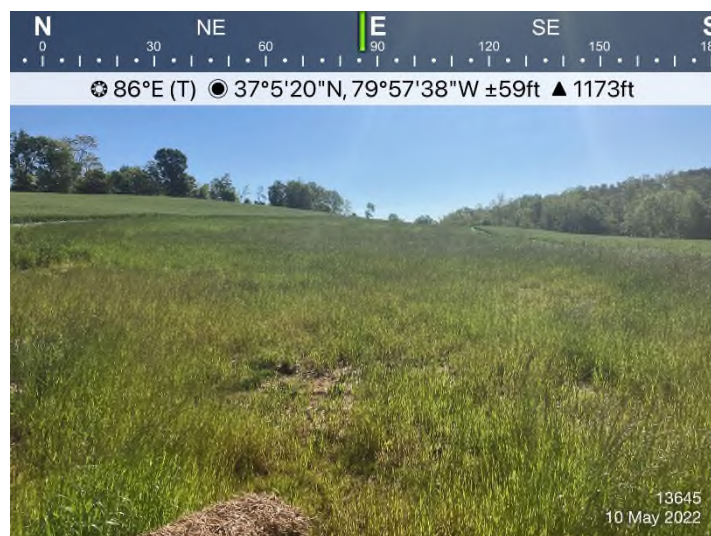
**Figure 1: STA 13645+00** – Controls in place and functioning properly.

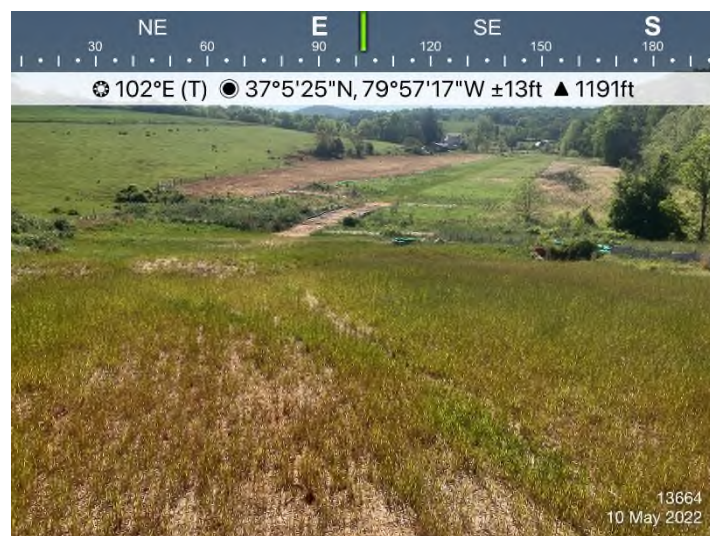
**Figure 2: STA 13664+00** – Controls in place and functioning properly.

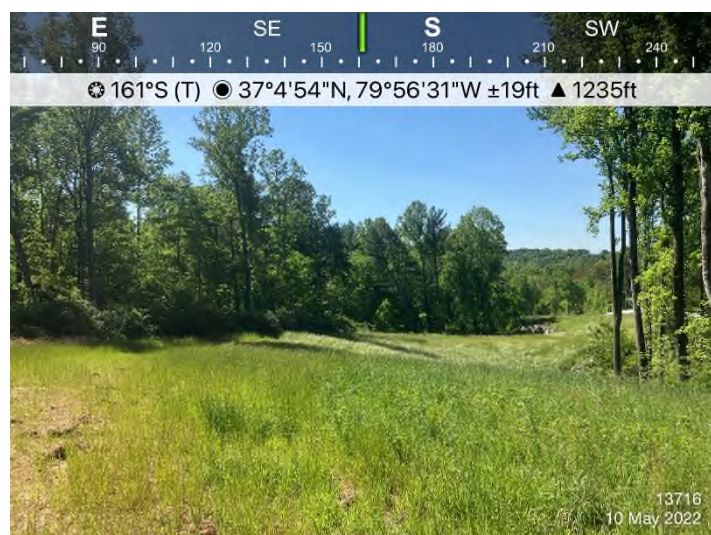
**Figure 3: STA 13716+00** – Controls in place and functioning properly.

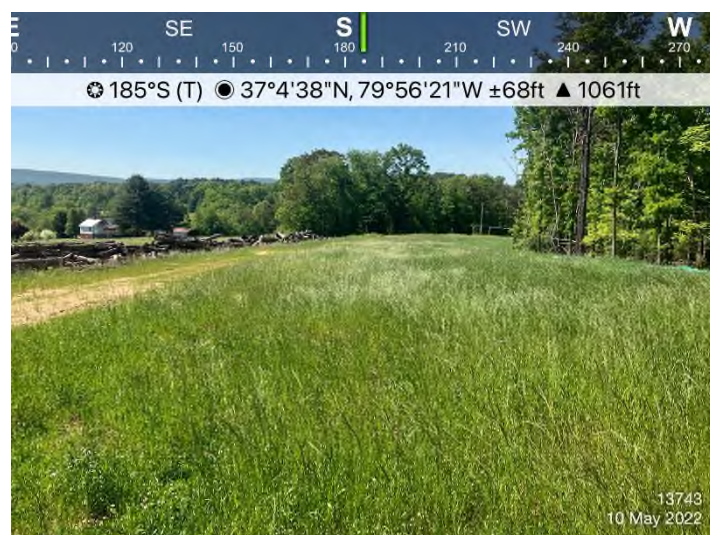
**Figure 4: STA 13743+00** – Controls in place and functioning properly.
