## FIELD INSPECTION REPORT

| Project Name: | Mountain Valley Pipeline | Inspector: | Marshall Willis |
| Inspection Date: | Wednesday, May 4, 2022 | Project Contact: | Brian Clauto, Cory Chalmers |
| Spread I:<br>Franklin County | STA 13575+21 – 13644+82 | Weather: | Dry |

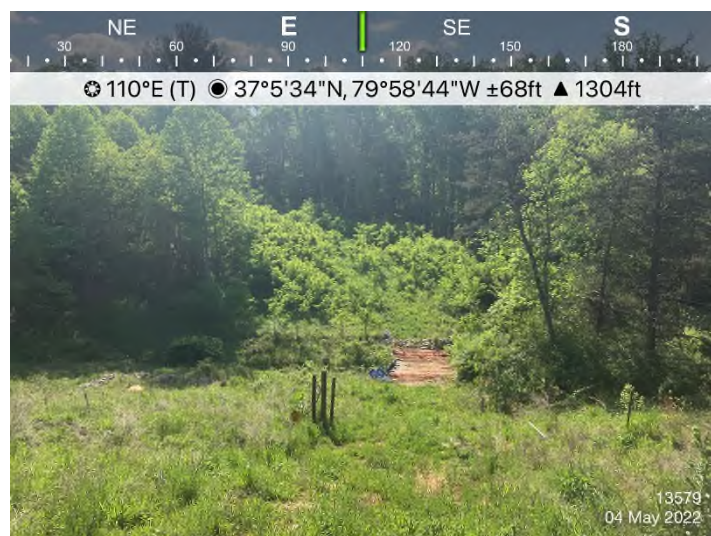
**Figure 1: STA 13579+00** – Controls in place and functioning properly.

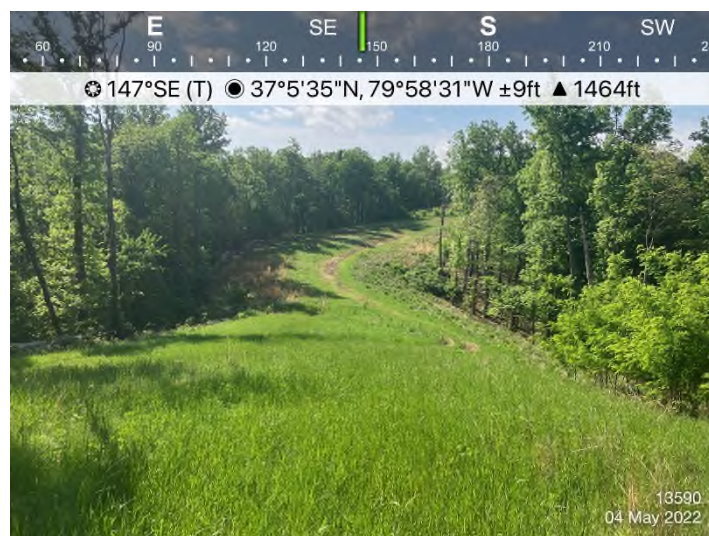
**Figure 2: STA 13590+00** – Controls in place and functioning properly.

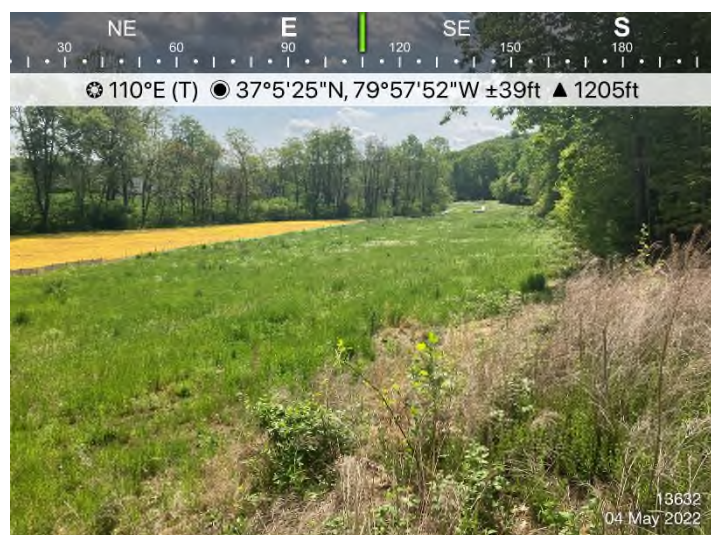
**Figure 3: STA 13632+00** – Controls in place and functioning properly.

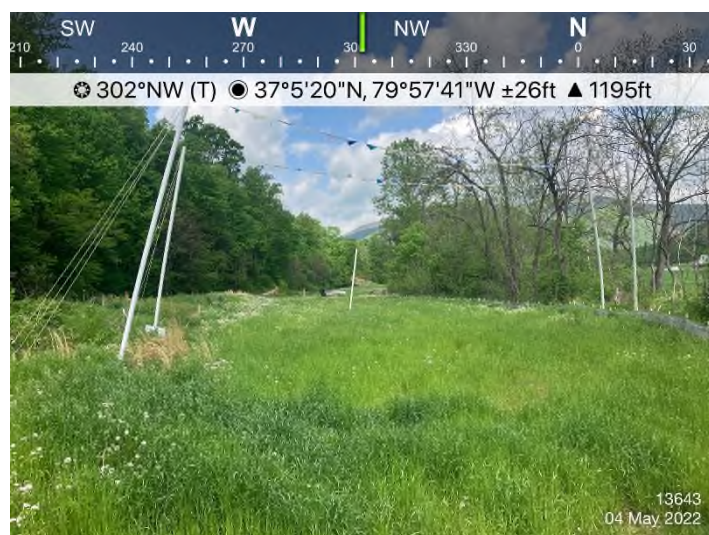
**Figure 4: STA 13643+00** – Controls in place and functioning properly.
