## FIELD INSPECTION REPORT

| Project Name: | Mountain Valley Pipeline | Inspector: | Marshall Willis |
| Inspection Date: | Monday, May 2, 2022 | Project Contact: | Brian Clauto, Cory Chalmers |
| Spread I:<br>Franklin County | STA 14861+31 – 14981+55 | Weather: | Dry |

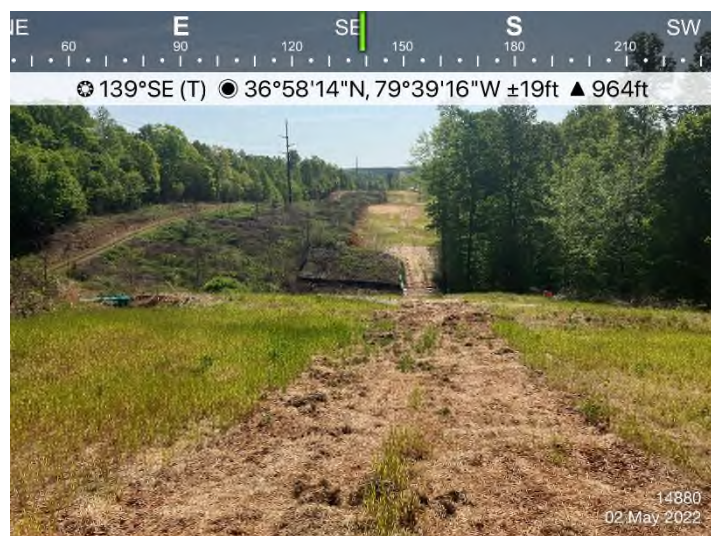
**Figure 1: STA 14880+00** – Controls in place and functioning properly.

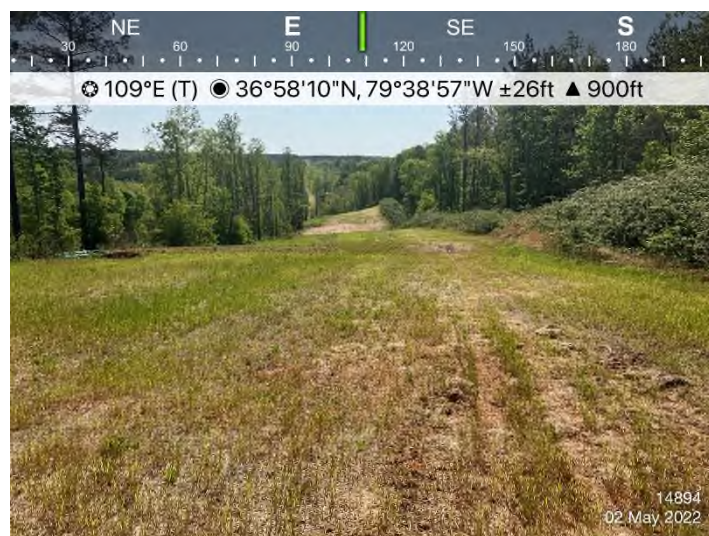
**Figure 2: STA 14894+00** – Controls in place and functioning properly.

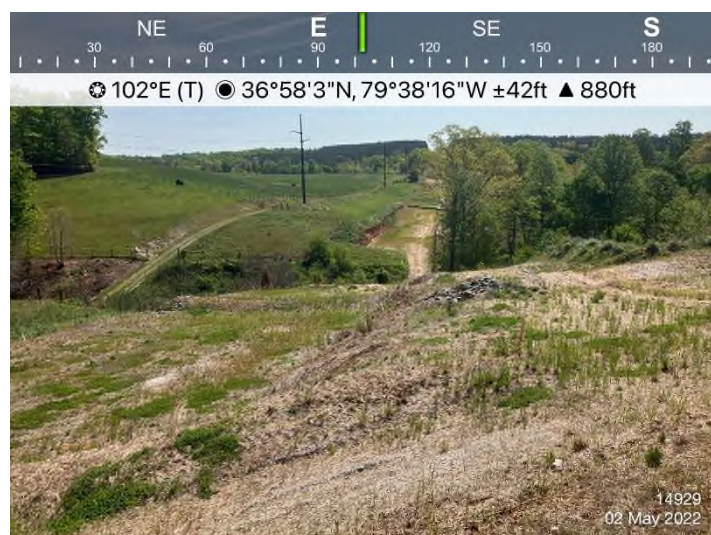
**Figure 3: STA 14929+00** – Controls in place and functioning properly.

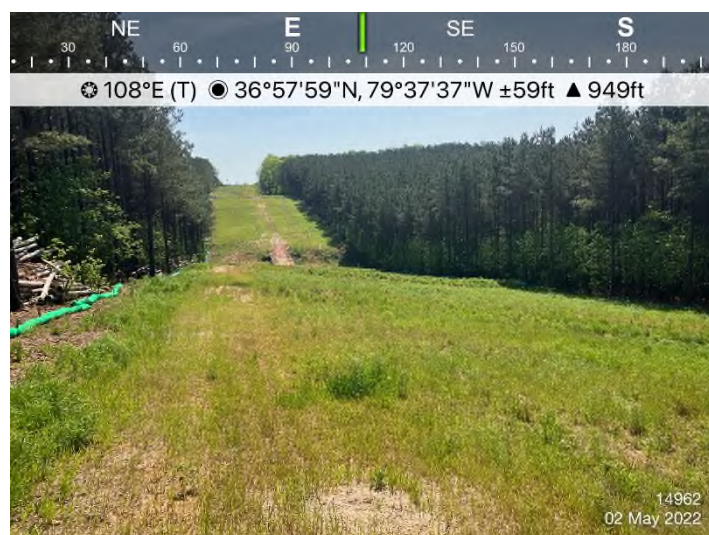
**Figure 4: STA 14962+00** – Controls in place and functioning properly.
