## FIELD INSPECTION REPORT

| Project Name: | Mountain Valley Pipeline | Inspector: | Marshall Willis |
| Spread I:<br>Franklin County | STA 13811+81 – 13852+25<br>MVP-FR-303.01 | Weather: | Dry |

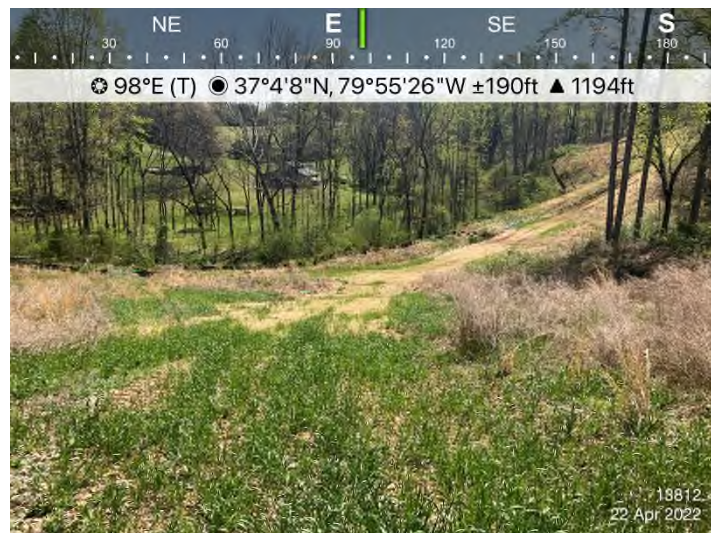
**Figure 1: STA 13812+00** – Controls in place and functioning properly.

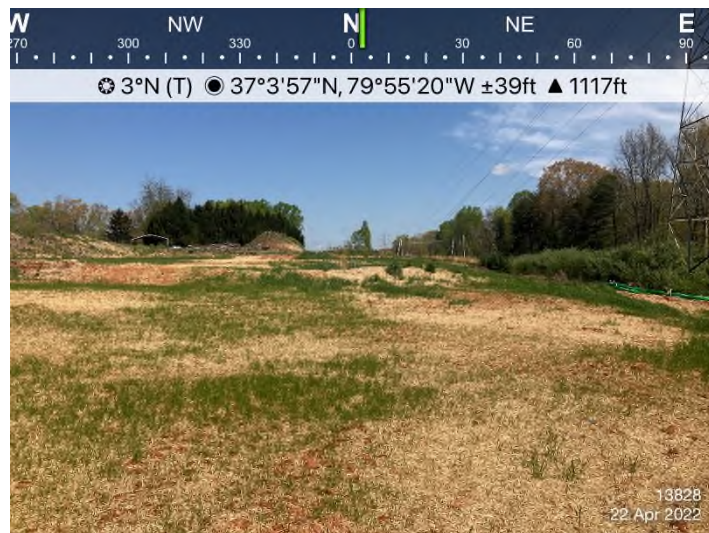
**Figure 2: STA 13828+00** – Controls in place and functioning properly.

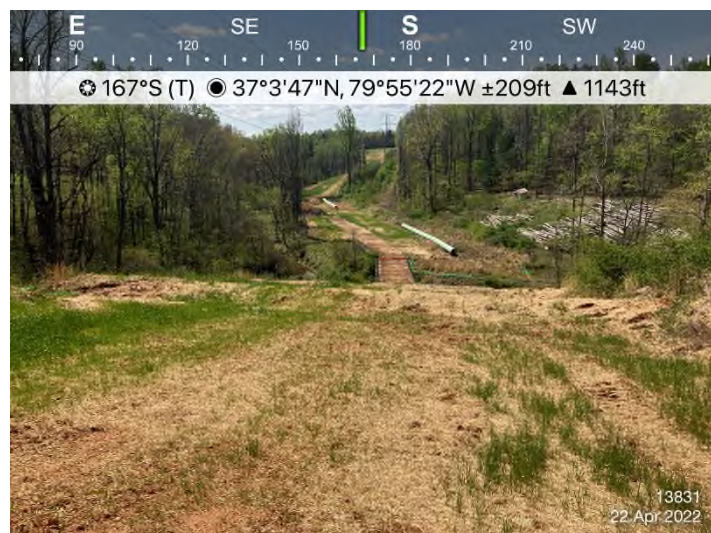
**Figure 3: STA 13831+00** – Controls in place and functioning properly.

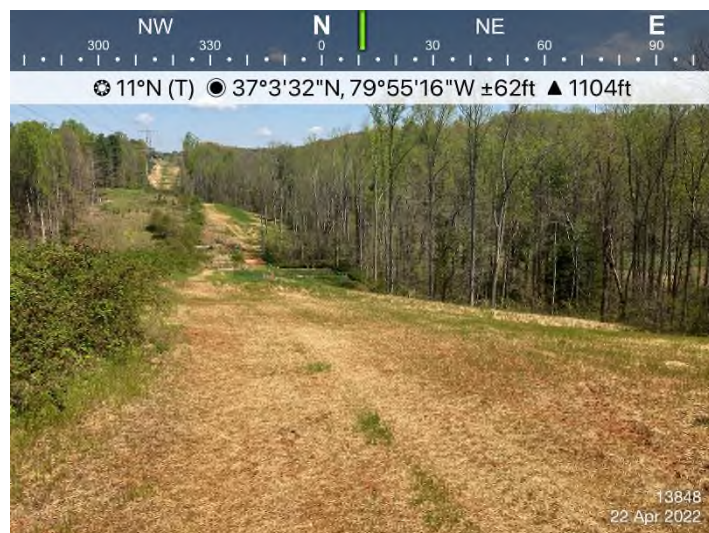
**Figure 4: STA 13848+00** – Controls in place and functioning properly.
