## FIELD INSPECTION REPORT

| Project Name: | Mountain Valley Pipeline | Inspector: | Marshall Willis |
| Spread I:<br>Franklin County | STA 14333+27 – 14411+04<br>MVP-FR-313.01/315 | Weather: | Dry |

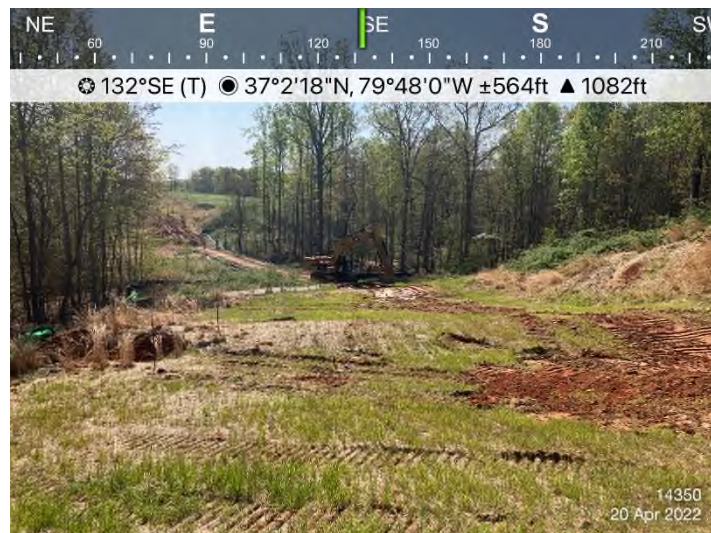
**Figure 1: STA 14350+00** – MVP actively replacing and maintaining controls and re-stabilizing.

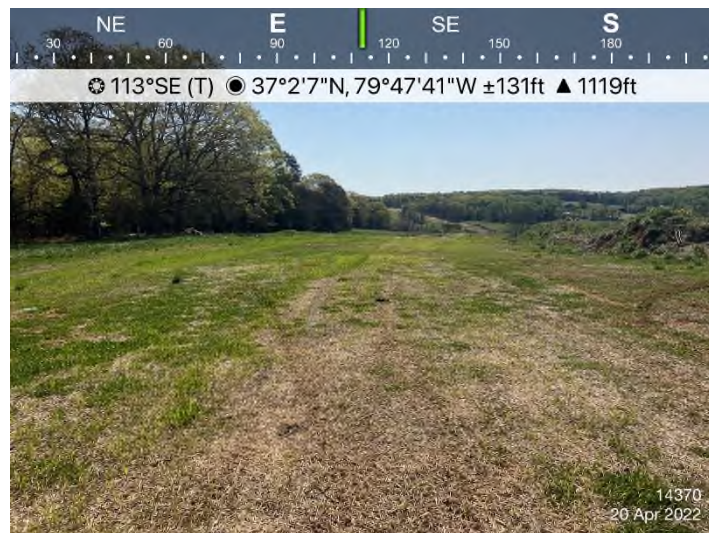
**Figure 2: STA 14370+00** – Controls in place and functioning properly.

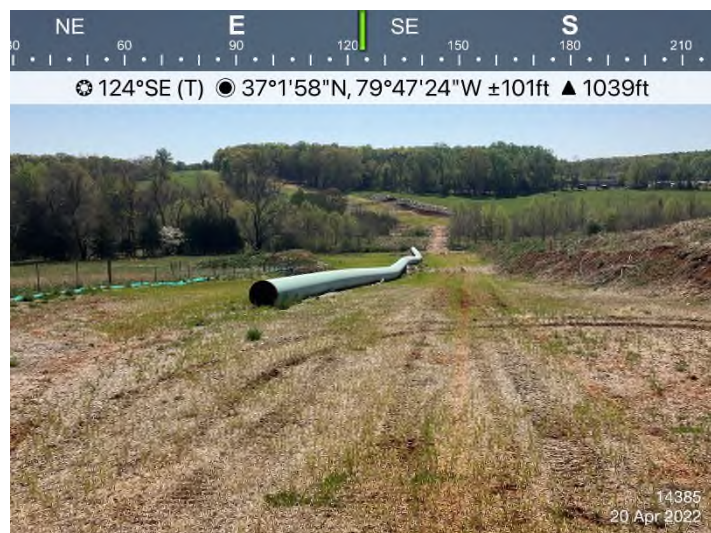
**Figure 3: STA 14385+00** – Controls in place and functioning properly.

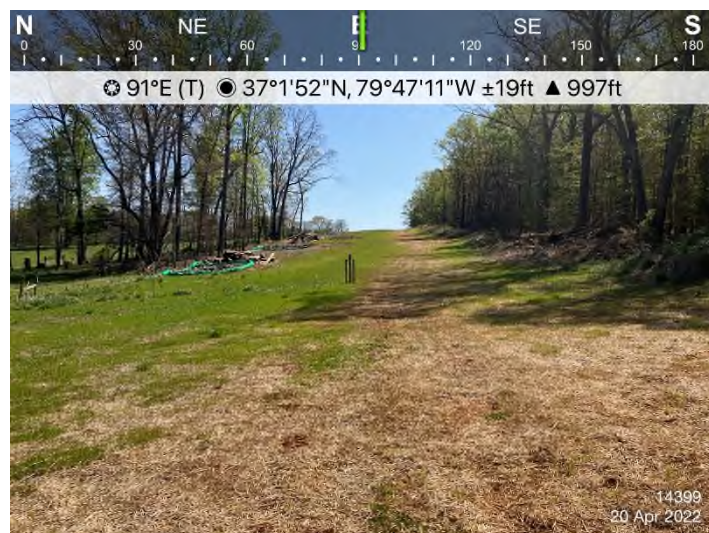
**Figure 4: STA 14399+00** – Controls in place and functioning properly.
