## FIELD INSPECTION REPORT

| Project Name: | Mountain Valley Pipeline | Inspector: | Marshall Willis |
| Spread H:<br>Franklin County | STA 13115+95 – 13141+53 | Weather: | Dry |

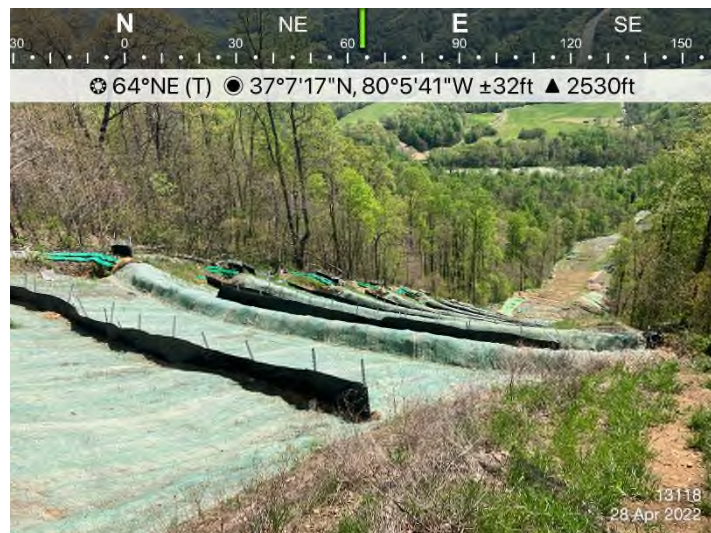
**Figure 1: STA 13118+00** – Controls in place and functioning properly.

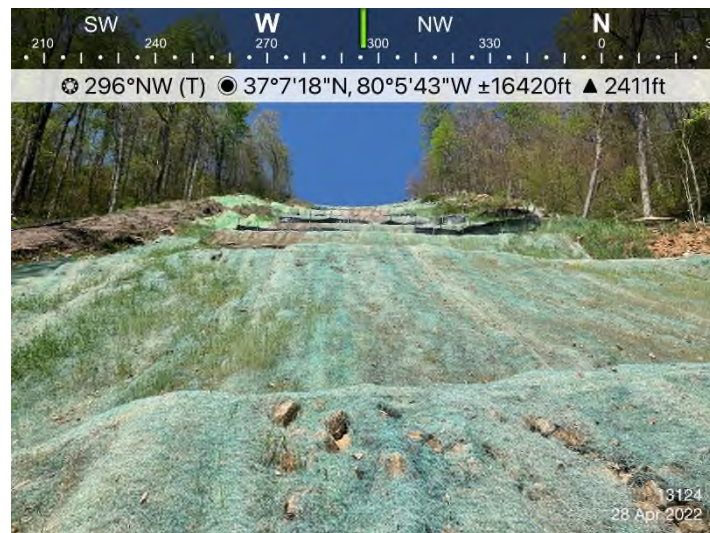
**Figure 2: STA 13124+00** – Controls in place and functioning properly.

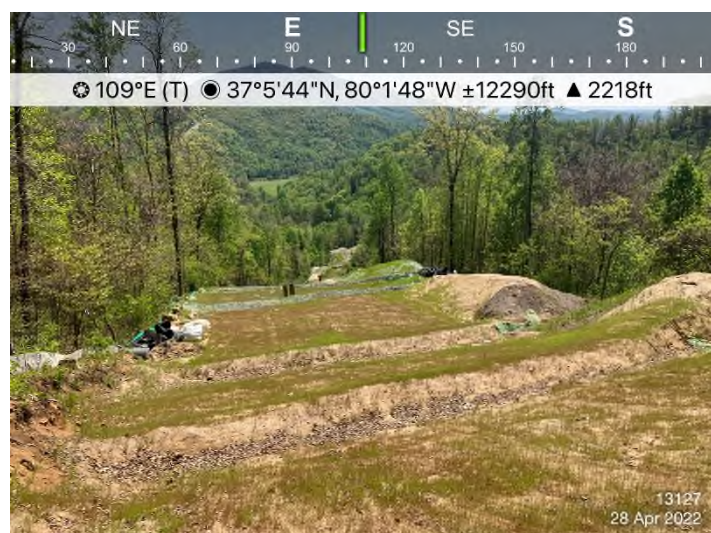
**Figure 3: STA 13127+00** – Controls in place and functioning properly.

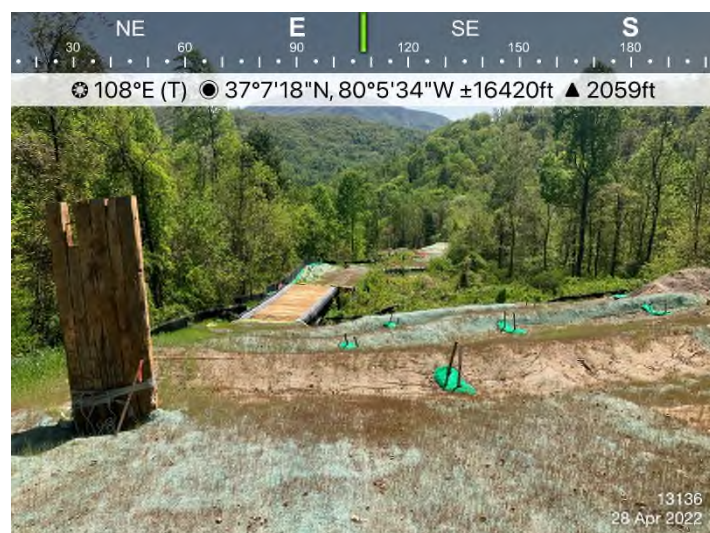
**Figure 4: STA 13136+00** – Controls in place and functioning properly.
