## FIELD INSPECTION REPORT

| Project Name: | Mountain Valley Pipeline | Inspector: | Marshall Willis |
| Spread H:<br>Franklin County | STA 13342+67 – 13415+51 | Weather: | Dry |

## FIELD INSPECTION PHOTO LOG

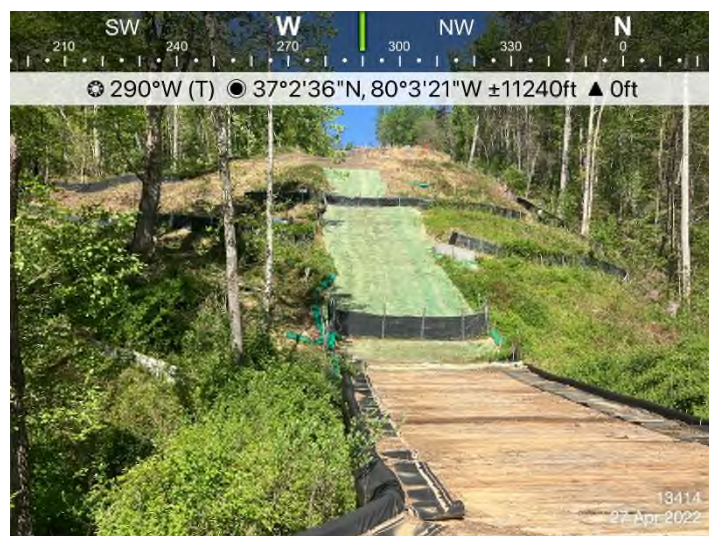
**Figure 1: STA 13314+00** – Controls in place and functioning properly.

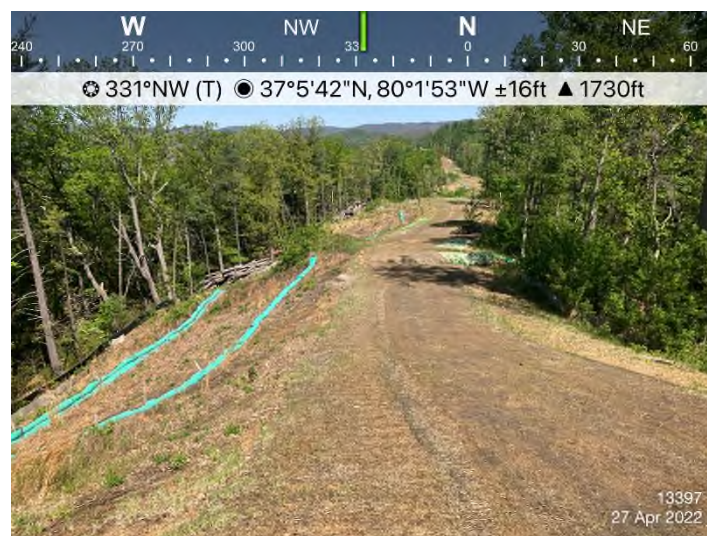
**Figure 2: STA 13397+00** – Controls in place and functioning properly.

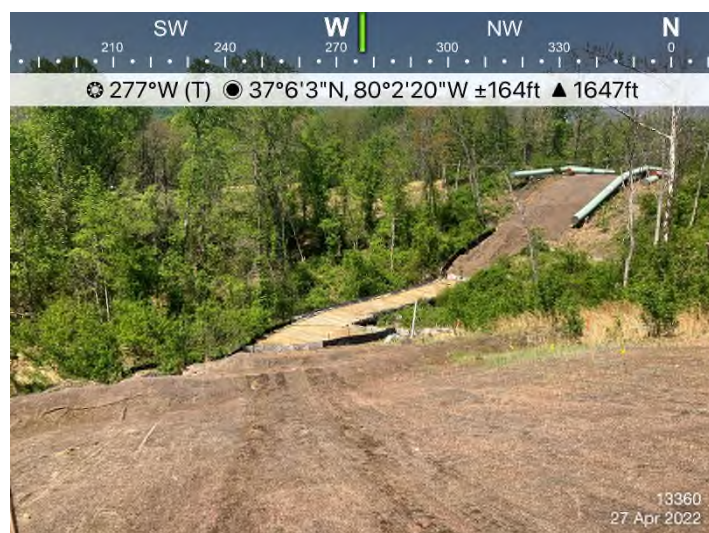
**Figure 3: STA 13360+00** – Controls in place and functioning properly.

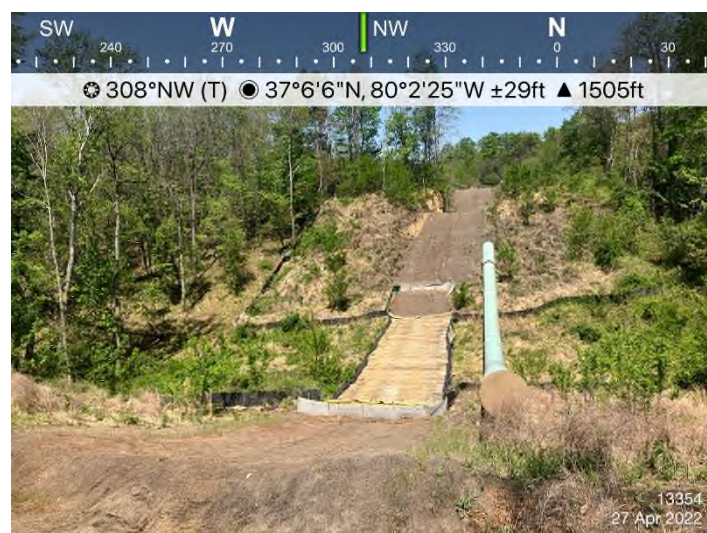
**Figure 4: STA 13354+00** – Controls in place and functioning properly.
