## FIELD INSPECTION REPORT

| Project Name: | Mountain Valley Pipeline | Inspector: | Marshall Willis |
| Inspection Date: | Thursday, April 21, 2022 | Project Contact: | Brian Clauto, Cory Chalmers |
| Spread H:<br>Franklin County | STA 13316+13 – 13342+67 | Weather: | Dry |

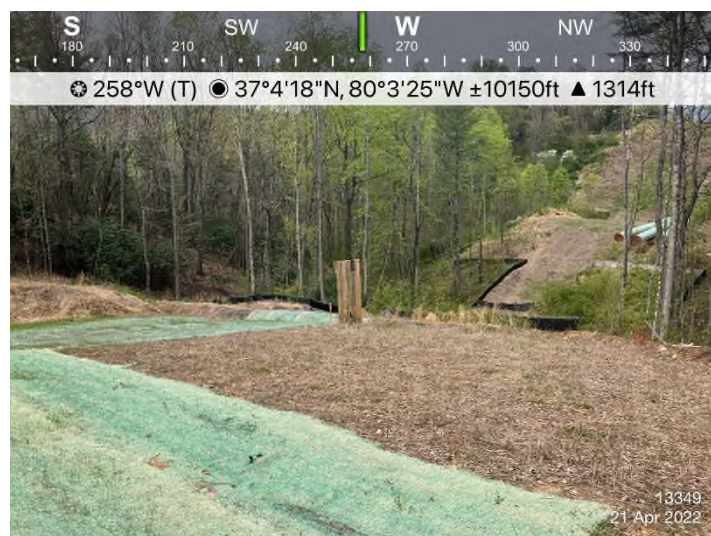
**Figure 1: STA 13349+00** – Controls in place and functioning properly.

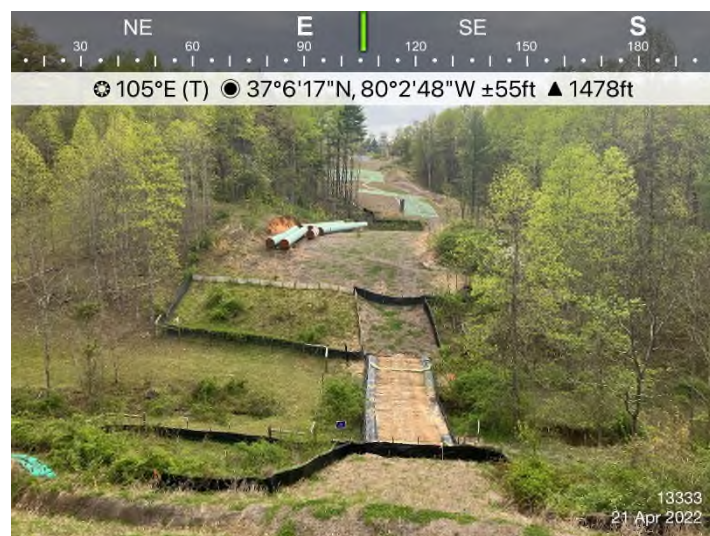
**Figure 2: STA 13333+00** – Controls in place and functioning properly.

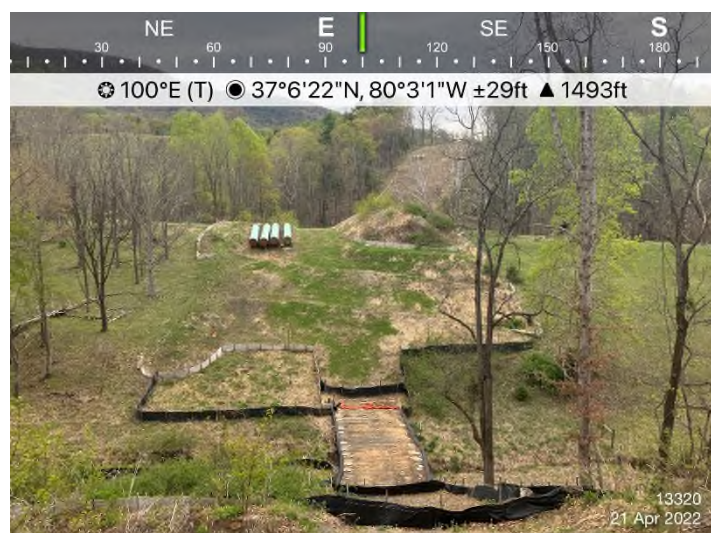
**Figure 3: STA 13320+00** – Controls in place and functioning properly.

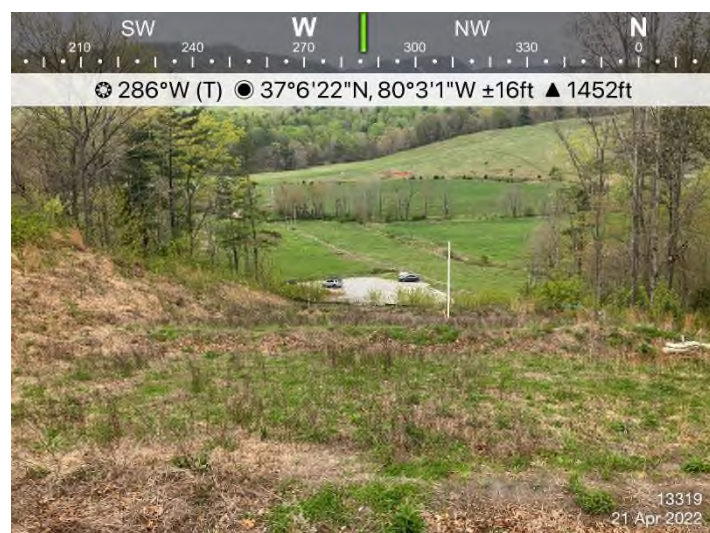
**Figure 4: STA 13319+00** – Controls in place and functioning properly.
