## FIELD INSPECTION REPORT

| Project Name: | Mountain Valley Pipeline | Inspector: | Marshall Willis |
| Spread I:<br>Franklin County | STA 14062+17 – 14131+28<br>MVP-FR-309/309.05 | Weather: | Rainy |

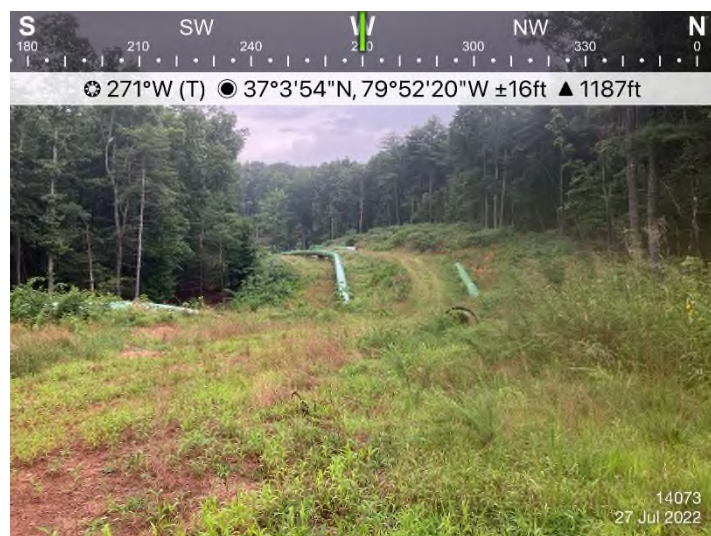
**Figure 1: STA 14073+00** – Controls in place and functioning properly.

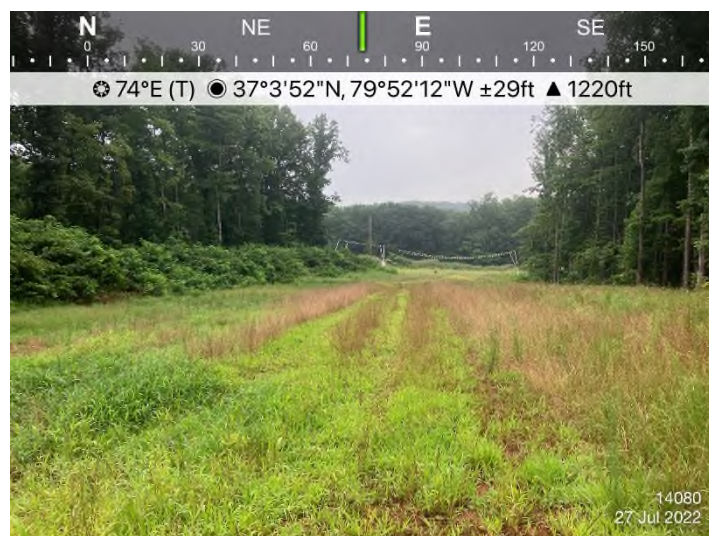
**Figure 2: STA 14080+00** – Controls in place and functioning properly.

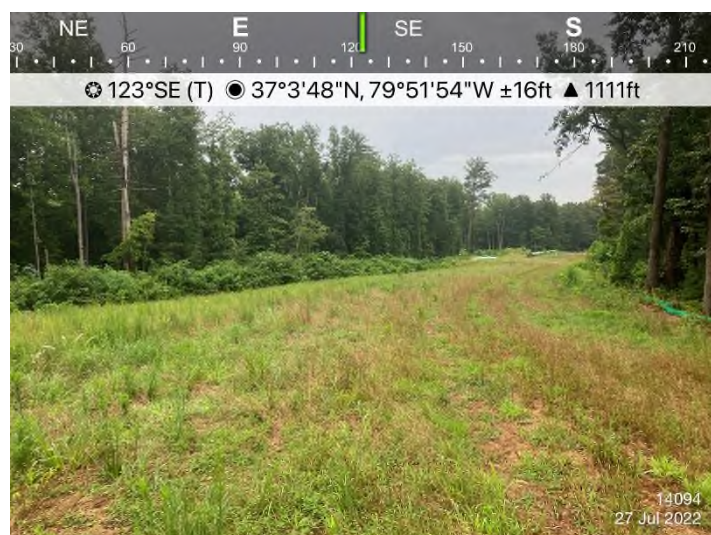
**Figure 3: STA 14094+00** – Controls in place and functioning properly.

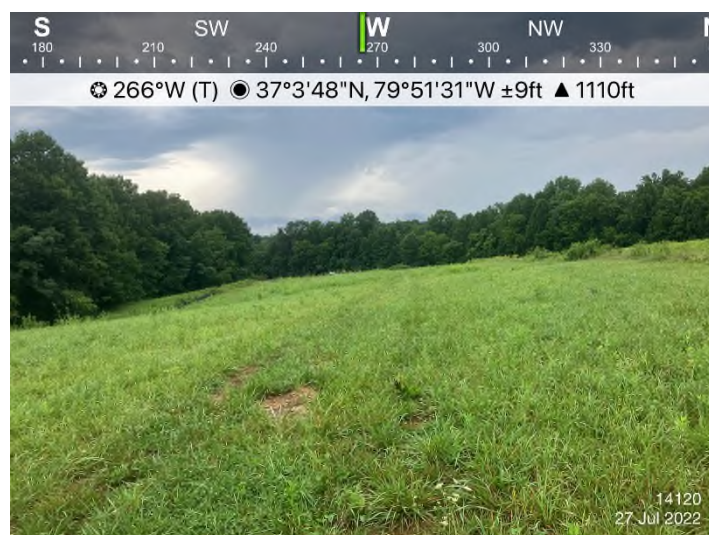
**Figure 4: STA 14120+00** – Controls in place and functioning properly.
