FIELD INSPECTION REPORT

Project Name:	Mountain Valley Pipeline	Inspector:	Marshall Willis
Inspection Date:	Friday, July 22, 2022	Project Contact:	Brian Clauto, Cory Chalmers
Spread I: Franklin County	STA 13748+30 - 13846+00 MVP-FR-302	Weather:	Dry

FIELD INSPECTION PHOTO LOG

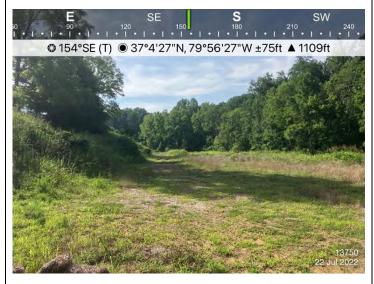
Figure 1: **STA 13750+00** – Controls in place and functioning properly.

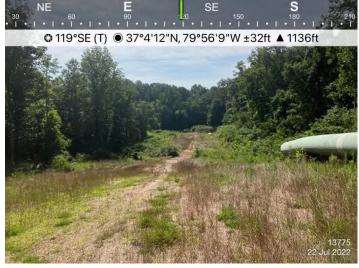
Figure 2: STA 13775+00 – Controls in place and functioning properly.

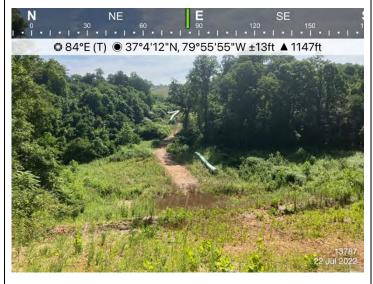
<u>Figure 3</u>: **STA 13787+00** – Controls in place and functioning properly.

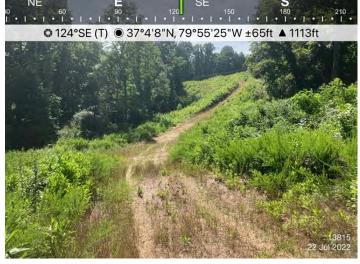
<u>Figure 4</u>: **STA 13815+00** – Controls in place and functioning properly.
