## FIELD INSPECTION REPORT

| Project Name: | Mountain Valley Pipeline | Inspector: | Marshall Willis |
| Inspection Date: | Wednesday, July 20, 2022 | Project Contact: | Brian Clauto, Cory Chalmers |
| Spread I:<br>Franklin County | STA 13415+51 – 13496+87<br>MVP-FR-293.02 | Weather: | Dry |

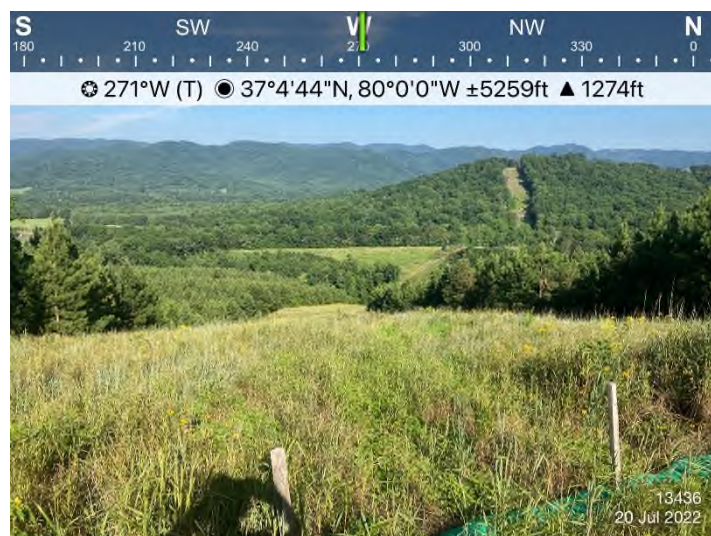
**Figure 1: STA 13436+00** – Controls in place and functioning properly.

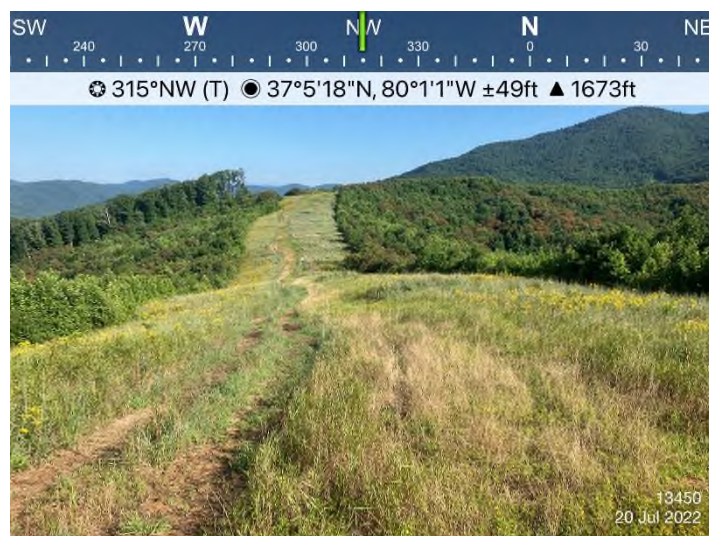
**Figure 2: STA 13450+00** – Controls in place and functioning properly.

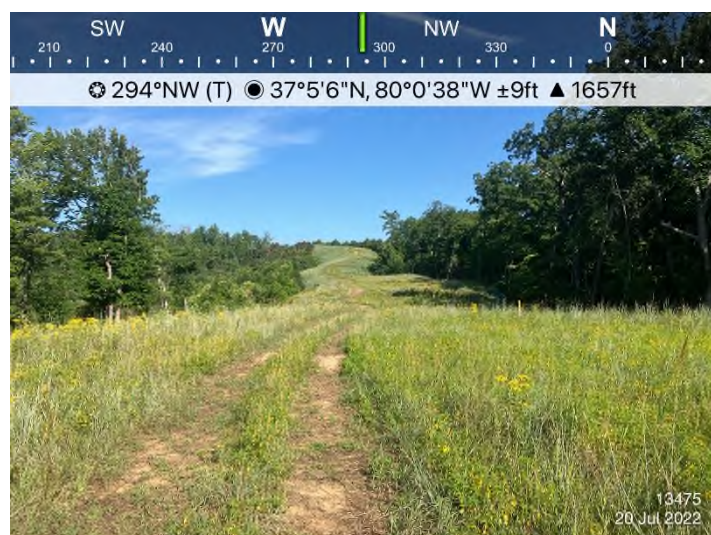
**Figure 3: STA 13475+00** – Controls in place and functioning properly.

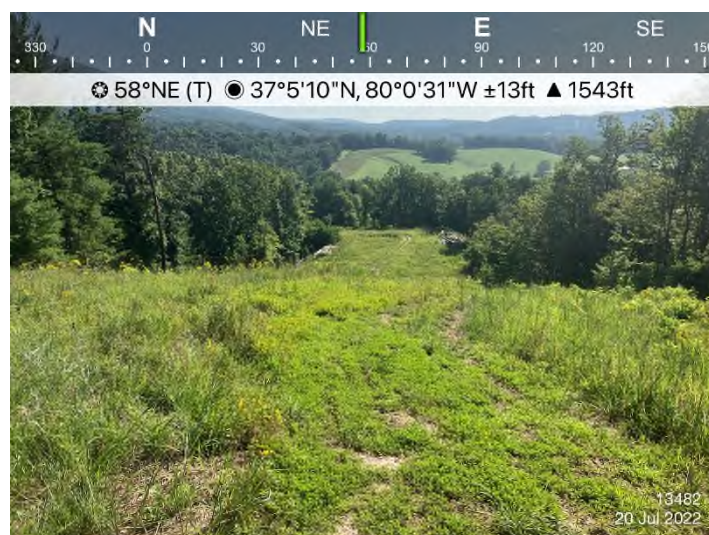
**Figure 4: STA 13482+00** – Controls in place and functioning properly.
