## FIELD INSPECTION REPORT

| Project Name: | Mountain Valley Pipeline | Inspector: | Marshall Willis |
| Inspection Date: | Friday, July 8, 2022 | Project Contact: | Brian Clauto, Cory Chalmers |
| Spread I:<br>Franklin County | STA 13541+00 – 13575+21 | Weather: | Wet |

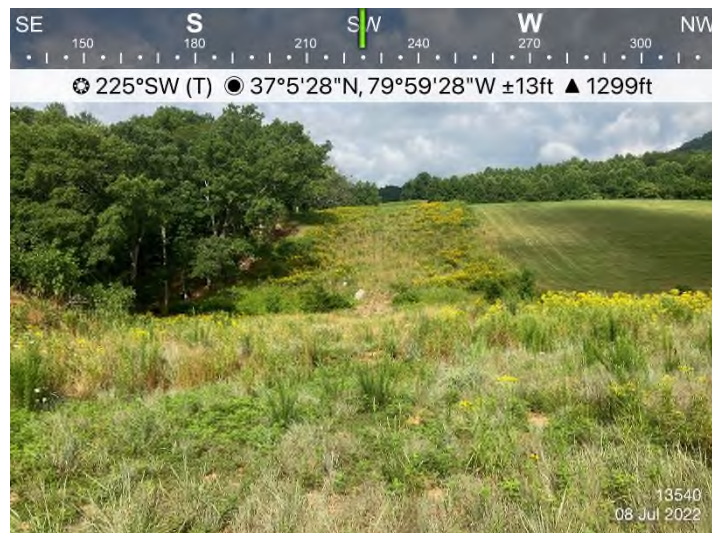
**Figure 1: STA 13540+00** – Controls in place and functioning properly.

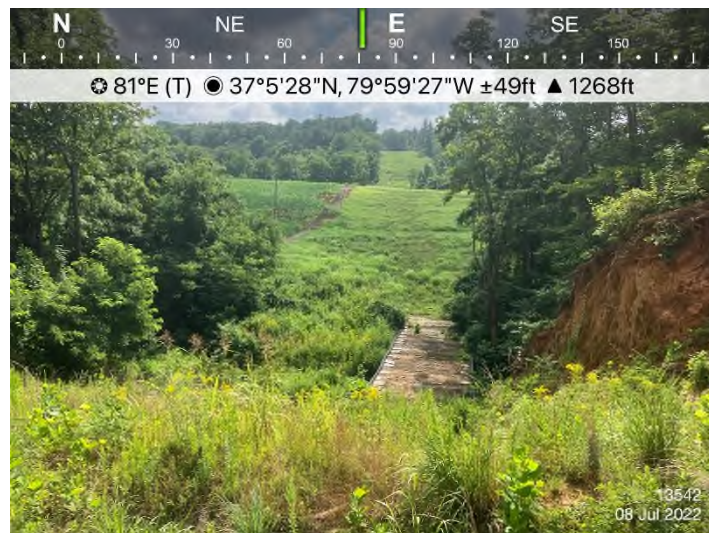
**Figure 2: STA 13542+00** – Controls in place and functioning properly.

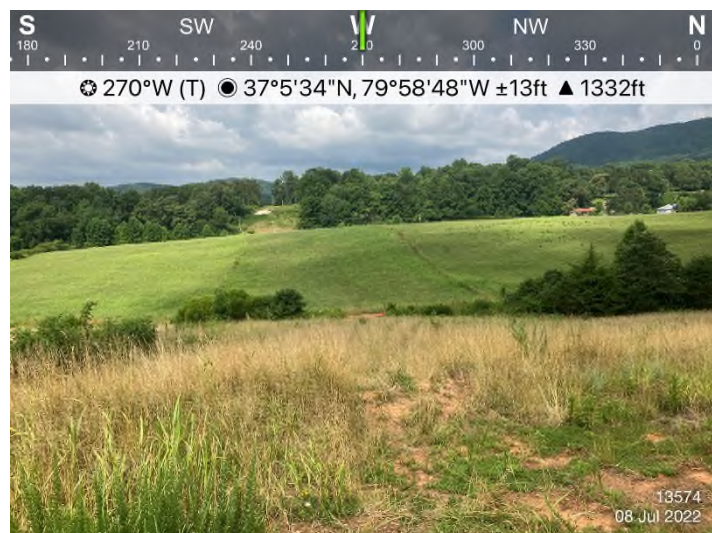
**Figure 3: STA 13574+00** – Controls in place and functioning properly.

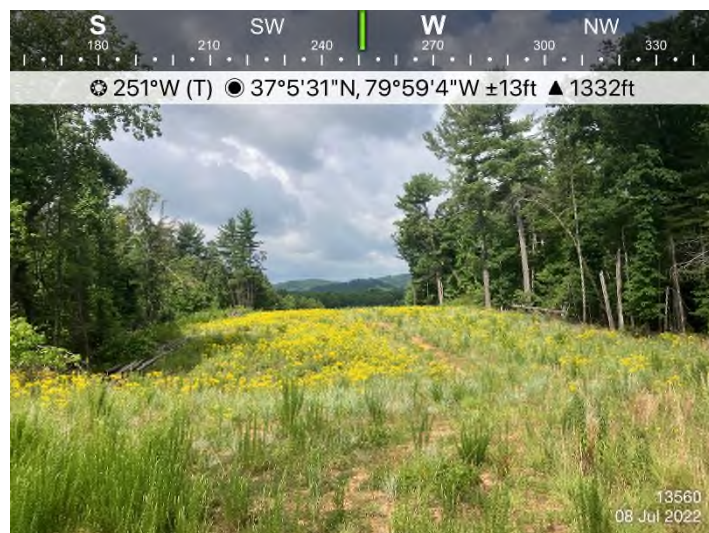
**Figure 4: STA 13560+00** – Controls in place and functioning properly.
