## FIELD INSPECTION REPORT

<b>Project Name:</b>	Mountain Valley Pipeline	<b>Inspector:</b>	Matthew Grant
<b>Inspection Date:</b>	Tuesday, August 9, 2022	<b>Project Contact:</b>	Brian Clauto
<b>Spread H: Roanoke</b>	ATWS 1326 AR RO286 ST12195-12867	<b>Weather:</b>	Dry

# FIELD INSPECTION PHOTO LOG

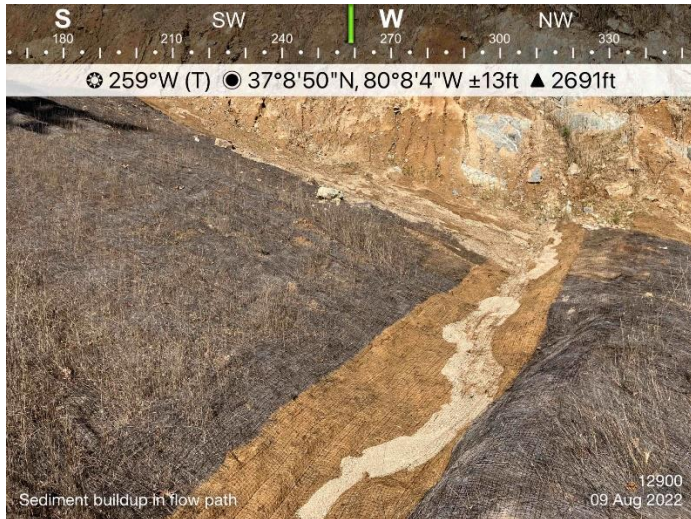
Figure 1: St12900 sediment build up along water bar flow path.

**Recommended Corrective Action:** Maintain and install all controls per the approved PSS&S.

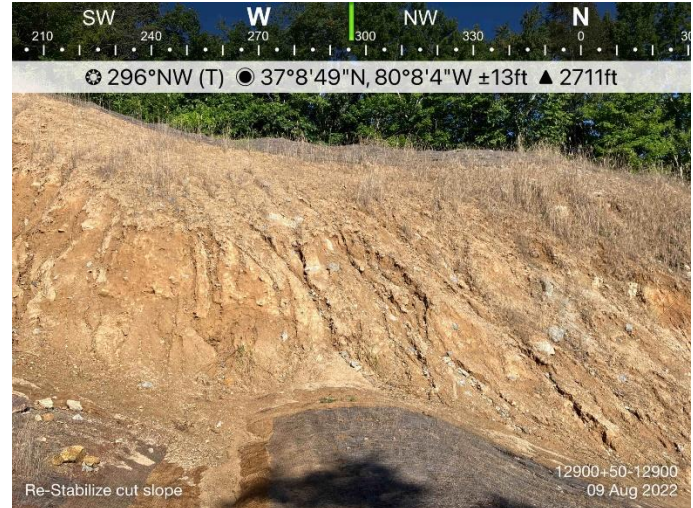
- St12900-12900+50, sediment buildup in flow path of waterbar.
- St12900-12900+50 Cut slope lacks adequate stabilization, rill erosion is evident and re-stabilization is required.
- St12898 sediment buildup in flow path of waterbar.

Figure 2: St12900-12900+50 cut slope requires re-stabilization

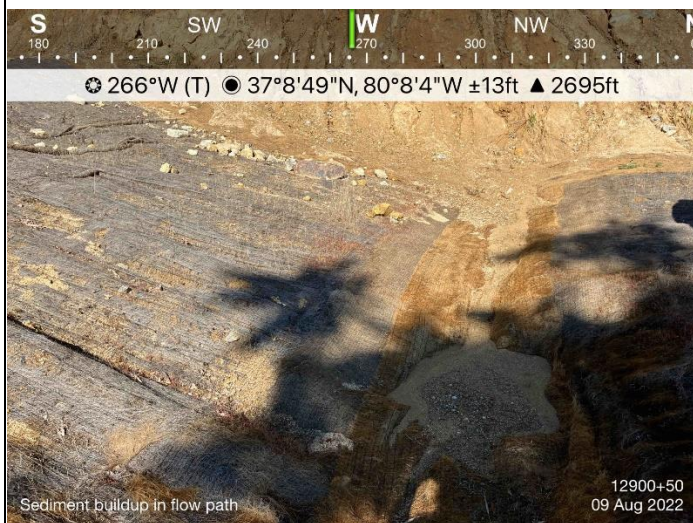
Figure 3: St12900+50 sediment build up along water bar flow path.

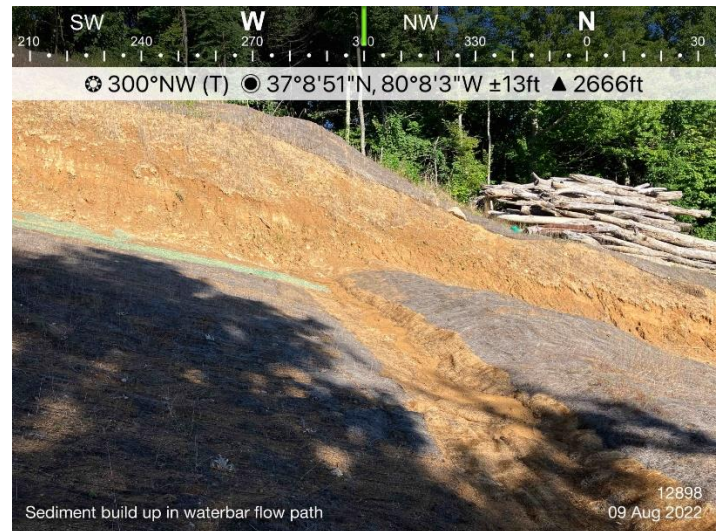
Figure 4: St12898 sediment build up along water bar flow path
