FIELD INSPECTION REPORT

Project Name:	Mountain Valley Pipeline	Inspector:	Matthew Grant
Inspection Date:	Tuesday, August 2, 2022	Project Contact:	Brian Clauto
Spread H: Franklin	ATWS 1251, 1483, 1482 AR FR292, 292.02 ST13142-13188	Weather:	Dry

FIELD INSPECTION PHOTO LOG

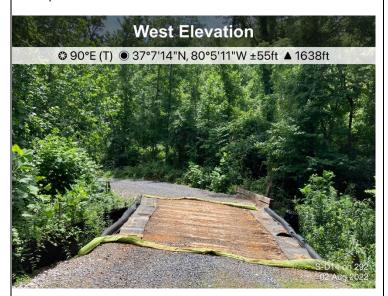
<u>Figure 1</u>: Designated crossing S-D14 on AR FR 292, ECD's are in place.

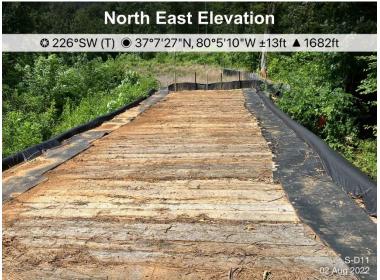
Figure 2: Designated crossing S-D11, ECD's are in place.

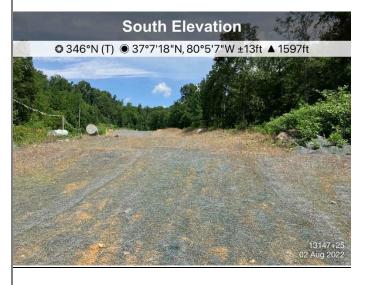
Figure 3: St13147+25 ECD's and stabilization are in place.

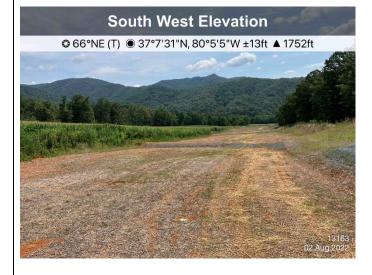
Figure 4: St13163 ECD's and stabilization are in place.
