COMPLAINT INVESTIGATION REPORT

Project Name:	Mountain Valley Pipeline	Inspector:	Marshall Willis, Matthew Grant
Inspection Date:	Wednesday, August 10, 2022	Project Contact:	Brian Clauto, Cory Chalmers
Spread H: Montgomery County	STA 12532+00 – 12544+27 MVP-MN-278.01	Weather:	Dry

Background: This investigation was conducted in response to a complaint (IR#: 306014) received on August 09, 2022 for the MVP ROW at Yellow Finch Lane (MVP-MN-278.01).

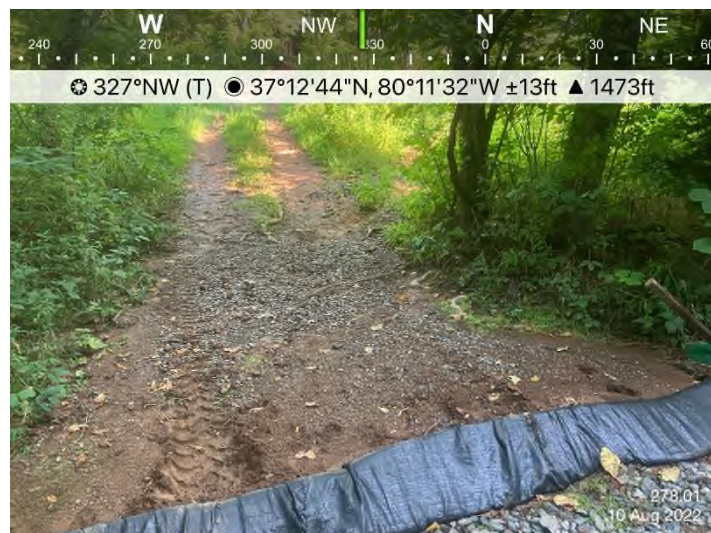
Figure 1: MVP-MN-278.01 – Landowner driveway adjacent to MN-278.01.

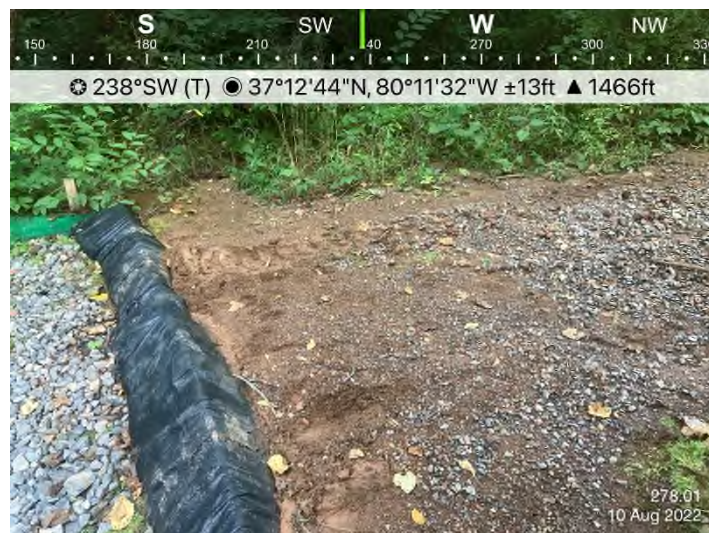
Figure 2: MVP-MN-278.01 – Landowner driveway adjacent to MN-278.01. Sediment buildup on triangular silt dike.

- MVP-MN-278.01: Maintain triangular silt dike by removing sediment build up from erosion on landowner access road.

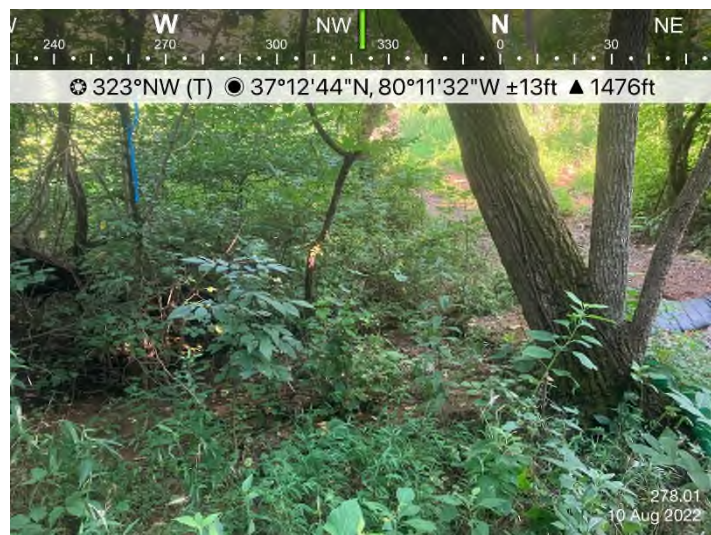
- Controls were in place and functioning properly along MVP-MN-278.01 and within the ROW from STA 12532+00 to 12544+27.
- ROW was adequately stabilized and no sediment deposition off ROW was observed.
- One maintenance item was noted during the inspection. See below.
- No evidence of undermined controls was found.
- Significant erosion occurring adjacent to the MVP ROW on denuded landowner driveway is causing sediment build up on MVP controls and subsequently flows into Stream S-EF54 above and outside the MVP LOD. See Figures 1-7.

Figure 3: MVP-MN-278.01 – Sediment from denuded driveway moving outside of ROW towards Stream S-EF54.

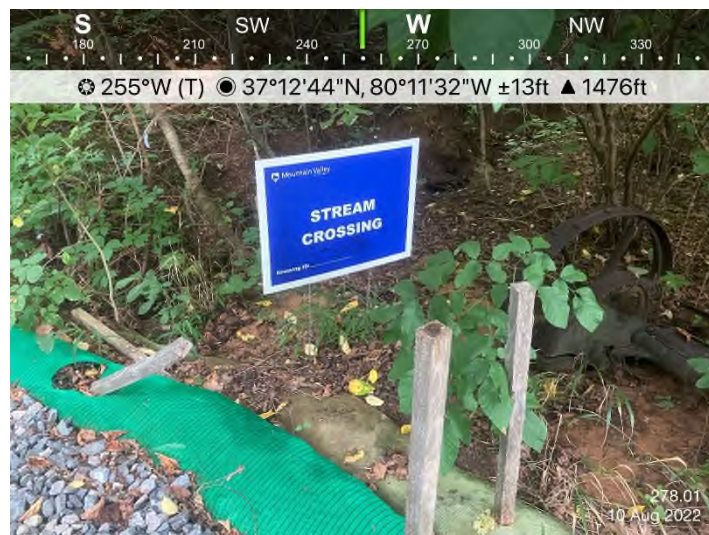
Figure 4: MVP-MN-278.01 – Stream S-EF54.

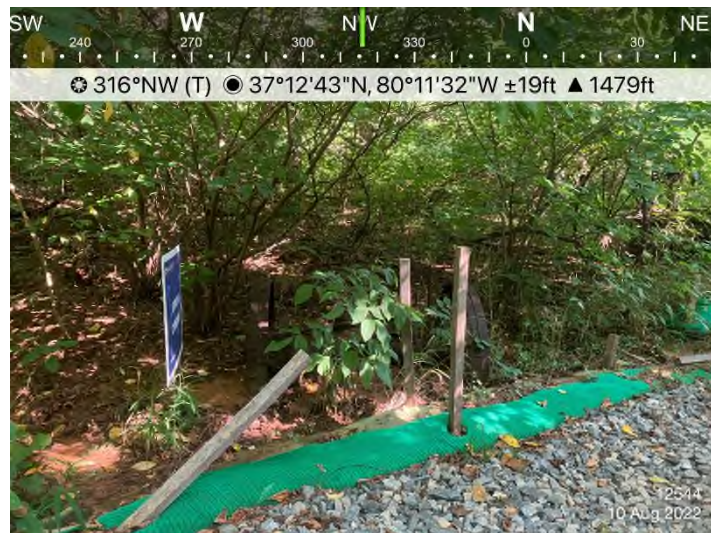
Figure 5: MVP-MN-278.01 – Stream S-EF54.

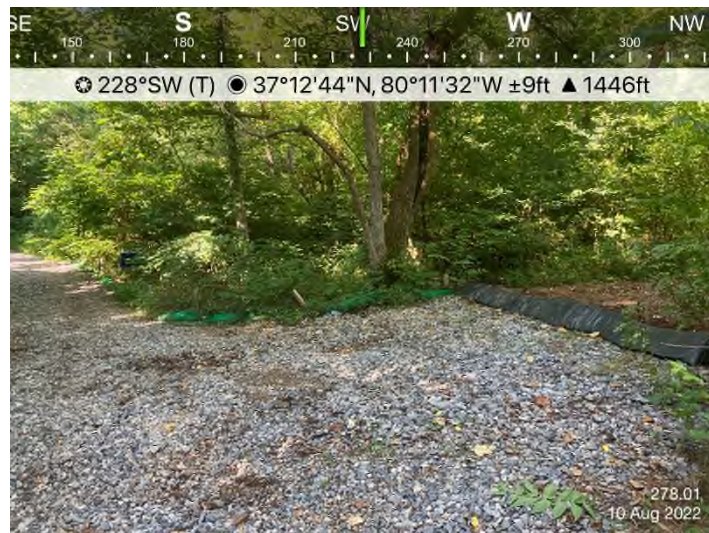
Figure 6: MVP-MN-278.01 – Landowner driveway adjacent to MN-278.01.

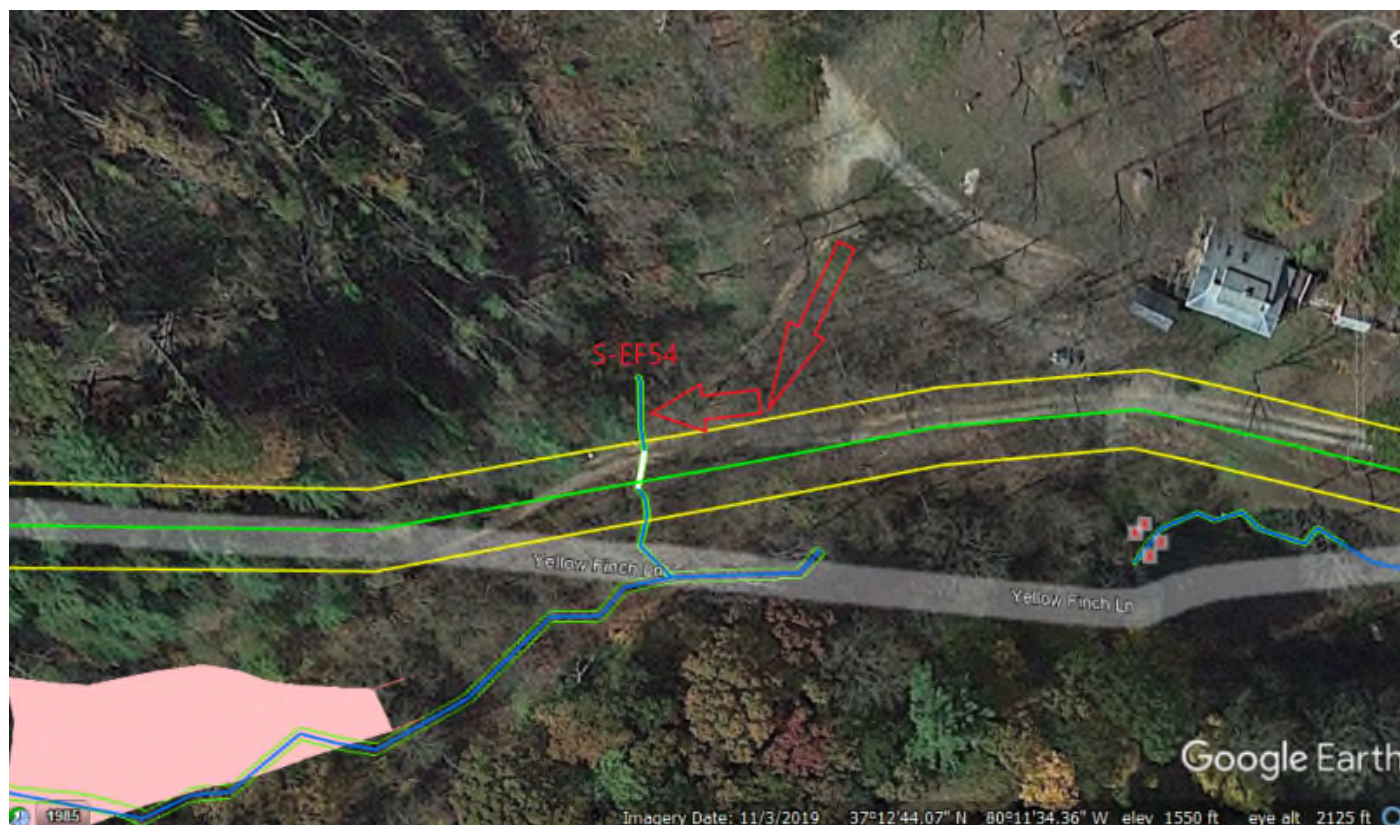
Figure 7: MVP-MN-278.01 – Landowner driveway adjacent to MN-278.01.
