FIELD INSPECTION REPORT

Project Name:	Mountain Valley Pipeline	Inspector:	Marshall Willis
Inspection Date:	Friday, August 12, 2022	Project Contact:	Brian Clauto, Cory Chalmers
Spread I: Franklin County	STA 14694+77 – 14758+16	Weather:	Wet

FIELD INSPECTION PHOTO LOG

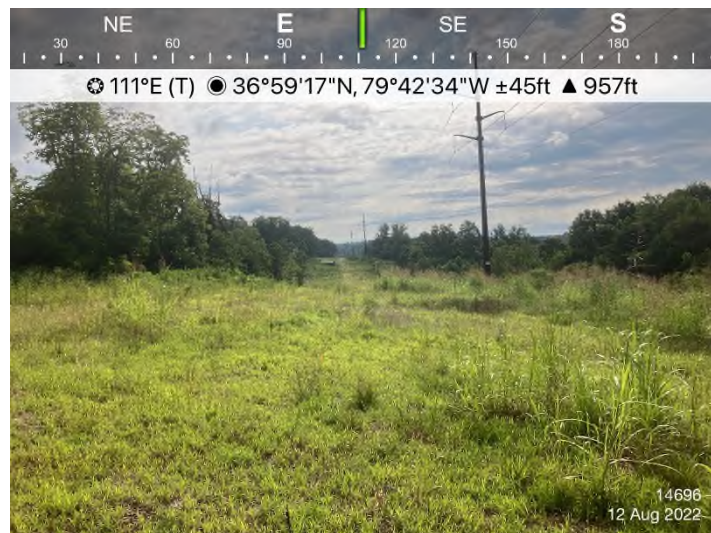
Figure 1: STA 14696+00 – Controls in place and functioning properly.

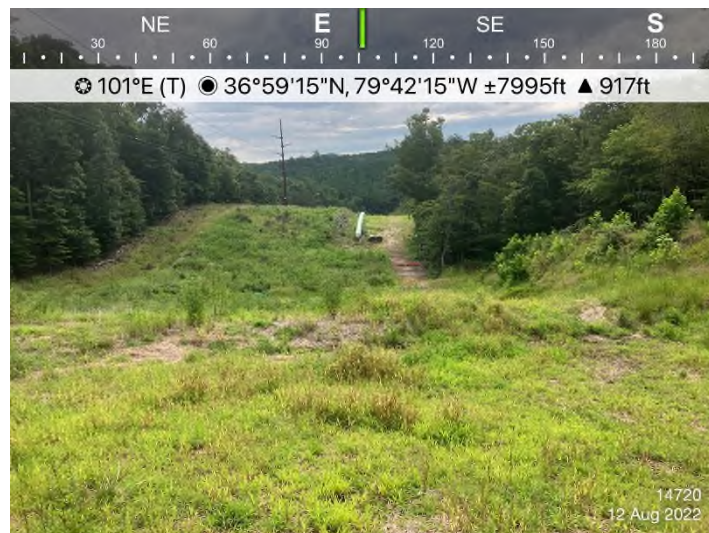
Figure 2: STA 14720+00 – Controls in place and functioning properly.

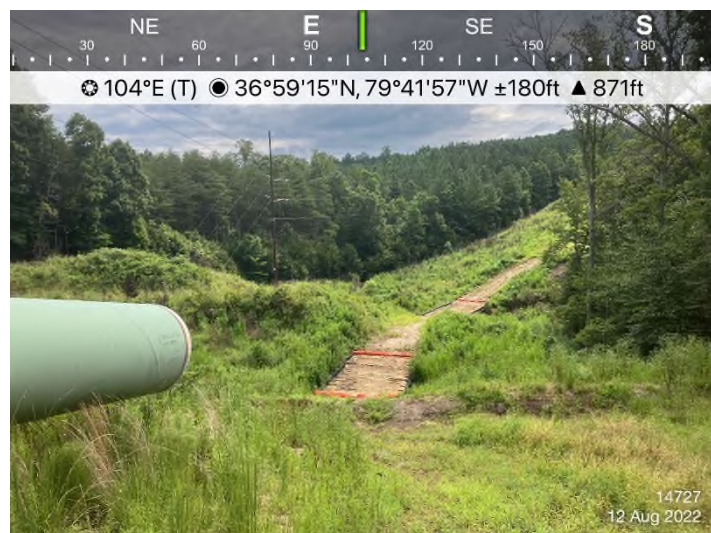
Figure 3: STA 14727+00 – Controls in place and functioning properly.

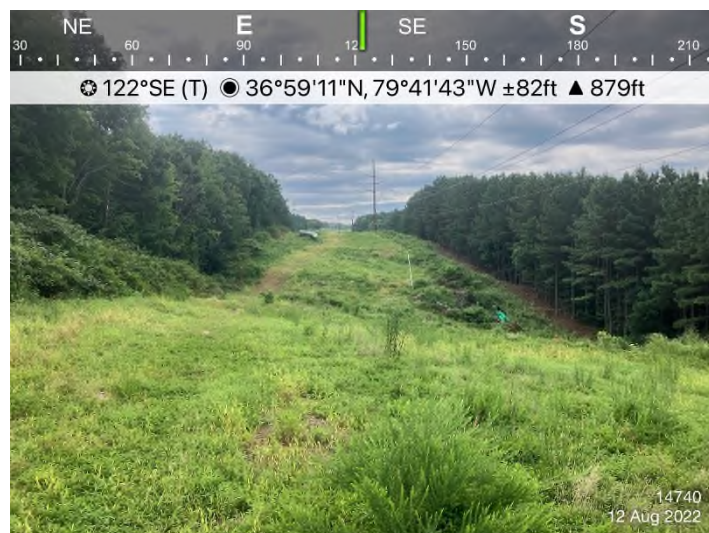
Figure 4: STA 14740+00 – Controls in place and functioning properly.
