## FIELD INSPECTION REPORT

| Project Name: | Mountain Valley Pipeline | Inspector: | Marshall Willis |
| Inspection Date: | Thursday, August 11, 2022 | Project Contact: | Brian Clauto, Cory Chalmers |
| Spread I:<br>Franklin County | STA 14649+67 – 14694+77 | Weather: | Wet |

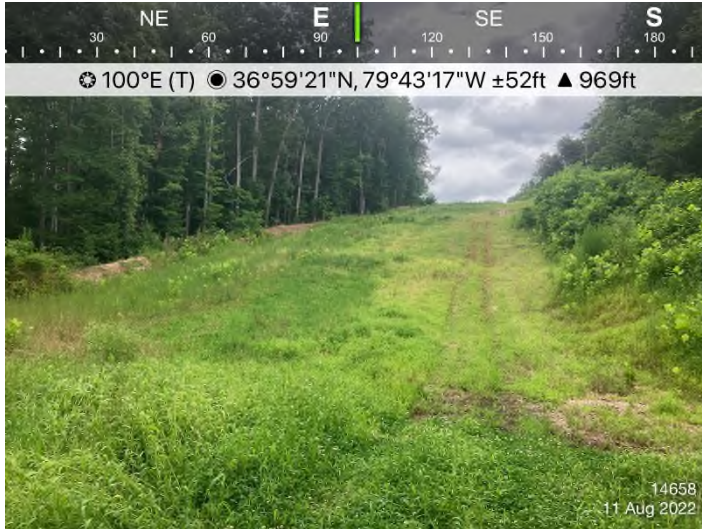
**Figure 1: STA 14658+00** – Controls in place and functioning properly.

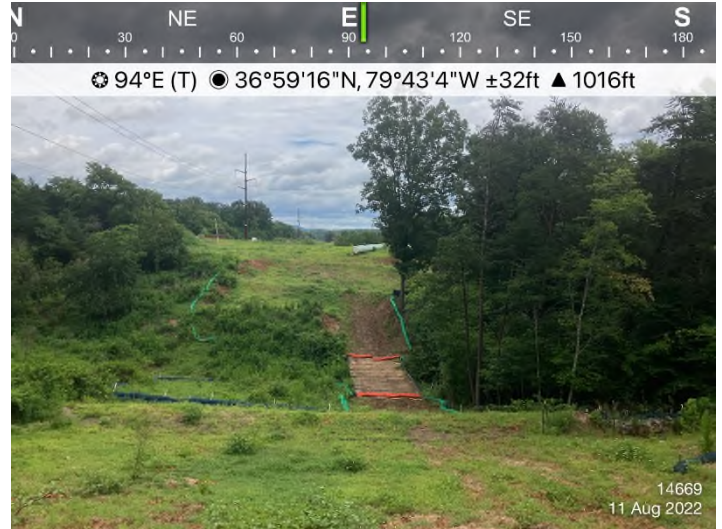
**Figure 2: STA 14669+00** – Controls in place and functioning properly.

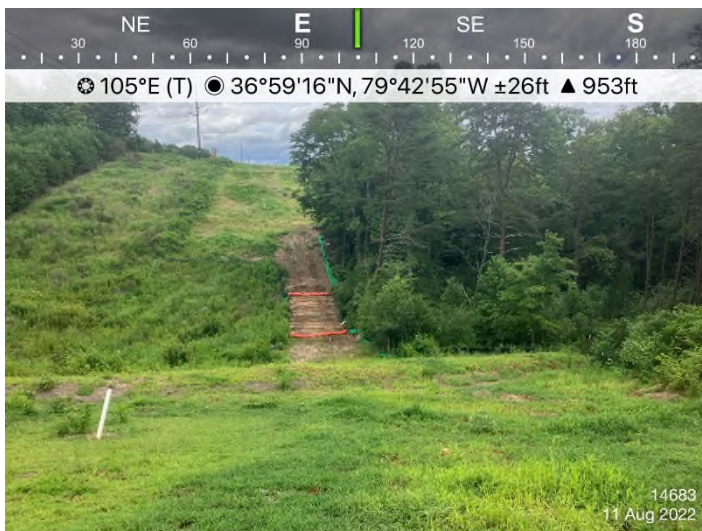
**Figure 3: STA 14683+00** – Controls in place and functioning properly.

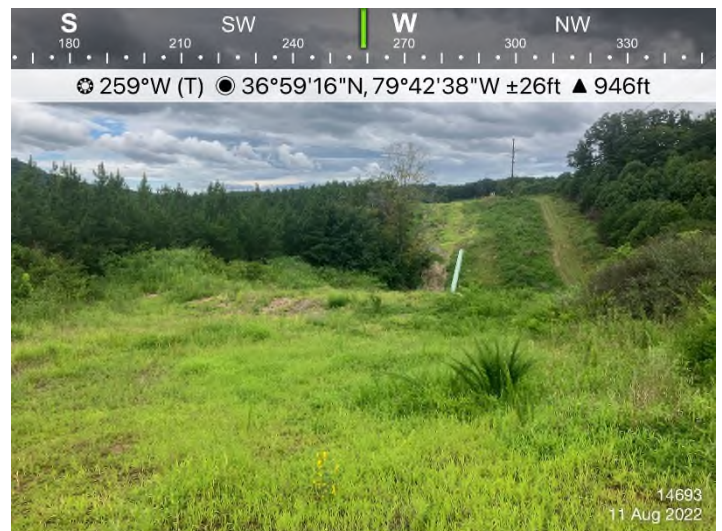
**Figure 4: STA 14693+00** – Controls in place and functioning properly.
