FIELD INSPECTION REPORT

Project Name:	Mountain Valley Pipeline	Inspector:	Marshall Willis
Inspection Date:	Tuesday, August 2, 2022	Project Contact:	Brian Clauto, Cory Chalmers
Spread H: Franklin County	STA 13140+00 - 13195+00 MVP-FR-292/.01/.02	Weather:	Wet

FIELD INSPECTION PHOTO LOG

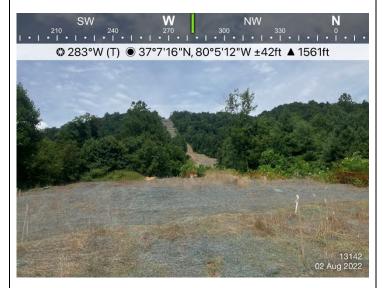
<u>Figure 1</u>: **STA 13142+00** – Controls in place and functioning properly.

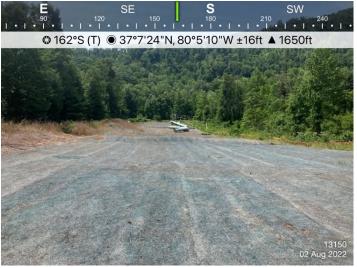
<u>Figure 2:</u> **STA 13150+00** – Controls in place and functioning properly.

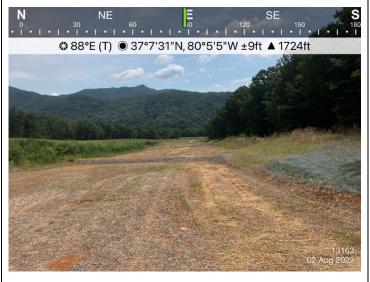
<u>Figure 3</u>: **STA 13163+00** – Controls in place and functioning properly.

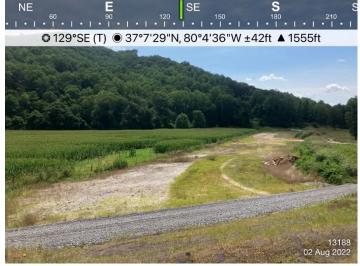
Figure 4: **STA 13188+00** – Controls in place and functioning properly.
