## FIELD INSPECTION REPORT

| Project Name: | Mountain Valley Pipeline | Inspector: | Marshall Willis |
| Spread H:<br>Roanoke County | STA 12601+00 – 12637+00<br>MVP-RO-279.01/02 | Weather: | Rainy |

## FIELD INSPECTION PHOTO LOG

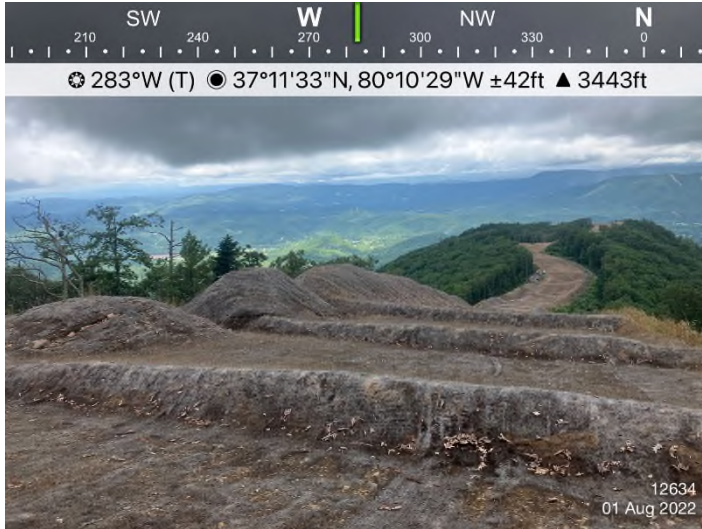
**Figure 1: STA 12634+00** – Controls in place and functioning properly.

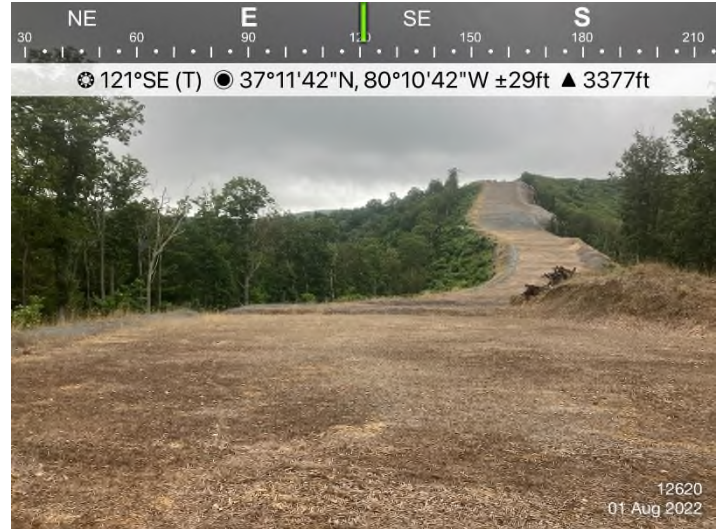
**Figure 2: STA 12620+00** – Controls in place and functioning properly.

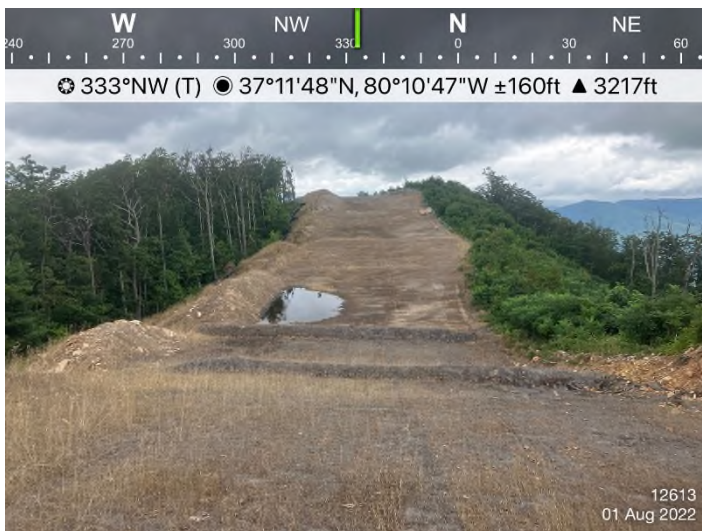
**Figure 3: STA 12613+00** – Controls in place and functioning properly.

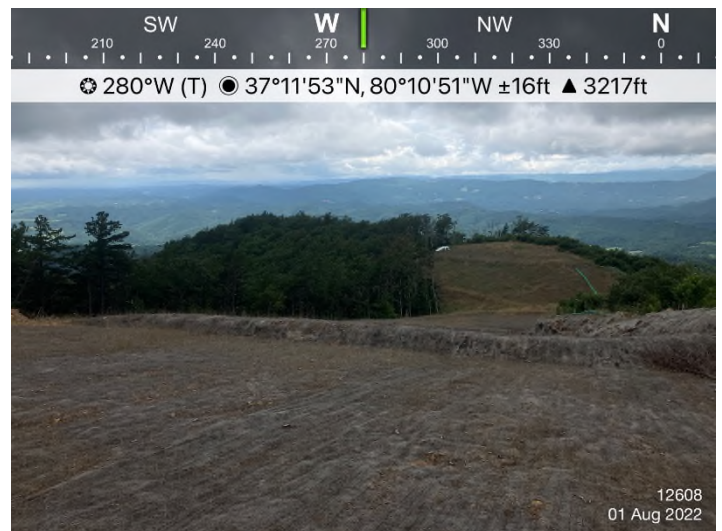
**Figure 4: STA 12608+00** – Controls in place and functioning properly.
