## FIELD INSPECTION REPORT

| Project Name: | Mountain Valley Pipeline | Inspector: | Marshall Willis |
| Inspection Date: | Thursday, February 9, 2023 | Project Contact: | Brian Clauto, Cory Chalmers |
| Spread I:<br>Franklin County | STA 13811+81 – 13892+45 | Weather: | Dry |

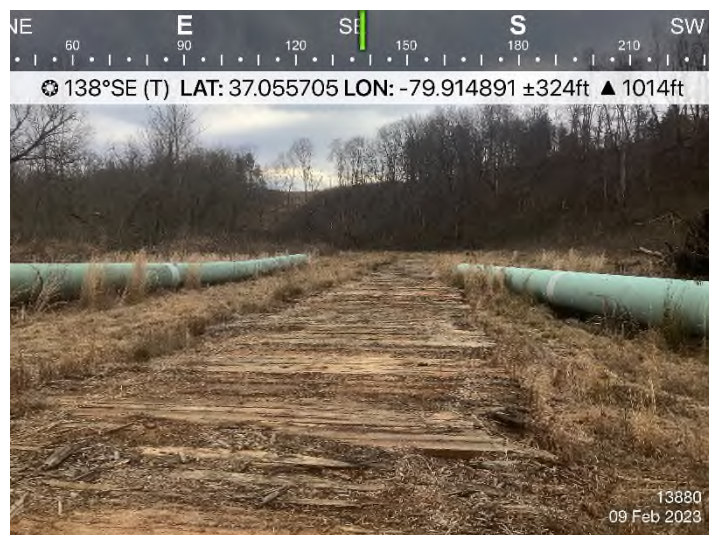
**Figure 1: STA 13880+00** – Controls in place and functioning properly.

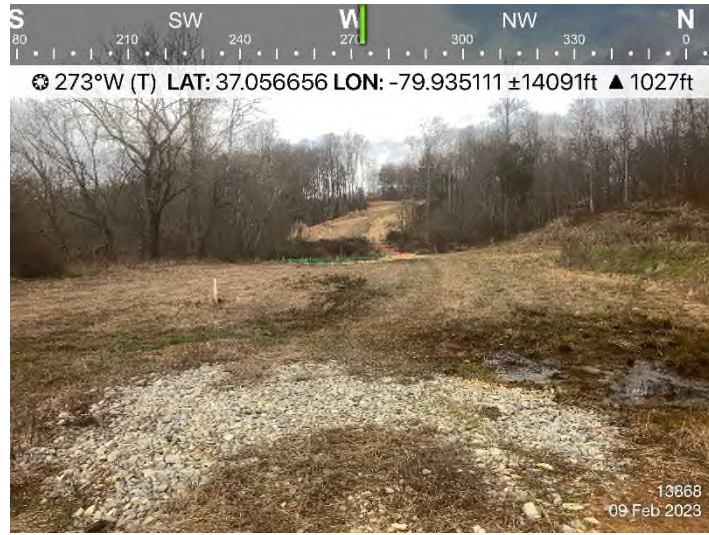
**Figure 2: STA 13868+00** – Controls in place and functioning properly.

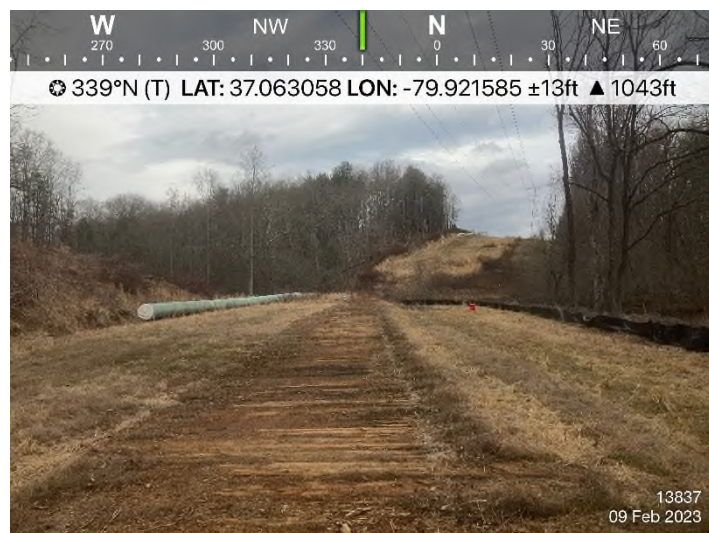
**Figure 3: STA 13837+00** – Controls in place and functioning properly.

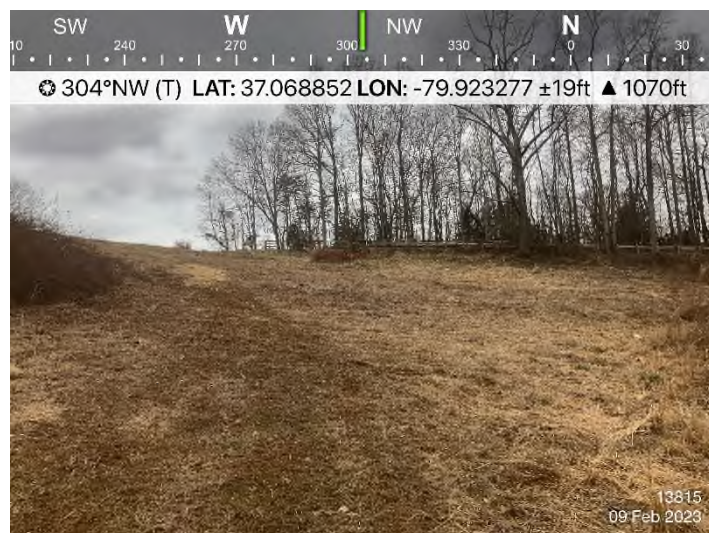
**Figure 4: STA 13815+00** – Controls in place and functioning properly.
