FIELD INSPECTION REPORT

Project Name:	Mountain Valley Pipeline	Inspector:	Marshall Willis
Inspection Date:	Tuesday, February 7, 2023	Project Contact:	Brian Clauto, Cory Chalmers
Spread I: Franklin County	STA 13690+91 - 13784+80 MVP-FR-300	Weather:	Wet

FIELD INSPECTION PHOTO LOG

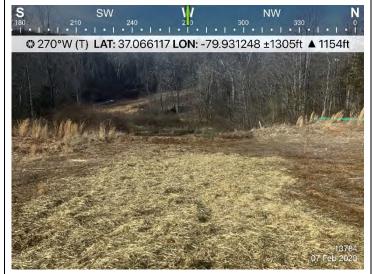
<u>Figure 1</u>: **STA 13784+00** – Controls in place and functioning properly.

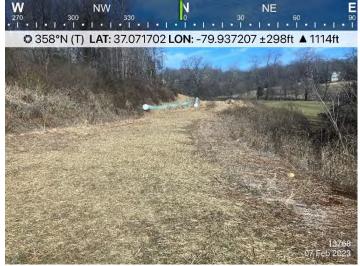
Figure 2: STA 13768+00 – Controls in place and functioning properly.

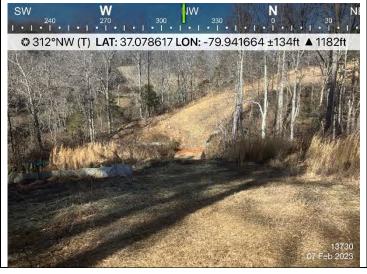
<u>Figure 3</u>: **STA 13730+00** – Controls in place and functioning properly.

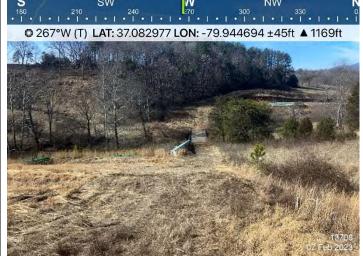
Figure 4: STA 13708+00 – Controls in place and functioning properly.
