FIELD INSPECTION REPORT

Project Name:	Mountain Valley Pipeline	Inspector:	Marshall Willis
Inspection Date:	Wednesday, January 25, 2023	Project Contact:	Brian Clauto, Cory Chalmers
Spread I: Franklin County	STA 13410+56 – 13425+00 MVP-FR-293.02 MVP-FR-303.01	Weather:	Rainy

FIELD INSPECTION PHOTO LOG

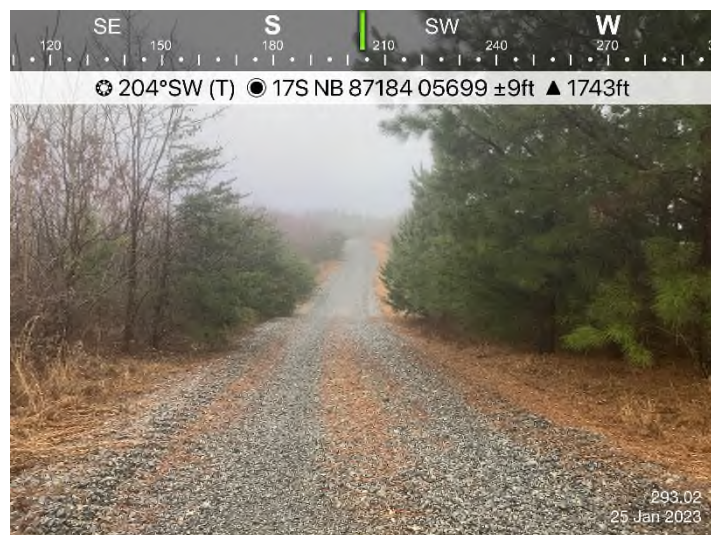
Figure 1: MVP-FR-293.02 – Controls in place and functioning properly along access road crossing.

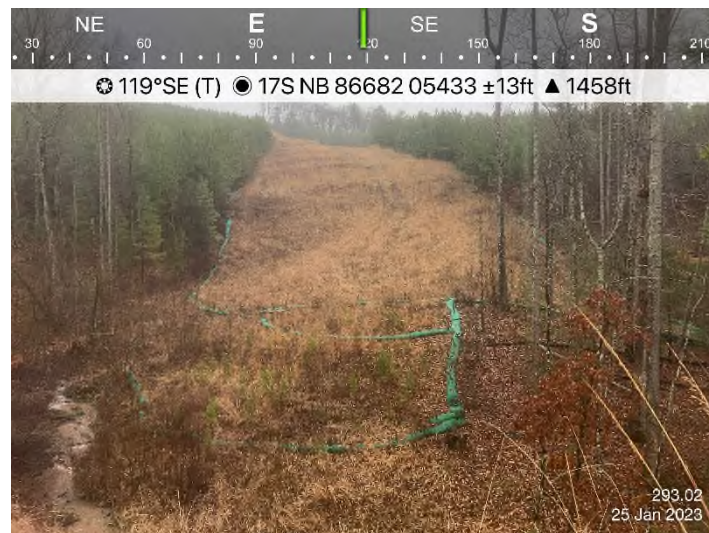
Figure 2: STA 13423+00 – Controls in place and functioning properly.

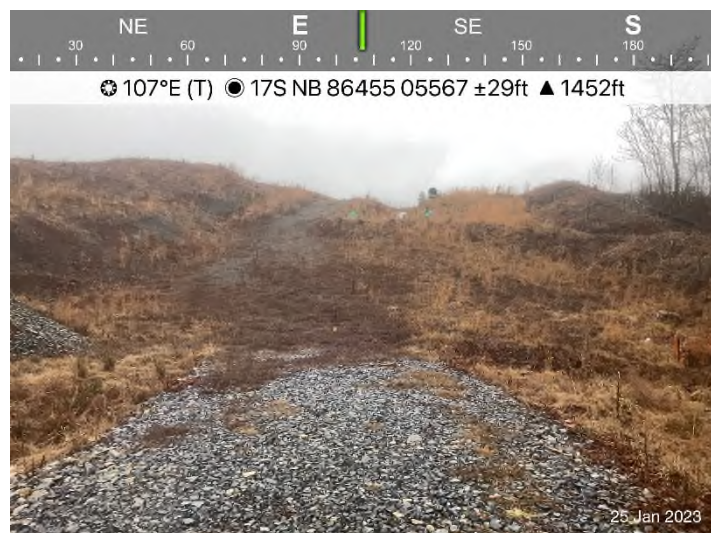
Figure 3: STA 13416+00 – Controls in place and functioning properly.

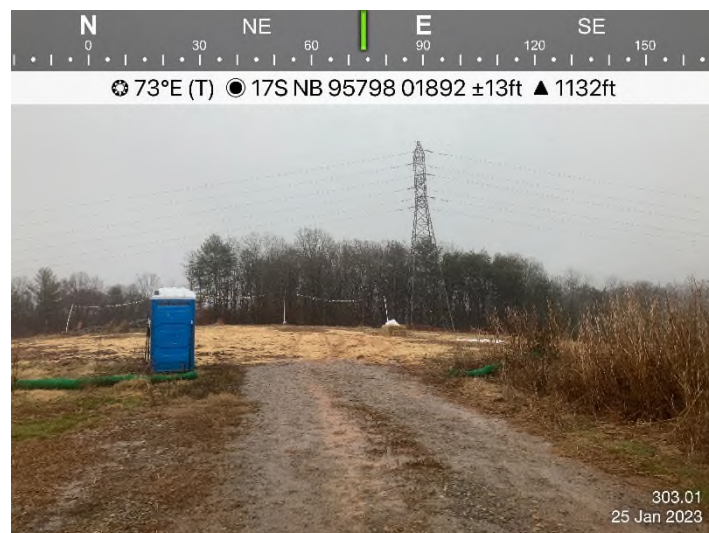
Figure 4: MVP-FR-303.01 – Controls in place and functioning properly.
