## FIELD INSPECTION REPORT

| Project Name: | Mountain Valley Pipeline | Inspector: | Marshall Willis |

## FIELD INSPECTION PHOTO LOG

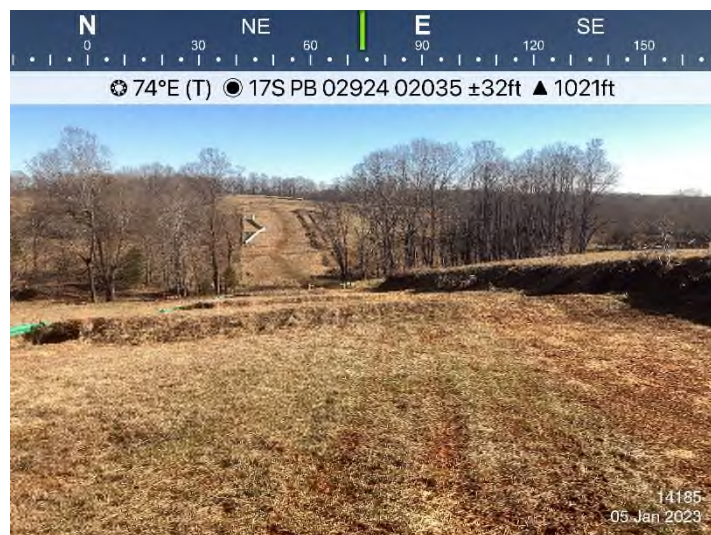
**Figure 1: STA 14185+00** – Controls in place and functioning properly.

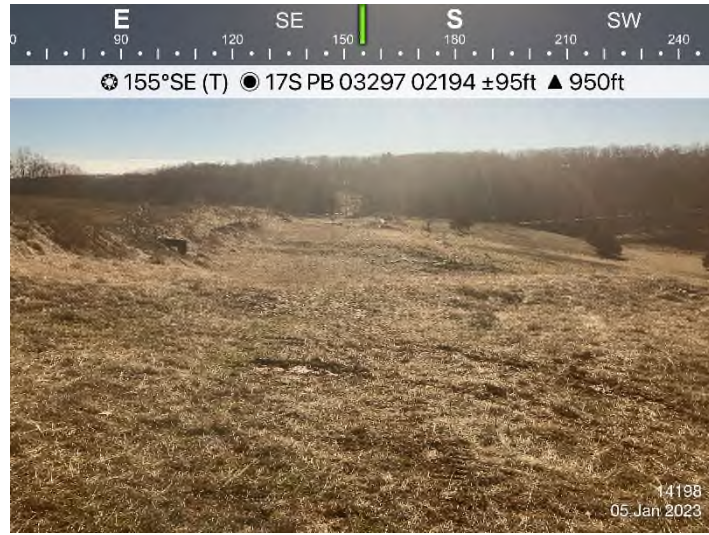
**Figure 2: STA 14198+00** – Controls in place and functioning properly.

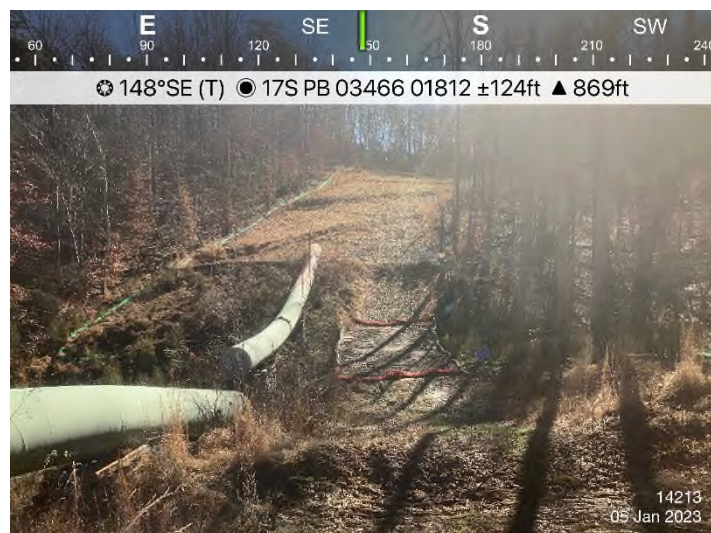
**Figure 3: STA 14213+00** – Controls in place and functioning properly.

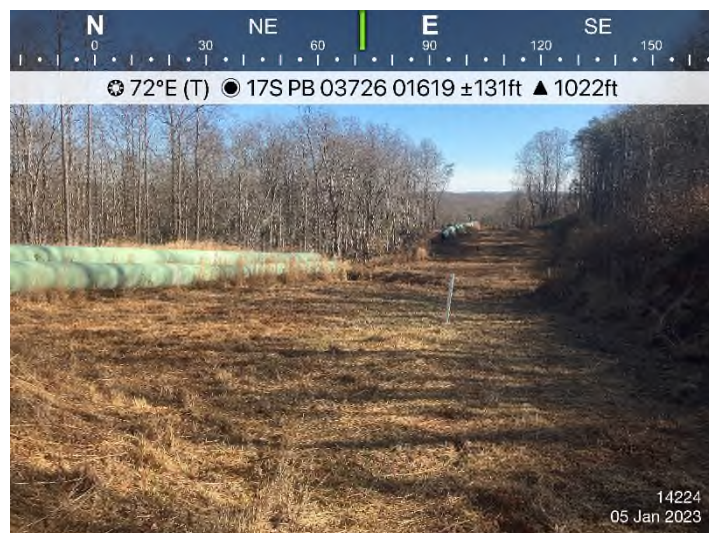
**Figure 4: STA 14224+00** – Controls in place and functioning properly.
