## FIELD INSPECTION REPORT

| Project Name: | Mountain Valley Pipeline | Inspector: | Marshall Willis |
| Inspection Date: | Tuesday, January 3, 2023 | Project Contact: | Brian Clauto, Cory Chalmers |
| Spread I:<br>Franklin County | STA 13575+42 – 13644+82 | Weather: | Wet |

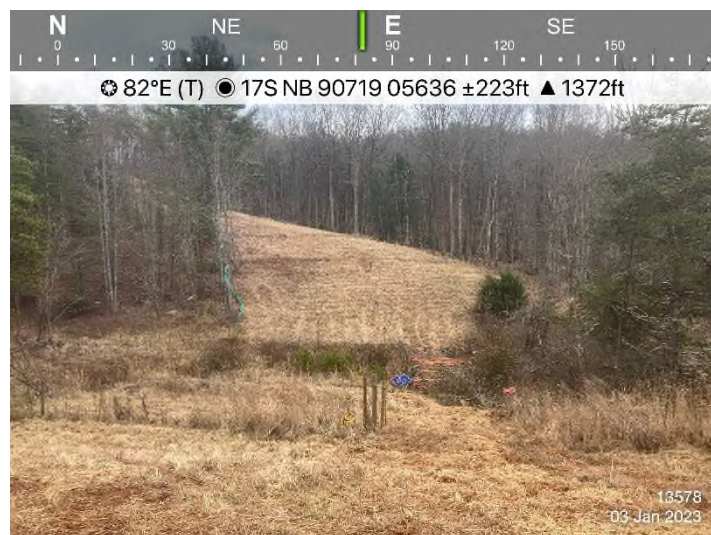
**Figure 1: STA 13578+00** – Controls in place and functioning properly.

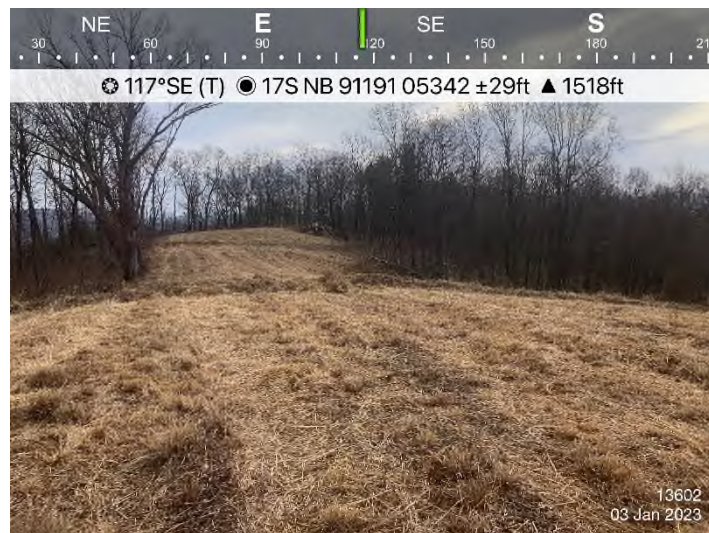
**Figure 2: STA 13602+00** – Controls in place and functioning properly.

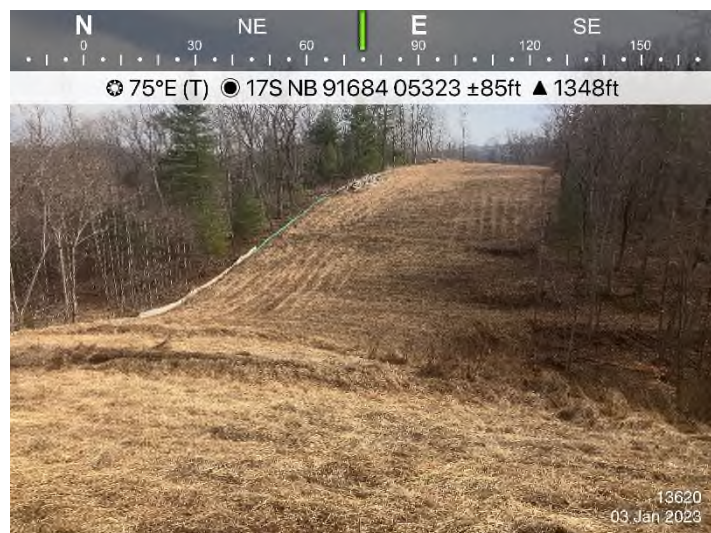
**Figure 3: STA 13620+00** – Controls in place and functioning properly.

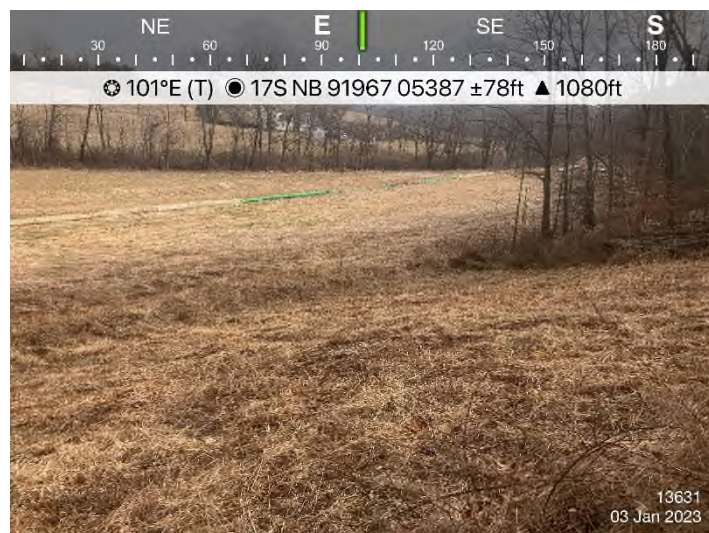
**Figure 4: STA 13631+00** – Controls in place and functioning properly.
