FIELD INSPECTION REPORT

Project Name:	Mountain Valley Pipeline	Inspector:	Marshall Willis
Inspection Date:	Thursday, December 29, 2022	Project Contact:	Brian Clauto, Cory Chalmers
Spread I: Franklin County	STA 14649+67 – 14758+07	Weather:	Wet

Project Name: Mountain Valley Pipeline

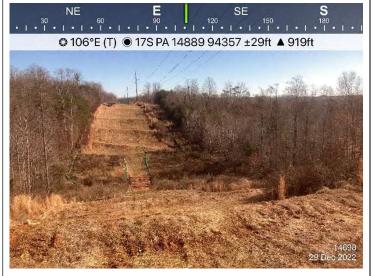
Figure 2: STA 14698+00 – Controls in place and functioning properly.

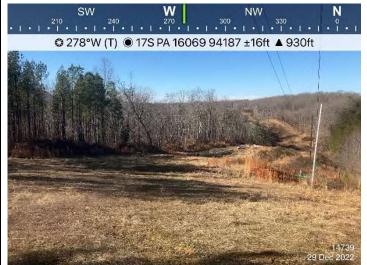
<u>Figure 3</u>: **STA 14739+00** – Controls in place and functioning properly.

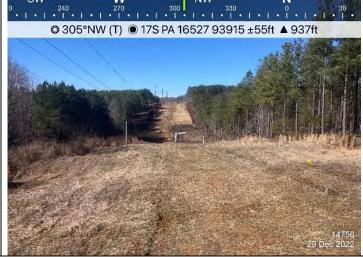
Figure 4: STA 14756+00 — Controls in place and functioning properly.
