FIELD INSPECTION REPORT

Project Name:	Mountain Valley Pipeline	Inspector:	Marshall Willis
Inspection Date:	Tuesday, December 20, 2022	Project Contact:	Brian Clauto, Cory Chalmers
Spread I: Franklin County	STA 14980+00 – 14996+00 MVP-FR-324	Weather:	Wet

FIELD INSPECTION PHOTO LOG

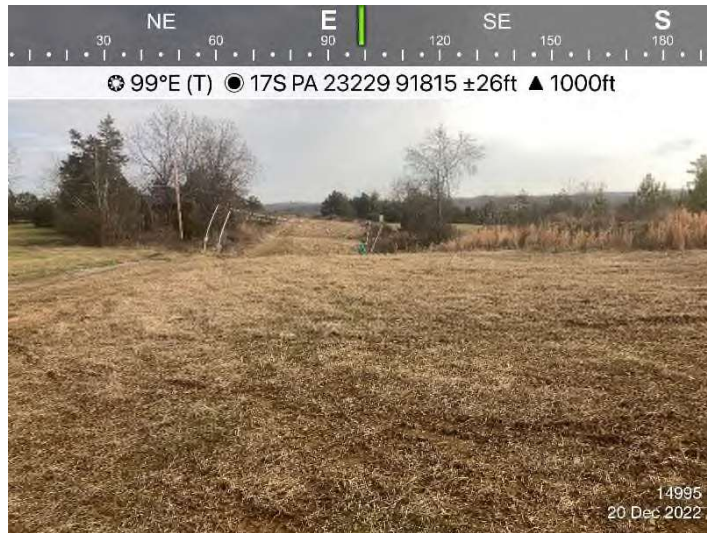
Figure 1: STA 14995+00 – Controls in place and functioning properly.

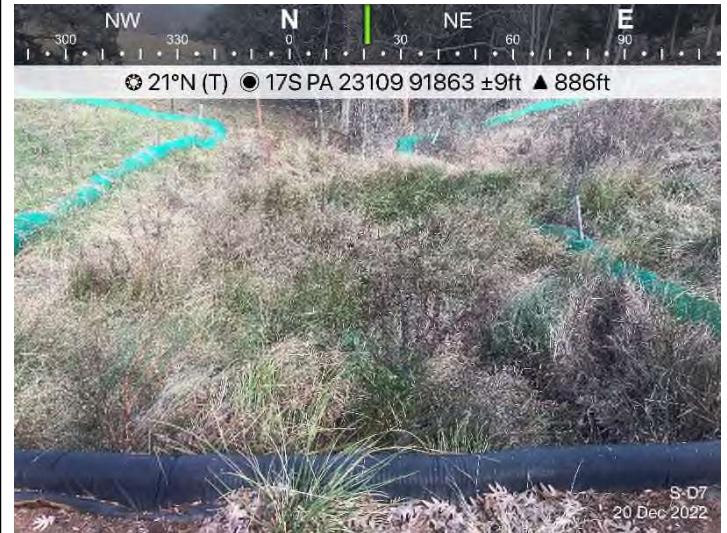
Figure 2: Stream S-D7 – Controls in place and functioning properly along stream crossing.

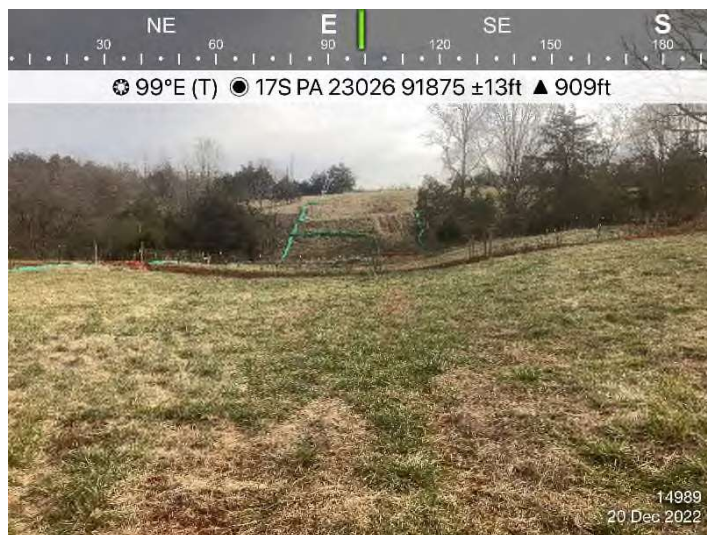
Figure 3: STA 14989+00 – Controls in place and functioning properly.

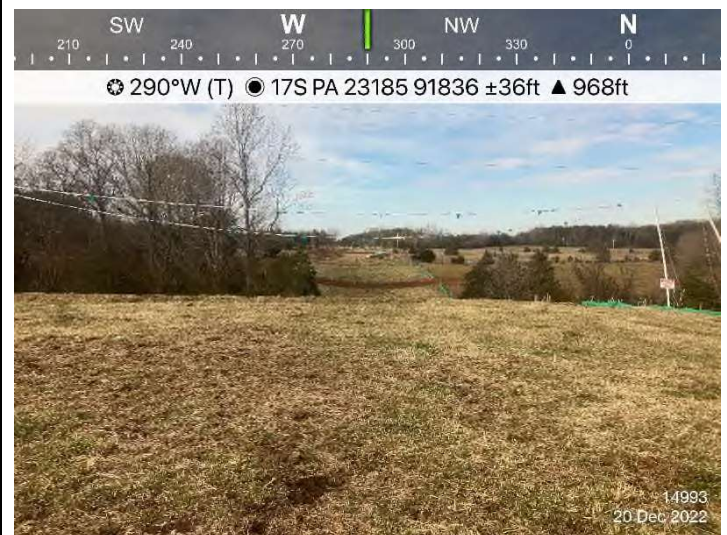
Figure 4: STA 14993+00 – Controls in place and functioning properly.
