FIELD INSPECTION REPORT

Project Name:	Mountain Valley Pipeline	Inspector:	Marshall Willis
Inspection Date:	Thursday, December 8, 2022	Project Contact:	Brian Clauto, Cory Chalmers
Spread I: Franklin County	STA 14333+27 - 14411+09 MVP-FR-313.01/314/315	Weather:	Wet

FIELD INSPECTION PHOTO LOG

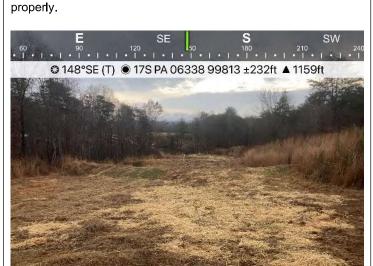
Figure 1: STA 14334+00 - Controls in place and functioning

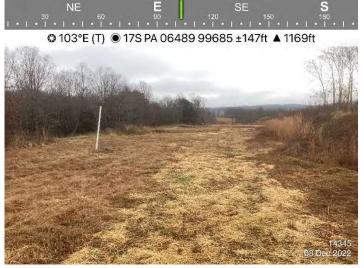
Figure 2: STA 14345+00 – Controls in place and functioning properly.

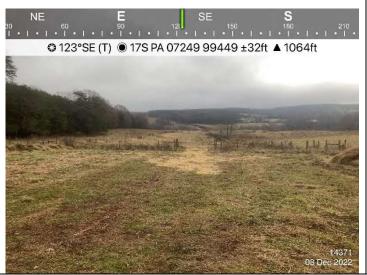
<u>Figure 3</u>: **STA 14371+00** – Controls in place and functioning properly.

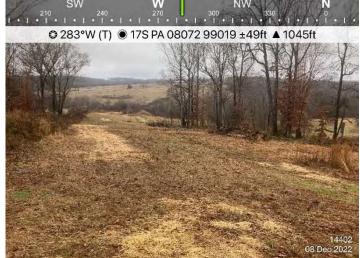
<u>Figure 4</u>: **STA 14402+00** – Controls in place and functioning properly.
