FIELD INSPECTION REPORT

Project Name:	Mountain Valley Pipeline	Inspector:	Marshall Willis
Inspection Date:	Thursday, December 1, 2022	Project Contact:	Brian Clauto, Cory Chalmers
Spread I: Franklin County	STA 14062+17 – 14132+29 MVP-FR-306.05/.06 MVP-FR-309	Weather:	Wet

FIELD INSPECTION PHOTO LOG

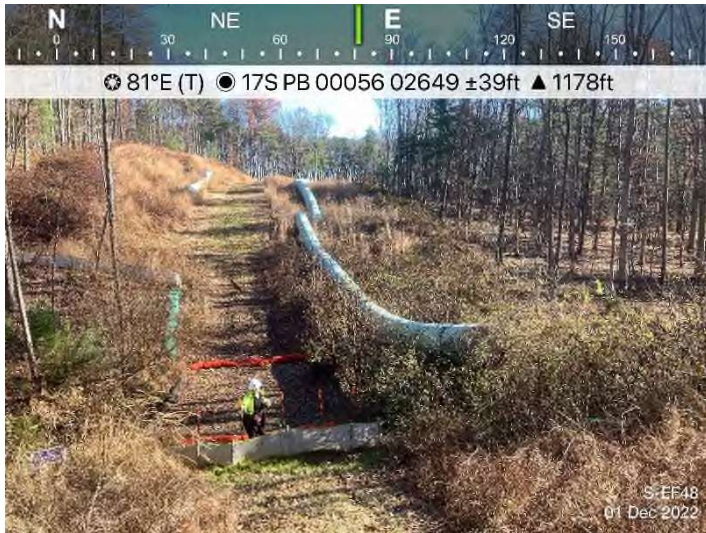
Figure 1: Stream S-EF48 – Controls in place and functioning properly along stream crossing.

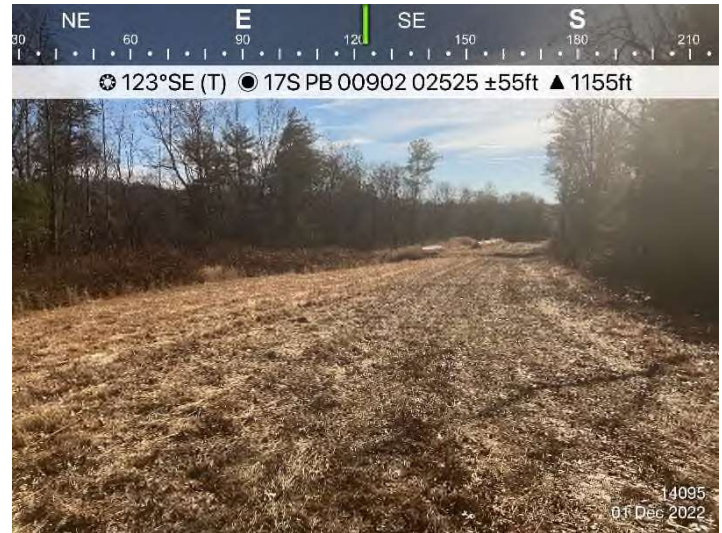
Figure 2: STA 14095+00 – Controls in place and functioning properly.

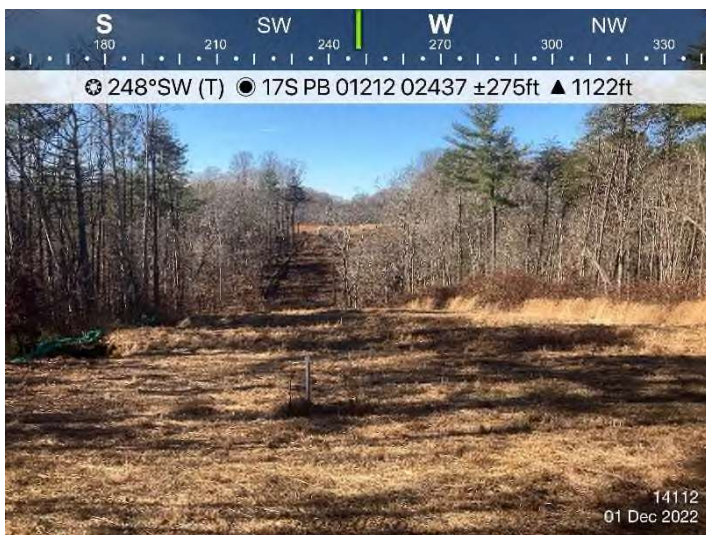
Figure 3: STA 14112+00 – Controls in place and functioning properly.

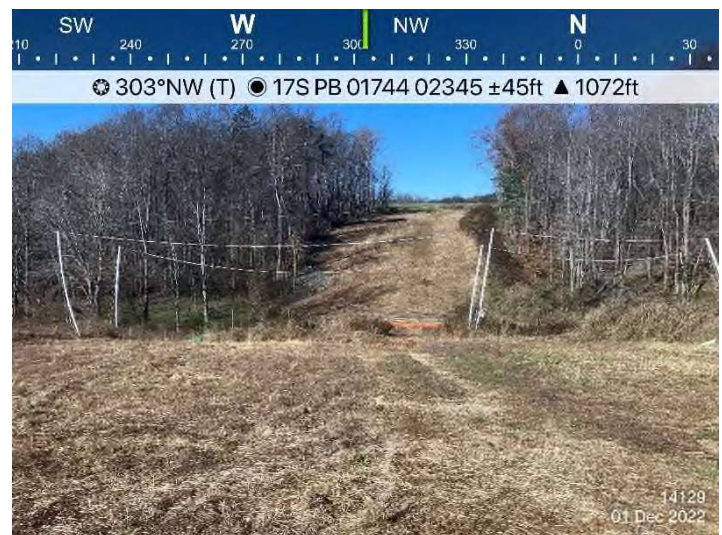
Figure 4: STA 14129+00 – Controls in place and functioning properly.
