## FIELD INSPECTION REPORT

| Project Name: | Mountain Valley Pipeline | Inspector: | Marshall Willis |
| Inspection Date: | Tuesday, November 29, 2022 | Project Contact: | Brian Clauto, Cory Chalmers |
| Spread I:<br>Franklin County | STA 13958+31 – 14062+17<br>MVP-FR-306.02/.03/.04 | Weather: | Dry |

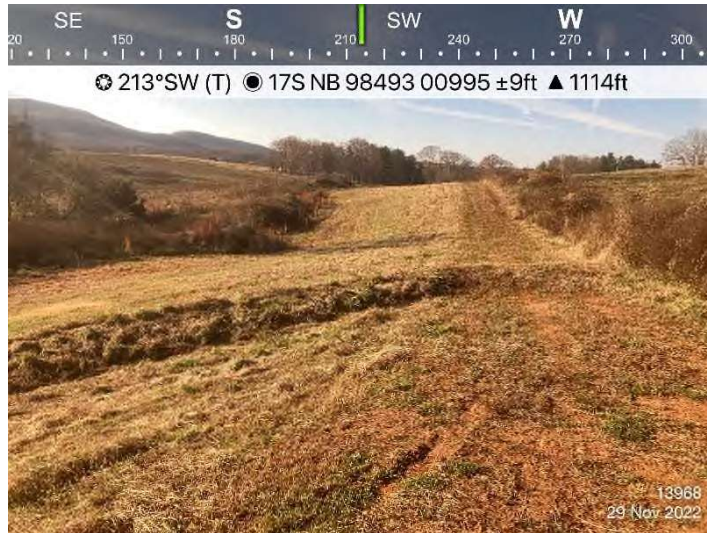
**Figure 1: STA 13968+00** – Controls in place and functioning properly.

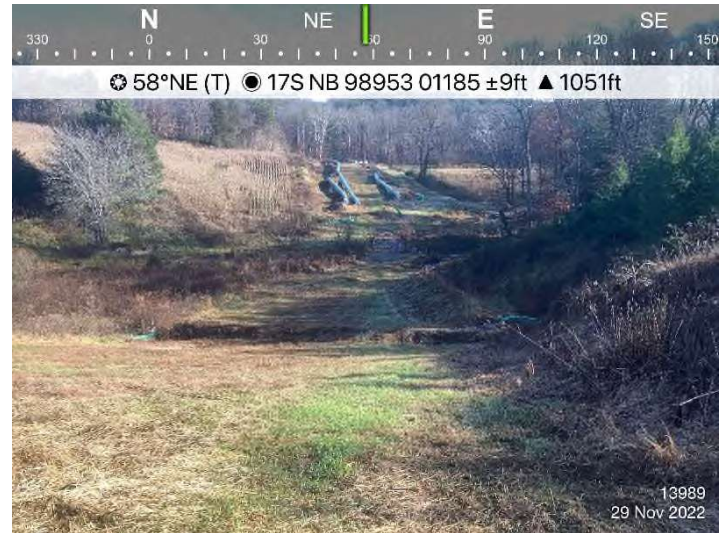
**Figure 2: STA 13989+00** – Controls in place and functioning properly.

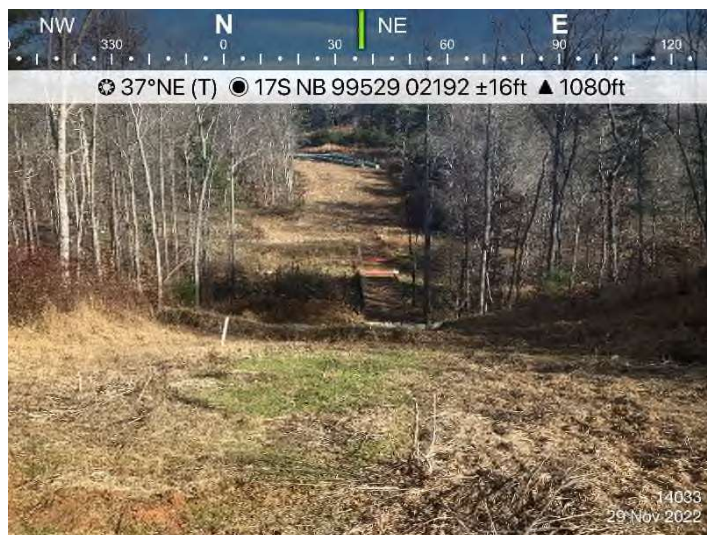
**Figure 3: STA 14033+00** – Controls in place and functioning properly.

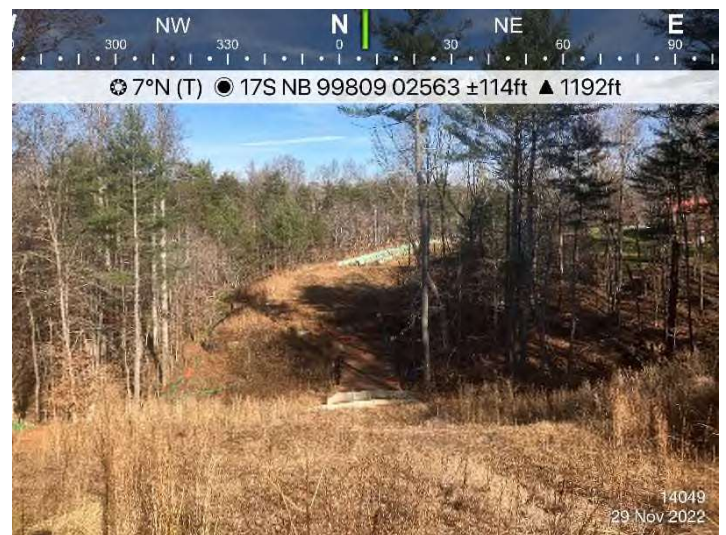
**Figure 4: STA 14049+00** – Controls in place and functioning properly.
