Project Name:	Mountain Valley Pipeline	Inspector:	Matthew Grant
Inspection Date:	Thursday, November 17, 2022	Project Contact:	Brian Clauto
Spread I: Franklin	ATWS1067, 613 13645-13690	Weather:	Wet

FIELD INSPECTION PHOTO LOG

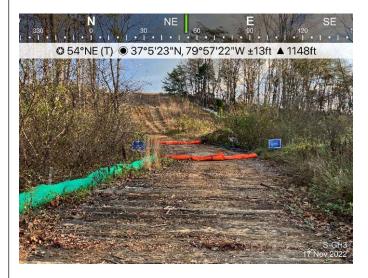
<u>Figure 1</u>: Designated crossing S-GH3, ESC controls were in place.

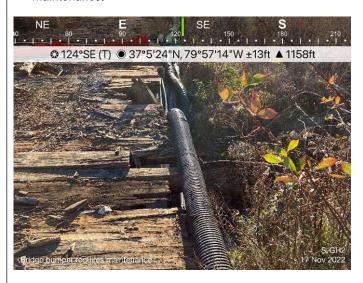
<u>Figure 2</u>: Designated crossing S-GH2, ESC bridge control requires maintenance.

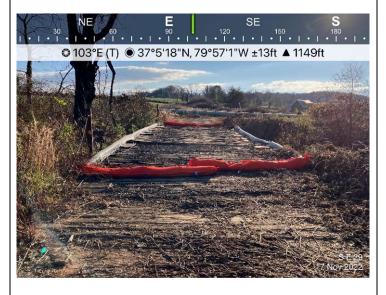
<u>Figure 3</u>: Designated crossing S-E29, ESC controls were in place.

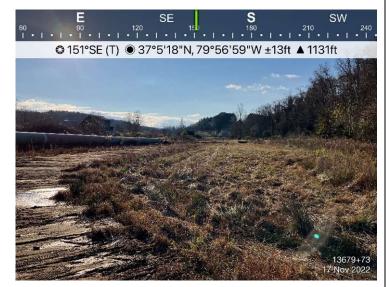
■ <u>Figure 4</u>: St 13679+73 ESC controls and stabilization remain in place.
